Aircraft Type: Slingsby T67 Firefly (all marks)

Title: Defective Standard Hardware – Self-Locking Nuts

MSAC IB 42 ISSUE 2 ANNEX A

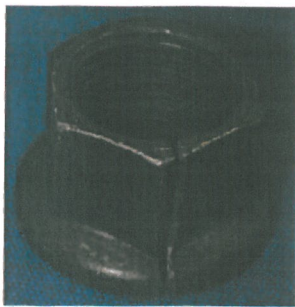
European Aviation Safety Agency (EASA) Safety Information Bulletin (SIB) 2012-06R1, Reference (1), provides information to manufacturers, aircraft owners, operators and maintenance staff of potential defective hardware that is known to have been installed on a variety of aircraft including the Slingsby T67 Firefly (all marks). In particular, many self-locking nuts have been found cracked, parallel to the nut axis (see Figure 1), in some instances only a short time after installation. Of the specifications noted in Reference (1), only self-locking nuts manufactured to LN9338 have been identified as applicable, specifically Kaylock HM14 and equivalent Simmonds type.

← **Figure 1 – Example of longitudinal crack reproduced from Reference (1)**

In the event that any self-locking nut has previously or is subsequently found cracked in the manner described in Reference (1) during any inspection or maintenance activity on a T67, the originator is asked to complete the attached form at Annex A and return it to the address provided. Additionally, consideration should be given to the recommendations included in Reference (1) to inspect self-locking nuts before installation and subject incoming lots of self-locking nuts to a torque check and inspection. For further information, please contact Gemma Hodgson, Marshall Slingsby Advanced Composites (MSAC) Product Support, on gemma.hodgson@marshall-slingsby.com
