Aircraft Type: Slingsby T67 Firefly (T67A, T67B, T67C, T67C3, T67M, T67M Mk11, T67M200, T67M260, T67M-T3A)

Title: Slick Service Bulletin SB1-15A – Potential of decreased service life of Slick 4-cylinder magneto distributor gear assemblies.

SUBJECT: Potential decreased service life of Slick 4-cylinder magneto distributor gear assemblies. **Based on process and component improvements following the initial release of this service bulletin, the serial number range is being extended in this revision. Magnetos previously returned for compliance to SB1-15 must be returned or inspected for compliance to this revision SB1-15A.**

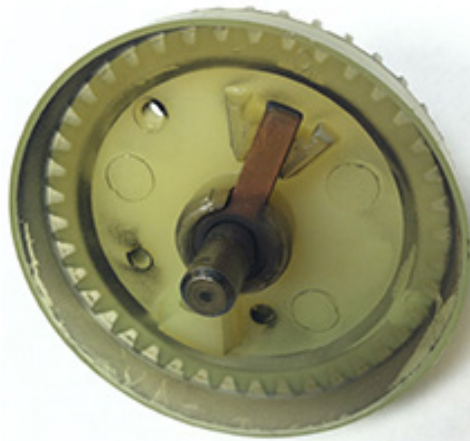
The initial release of SB1-15 was based on a limited number of field reports and product returns, Champion Aerospace has identified a possible condition in the distributor gear assemblies of 4-cylinder magnetos that can lead to decreased service life. Some of the returned products contained distributor gears exhibiting loosening of the electrode finger. This condition was observed in magnetos with a varying number of service hours. Typical symptoms are unusual RPM drop during magneto check, difficulty starting, and/or rough running engines.

Figure 3. Affected K3008 Distributor Gear With Copper Electrode

If it is not possible to confirm the version of the distributor gear that is installed in a given magneto from maintenance records, the magneto may be removed from the engine in order to have the housing and distributor block removed to allow visual inspection of the distributor gear. Distributor gears with Copper electrodes must be replaced with distributor gears with Monel electrodes.

COMPLIANCE: REMOVE affected distributor gear assembly in subject magnetos and REPLACE with replacement distributor gear assembly, K3008, as soon as possible, not to exceed the next 50 hours. Document Service Bulletin compliance as written entry in applicable Aircraft and/or Engine logbook.

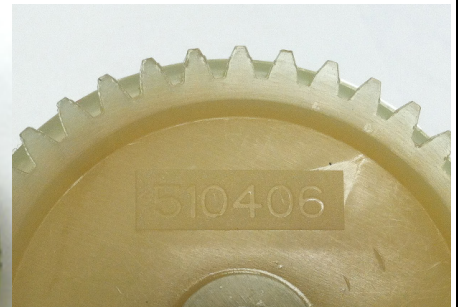
Figure 4. K3008 Distributor Gear Marked 510406 (Backside)

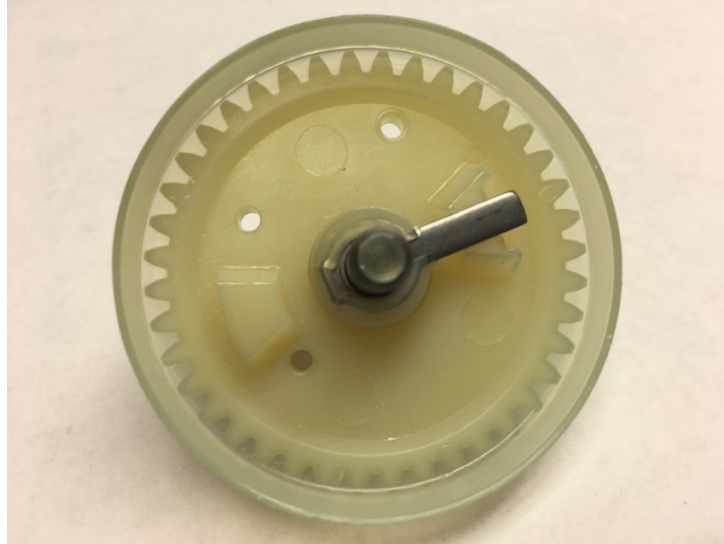
Figure 5. K3008 Distributor Gear With Monel Electrode
