Aircraft Type: Slingsby T67 Firefly (all marks)

Title: Defective Standard Hardware – Self-Locking Nuts

Information Bulletin

MSAC IB 42 ANNEX A

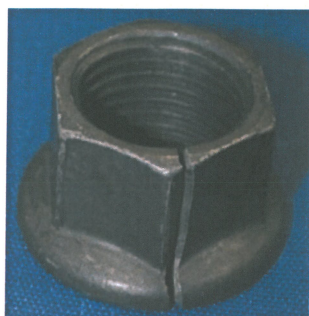
European Aviation Safety Agency (EASA) Safety Information Bulletin (SIB) 2012-06R1, Reference (1), provides information to manufacturers, aircraft owners, operators and maintenance staff of potential defective hardware that is known to have been installed on a variety of aircraft including the Slingsby T67 Firefly (all marks). In particular, many self-locking nuts have been found cracked, parallel to the nut axis (see Figure 1), in some instances only a short time after installation. Of the specifications noted in Reference (1), only self-locking nuts manufactured to LN9338 have been identified as applicable, specifically Kaylock HM14 and equivalent Simmonds type.

Figure 1 – Example of longitudinal crack reproduced from Reference (1)

In the event that any self-locking nut has previously or is subsequently found cracked in the manner described in Reference (1) during any inspection or maintenance activity on a T67, the originator is asked to complete the attached form at Annex A and return it to the address provided. Additionally, consideration should be given to the recommendations included in Reference (1) to inspect self-locking nuts before installation and subject incoming lots of self-locking nuts to a torque check and inspection. For further information, please contact Gemma Hodgson, Marshall Slingsby Advanced Composites (MSAC) Product Support, on gemma.hodgson@marshall-slingsby.com
