MARSHALL AEROSPACE AND DEFENCE GROUP SERVICE BULLETIN SBM 200

MARSHALL AEROSPACE AND DEFENCE GROUP BRAKE MASTER CYLINDER PIVOT PIN
EXAMINATION

Slingsby T67 Firefly T67B, T67C Series, T67M, T67M MkII, T67M200, T67M260.

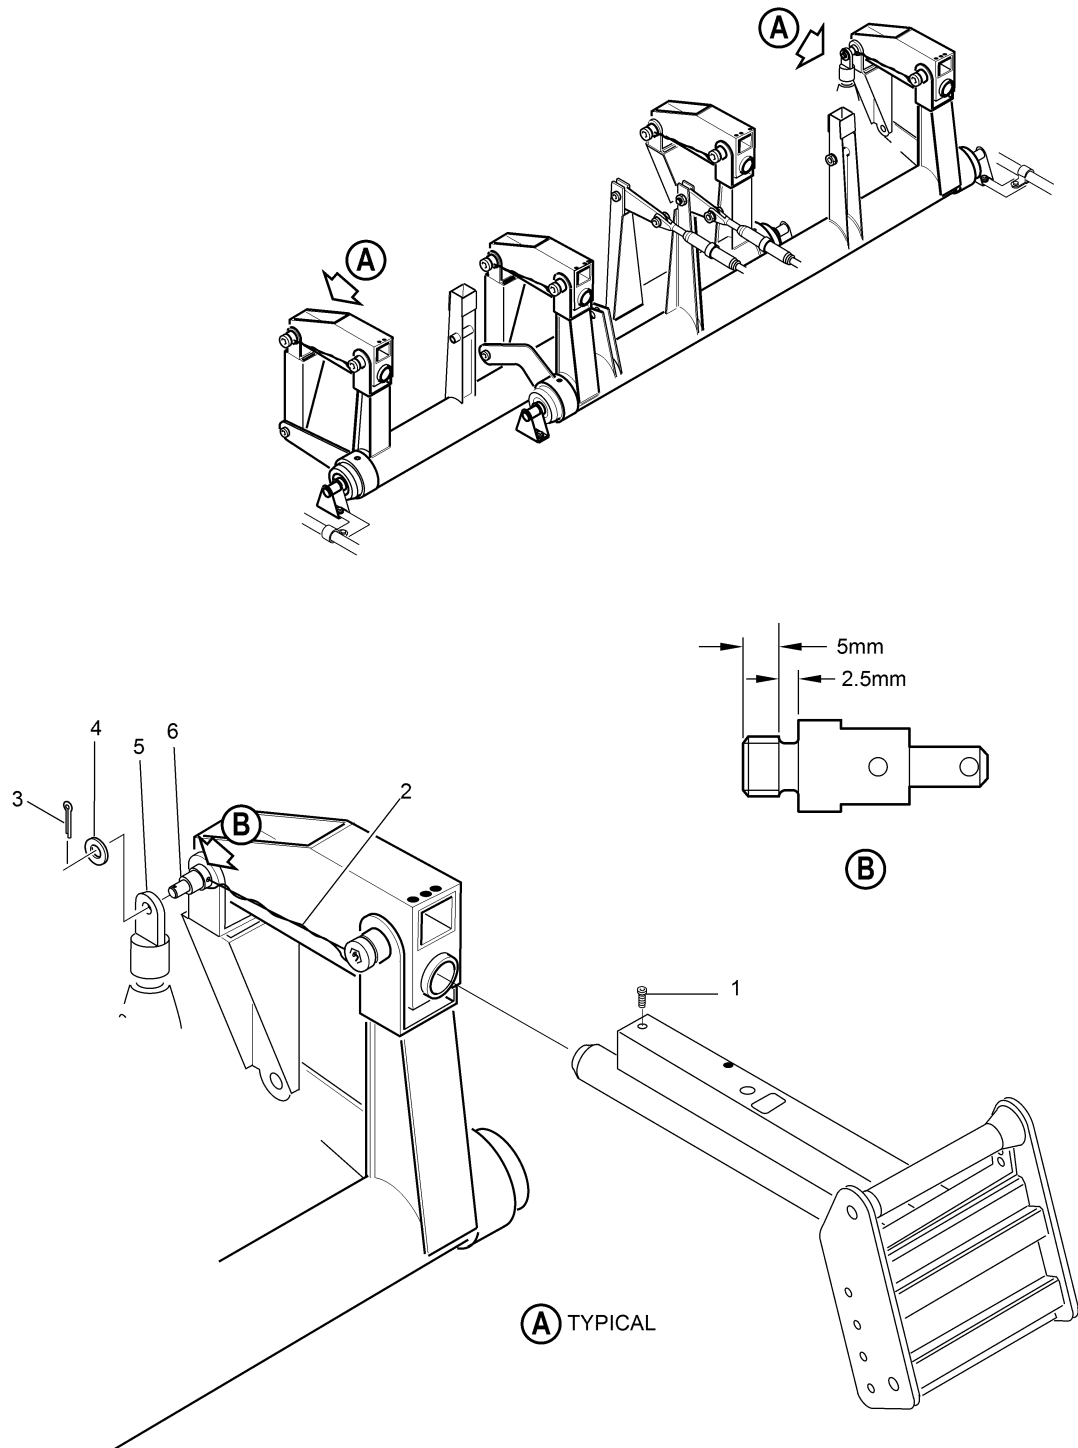
Examination - Brake Master Cylinder Pivot Pin
Figure 1

A case has been reported of the failure of a brake master cylinder pivot pin part number T67M-45-539 (Figure 1). Two of these pivot pins are fitted per aircraft, one to the #1 pedal assembly and one to the #4 pedal assembly. The operator reported hearing a breaking noise from the rudder pedal area during taxiing. An investigation was carried out and it was discovered that the brake master cylinder pivot pin had broken on the #4 pedal assembly.

- (g) Carry out visual inspection of brake master cylinder pivot pin for damage, cracks or distortion (Reference Figure 1 and Figure 2).
- (h) Carry out visual inspection for dimensional accuracy of threaded portion of the brake master cylinder pivot pin (Reference Figure 1 and Figure 3). (Ensure that threaded portion is 5 mm in length, and adjacent shank is 2.5 mm in length).

- (j) If any damage, crack or distortion to the brake master cylinder pivot pin is discovered or the pivot pin fails the dimensional requirement then it is considered to be unserviceable and is to be replaced.

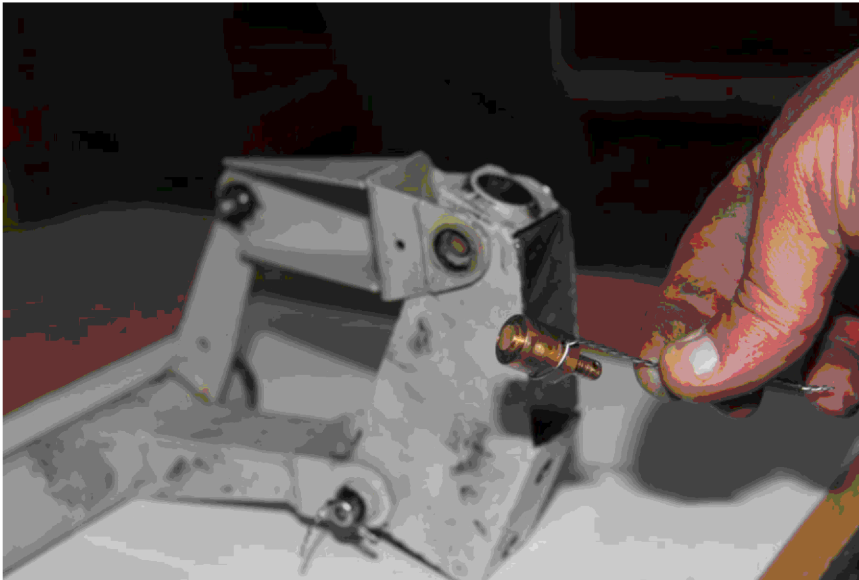
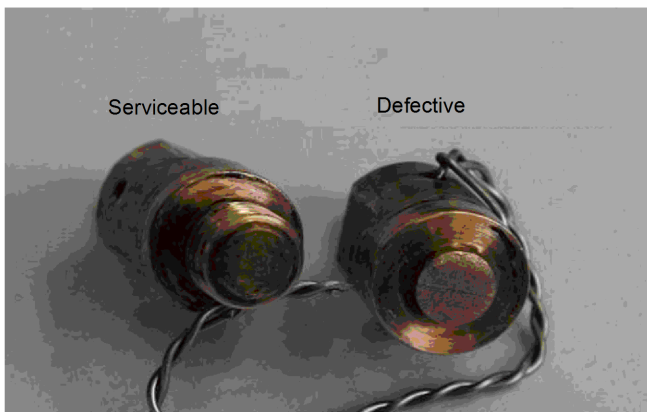
**Pivot pin
Figure 2**

The pin was broken between the threaded section and the larger central barrel (Figure 2). The surface of the broken material was found to be dull, indicating a possible fatigue related fracture.

- (i) Carry out NDI (fluorescent dye penetrant), using local regulations, of the brake master cylinder pivot pin threaded portion and shank where it enters the central barrel.

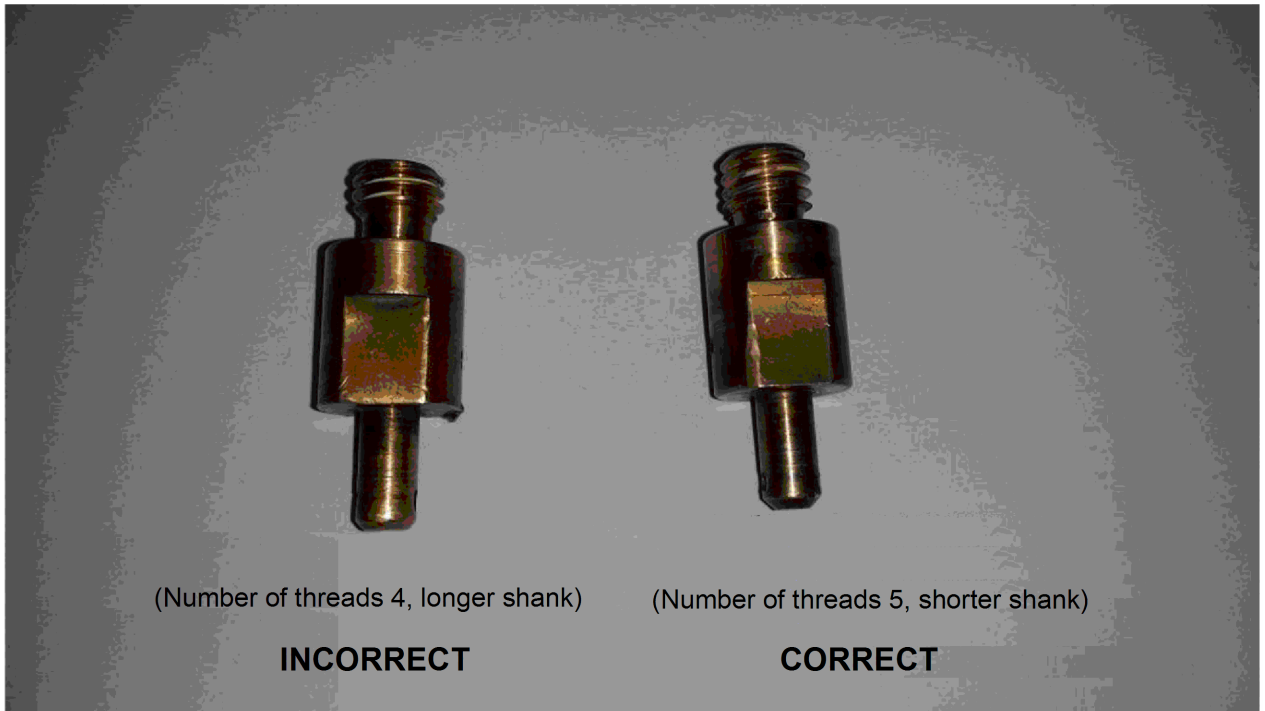
**Pivot pin threads
Figure 3**

Unrelated to the pivot pin failure instances of dimensional differences to the brake master cylinder pivot pin design have been discovered (Figure 3).
