SERVICE BULLETIN

SB No. 017

T67A AFT TAILPLANE LOCATION BRACKETS

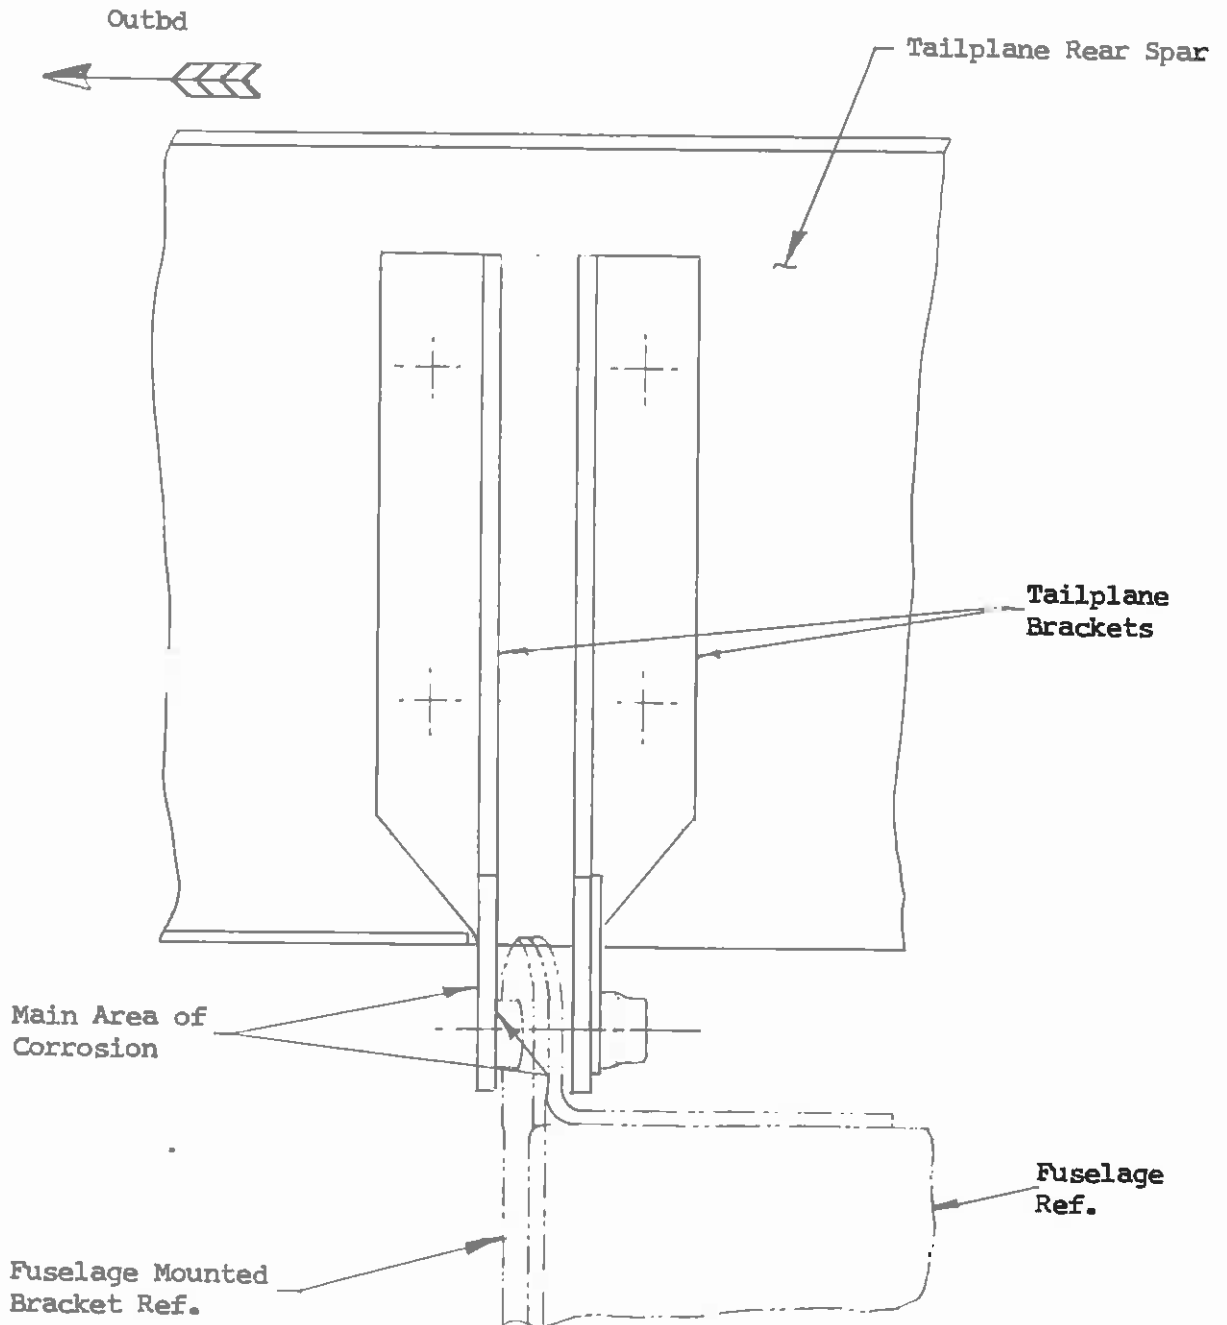
VIEW ON PORT BRACKETS

Recent inspections have highlighted exfoliation (layer corrosion) on unanodised tailplane mounting brackets. This Service Bulletin S.B. No.017) describes inspection and rectification procedures.

Partially remove tailplane and inspect for corrosion, especially on the inside of the outer brackets. Ref. Fig. 1 on page 2.

3.2.1 If no corrosion found reassemble tailplane.

3.2.2 If corrosion found change brackets refer Modification Bulletin M255.
