**SERVICE BULLETIN**

SB No. 84 Issue No. 1

INSPECTION OF RIB 2 LOWER FLANGE BOND TO WING SKIN

APPLICABILITY: T67M260 and T67M260-T3A

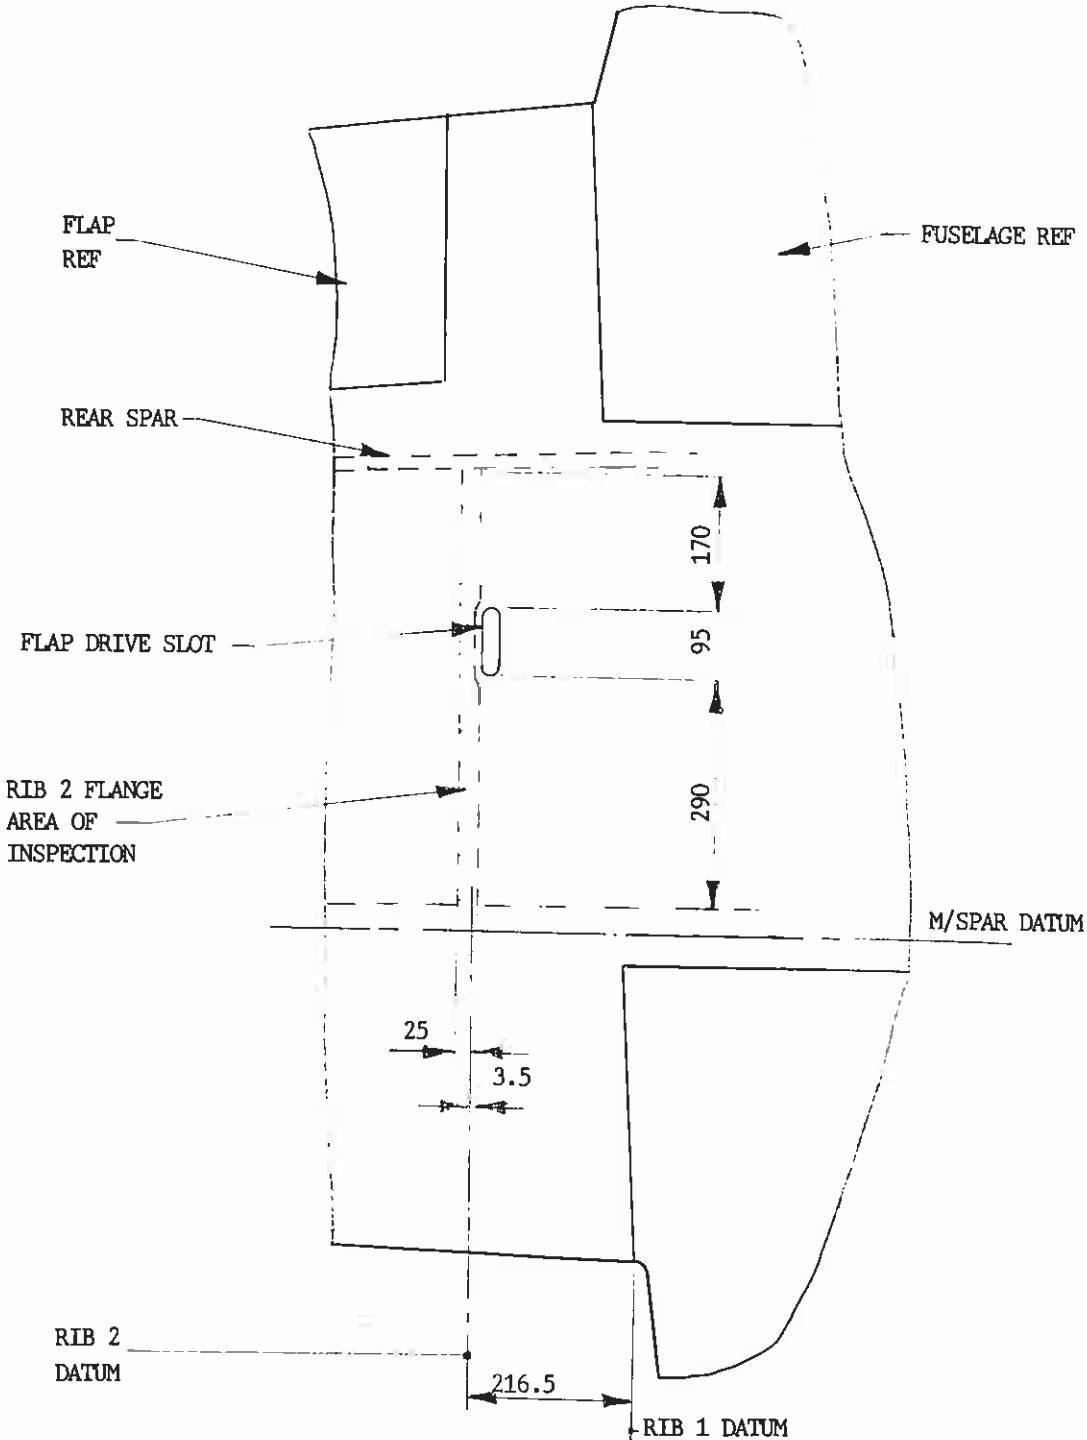
FIG 1
LOWER SURFACE PORT WING
STBD SIMILAR

It is possible that the bond between Rib 2 lower flange and inner wing skin is not satisfactory.

1. Referring to Fig. 1, over area indicated, determine integrity of bond by applying tap test and listening for tonal changes which indicate voids. (This should be only carried out by persons with composite bonding experience.)
2. If bond is found to be satisfactory annotate in Logbook "S.B. 84 complied with".
3. If bond is suspect or found to be de-bonded inform SAL Product Support Department quoting Works/Construction/Serial Number of affected aircraft. Rectify in accordance with (Mod M678) Repair Drawing T67G-03-049 before further flight.
4. On completion of repair annotate logbook "Mod M678 incorporated".

For Repair Drawing T67G-03-049 "Repair to Rib 2 Flange to Lower Skin Bond". contact SAL Product Support Department.
