**SERVICE BULLETIN**

SB No. 100 Issue No. 1

TITLE **WATER INGRESS INTO COCKPIT FROM ECS FRAME 2 BAY**

T67M260-T3A Post Mod M501A aircraft.

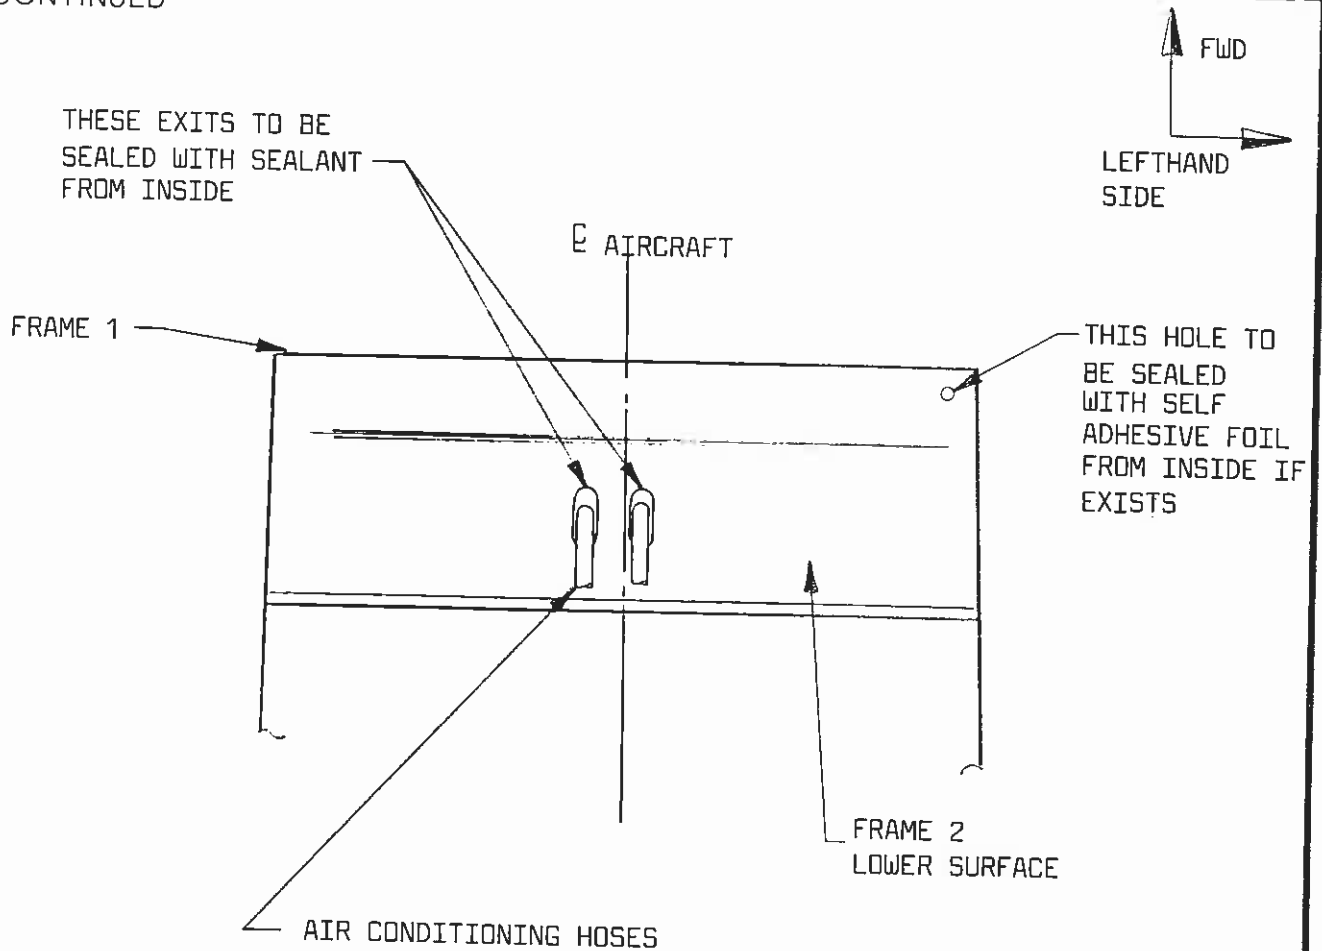
FIG 1  
VIEW LOOKING UP ONTO UNDERSIDE OF FRAME 2

Cases have occurred of water ingress into cockpit from Frame 2 bay which houses the ECS evaporator. Upon further investigation it was found that the bay had not been sealed.

1. From the underside of Frame 2, check suspect areas for sealant. Refer Fig. 1.
2. If holes are visible gain access into Frame 2, remove any water, clean and degrease around areas to be sealed.

Apply sealant RTV 781 (or 732 or 786) around air conditioning rubber hoses.
3. From a sheet of aluminium self adhesive foil, cut a blank approx. ½" oversize than the hole and bond into position.
4. Record in logbook SB 100 complied with.
