# Service Bulletin

S.B. No: 75

INSPECTION OF RUDDER PEDAL SLIDER/HEATER DISTRIBUTION BOX CLEARANCE

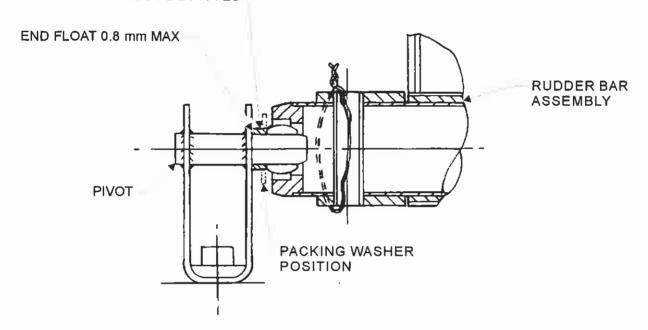
FIG 1

At each rudder bar pivot position (4 places) there should be one spacer T67M-45-507 **OR** one off washer 126-23-748 (AN960-516) and up to a maximum of two off 126-23-749 (AN 960-516L) ie 3 washers maximum.

SPACER T67M-45-507 OR 1 OFF 126-23-748 PLUS 1 OR 2 OFF 126-23-749 WASHERS MUST BE FITTED

If end float of greater than 0.8mm is present, then 1 off only packing washer may be added at each pivot position as required, ie 126-23-105 M8 washer or 126-23-748 or 126-23-749 washers.

If packing washers are required on the right hand rudder bar (T67M-45-259) then the packing washer (or the thicker washer if a thick and thin washer are required) should be placed at the outboard pivot.

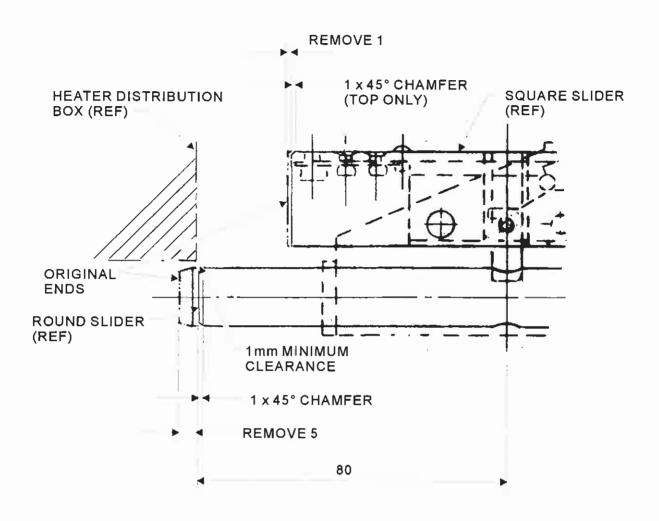
FIG 4

DIMENSIONS IN MILLIMETRES
ETCH PRIME CUT ENDS

- 3.3 Modify pedal assy No.2, as follows:
  - 3.3.1 Remove No.2 pedal assy and modify as per Figure 4.

Note: Modify both square and round slider.

- 3.3.2 No.2 pedal assy to be re-identified as T67G-03-851 and Mod M663. Annotate Mod M663 incorporated.
- 3.3.3 If clearance, ref paragraphs 1. and 2, is achieved, annotate in Log Book "SB No.75 complied with". If not, proceed to paragraph 3.4.
- 3.4 Check heater box seating as follows, ref. Figure 5:
  - 3.4.1 Remove heater box and counter bore holes in accordance with Figure 5, Section A-A.
  - 3.4.2 Replace box and check seating. If box top flange fouls cleat cloth joining Frame 1 to Frame 2, then it is to be removed in accordance with Figure 5, Section B-B.
  - 3.4.3 Replace box. If clearance, ref paragraphs 1 and 2, is achieved, annotate in Log Book "SB No.75 complied with".
  - 3.4.4 If clearance is not achieved, then inform SAL.

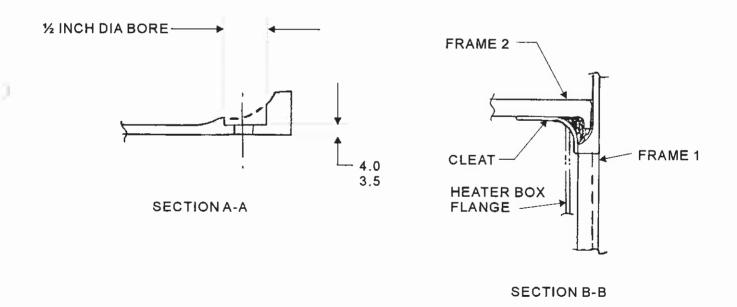
FIG 5

# CLEAT REMOVE MINIMUM REQUIRED TO SEAT HOT AIR BOX FRAME 2 CLEAT CLOTH
