# SERVICE BULLETIN

56

**TITLE**
**INSPECTION OF AIR INTAKE BOX BY-PASS FLAP HINGE.**
**CLASSIFICATION**

All T67M, M MKII and M200 Series Aircraft.

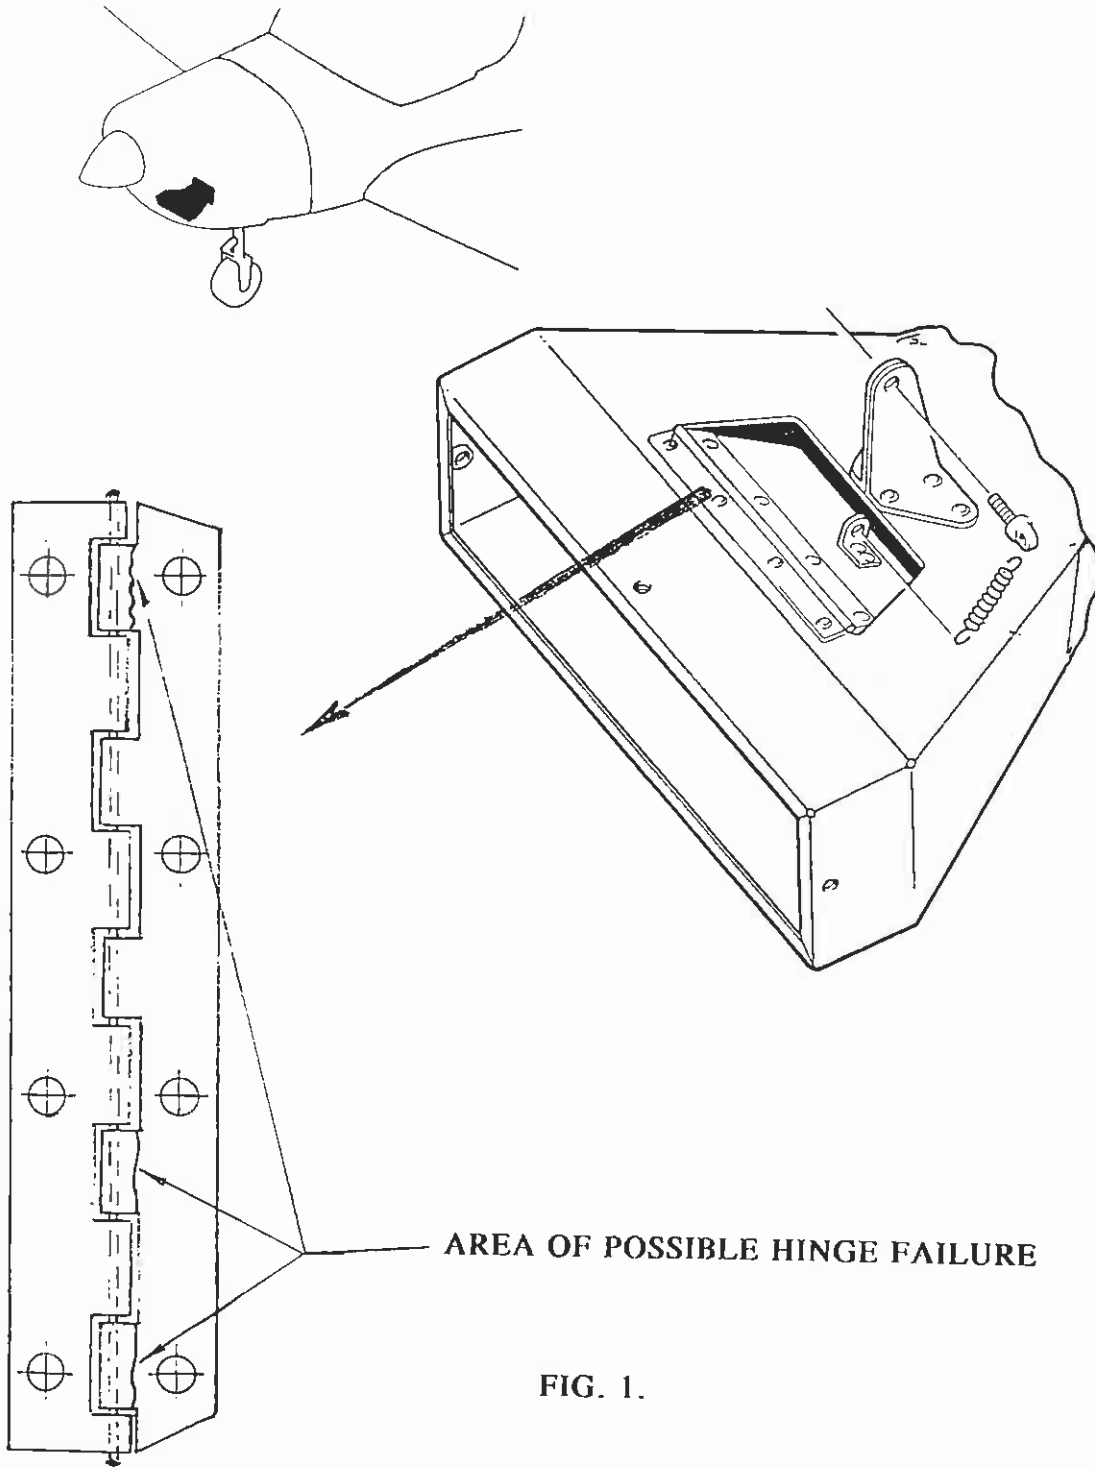
An incident has occurred whereby the rivets holding the hinge assembly to the air duct have loosened and the flap assembly has become detached.

Inspect the Air Duct Assembly for signs of loose rivets and loose hinge pin. Particular attention should also be paid to each piano hinge segment as cracks can develop in the area shown in fig 1.

If three or more hinge segments are found to have cracked or loose hinge pins are found, the unit is not acceptable for continued service.

If one or two hinge segments are found to have cracked the aircraft can continue to fly subject to further inspections at subsequent 50 hour checks.

If no cracks or damage are found repeat this inspection at every subsequent 150 hour check.
