SERVICE BULLETIN

033

SPECIAL INSPECTION OF RUDDER BAR PEDAL SUPPORT LUGS ON T67
 GRP SERIES AIRCRAFT

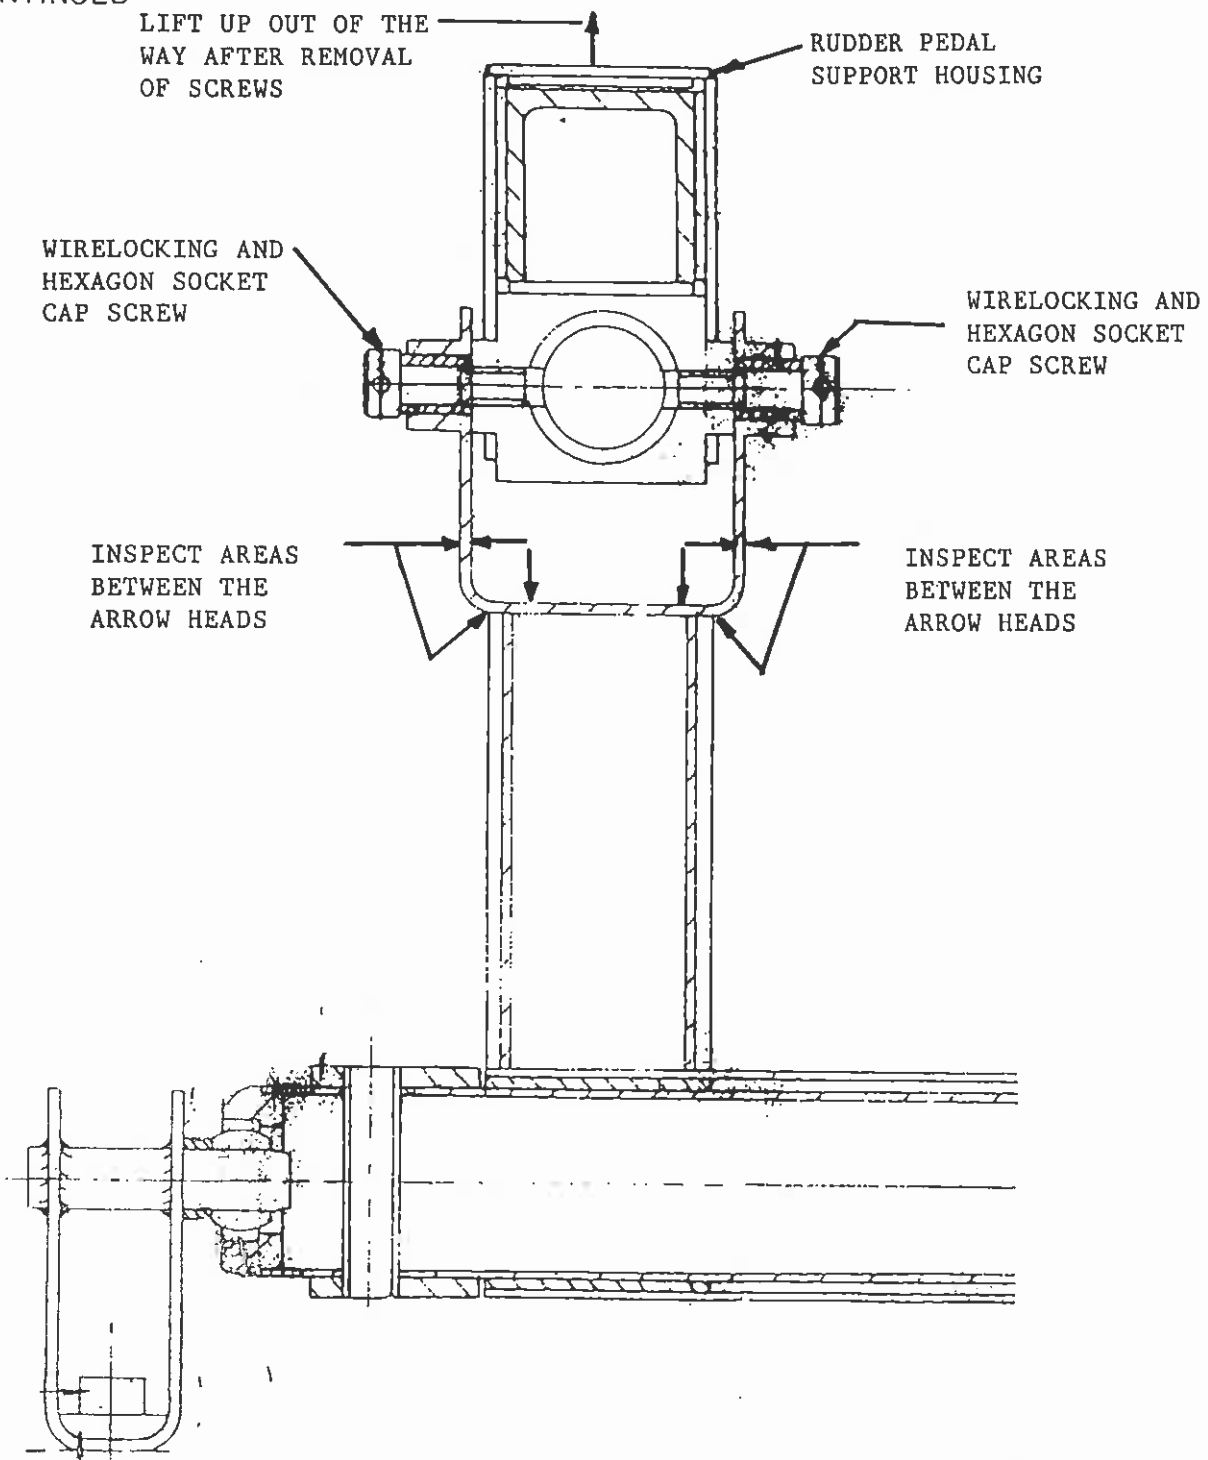
FIG 1: SECTION THROUGH PART OF RUDDER BAR ASSY. (TYP 4 POSNS)

Two instances of the rudder bar pedal support lugs having broken off have occurred. The first case was considered to be caused by damage sustained during the manufacturing process. The second case, which occurred during taxiing manoeuvres, has led to an SAL investigation into all aspects of the lug design. Pending the results, the following inspection procedure must be carried out.

- (i) Remove the hexagon socket cap screw retaining each of the rudder pedals. Remove the rudder pedals.
- (ii) Remove the locking wire from the 2 (off) hexagon socket cap screws retaining the aft end of each rudder pedal support housing. See Fig. 1. Remove the screws.
- (iii) Lift the aft end of the rudder pedal support housings upwards out of the way - retain in this position.
- (iv) Remove the protective treatment from the area of the lug lower radii shown in Fig. 1.
- (v) Inspect the areas shown using a dye penetrant method to check for cracks.

INSPECT AREAS BETWEEN THE ARROW HEADS

- (vi) If cracks are not found then restore to standard finish i.e. etch prime and spray 1 coat cellulose hammerite hammer grey, or equivalent, and reassemble as standard practice.
- (vii) If any cracks are found then the relevant rudder bar/s must be replaced by new items before next flight.
