Service Bulletin

S.B. No: 179

Title: INSPECTION OF TAILPLANE ATTACHMENT BRACKETS

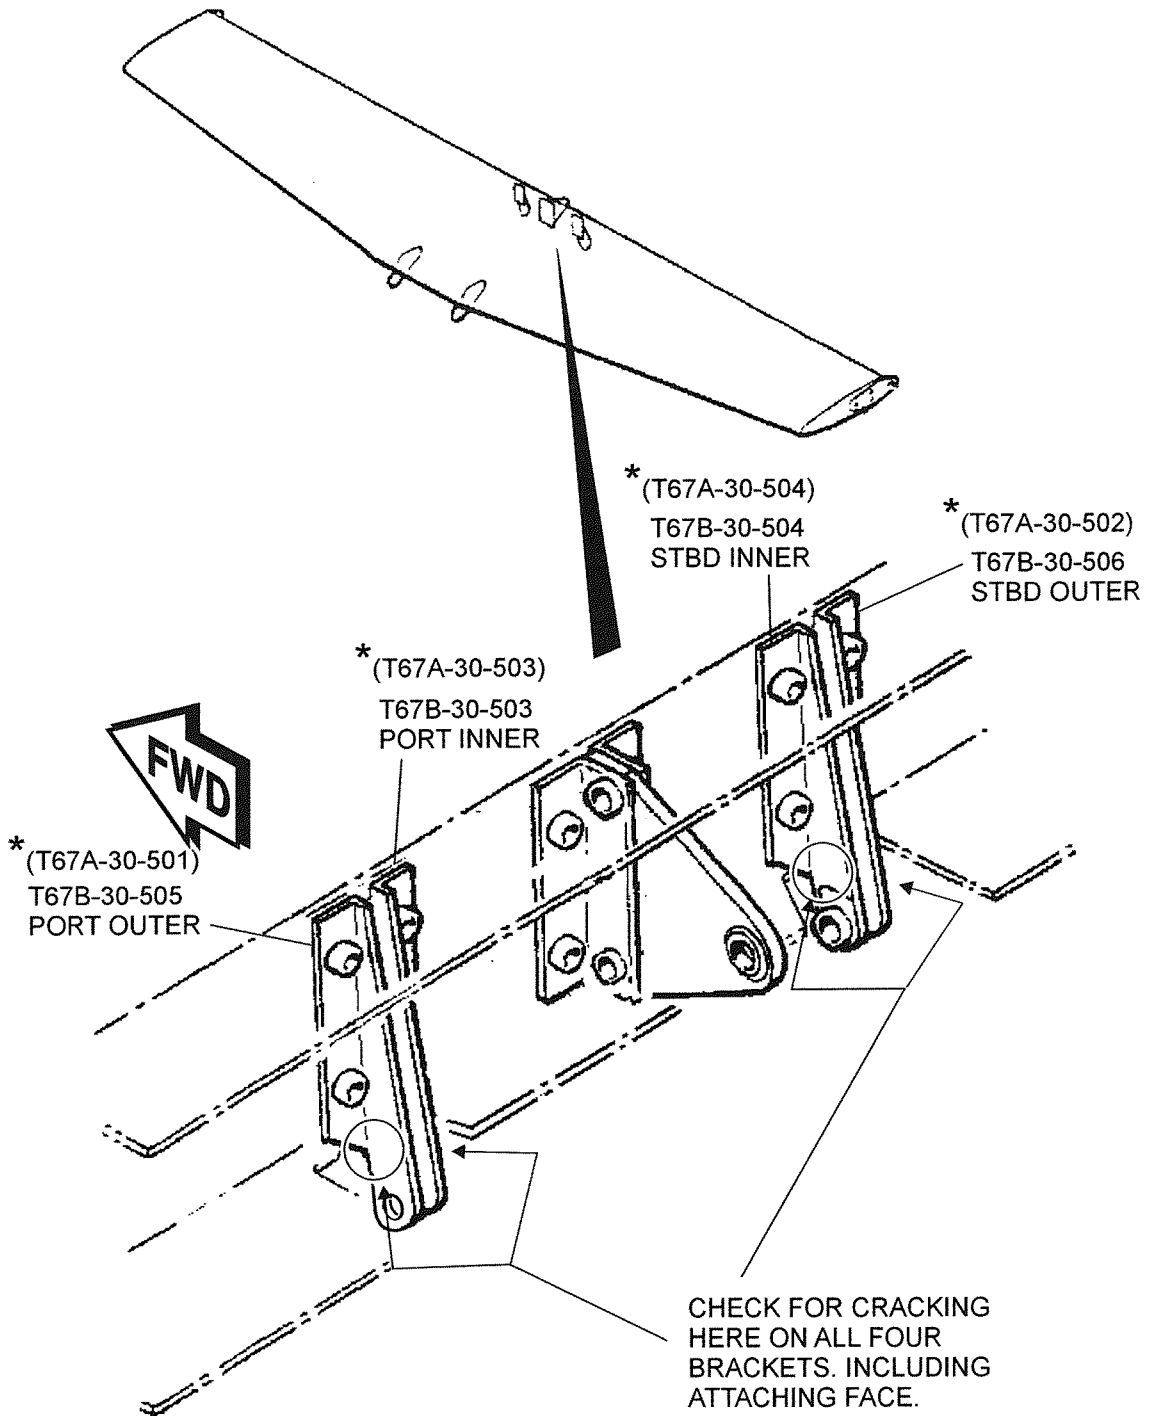
FIGURE 1

Cases have been reported of cracked tailplane brackets. This Service Bulletin details inspection of the aft tailplane brackets in order to discover similar cracks.

4. Perform dye penetrant (or similar) NDT crack detection on brackets and examine, paying particular attention to the region illustrated in Figure 1.
5. Should any crack be discovered, then all four tailplane-mounted brackets from the subject aircraft shall be returned to SAL and replaced with new items.

1. Check master switch, ignition switch and fuel are OFF. Disconnect external power and hangar aircraft, if required.
2. Remove tailplane and gain access to aft tailplane mounting brackets and remove from tailplane main spar. Ref. Figure 1.

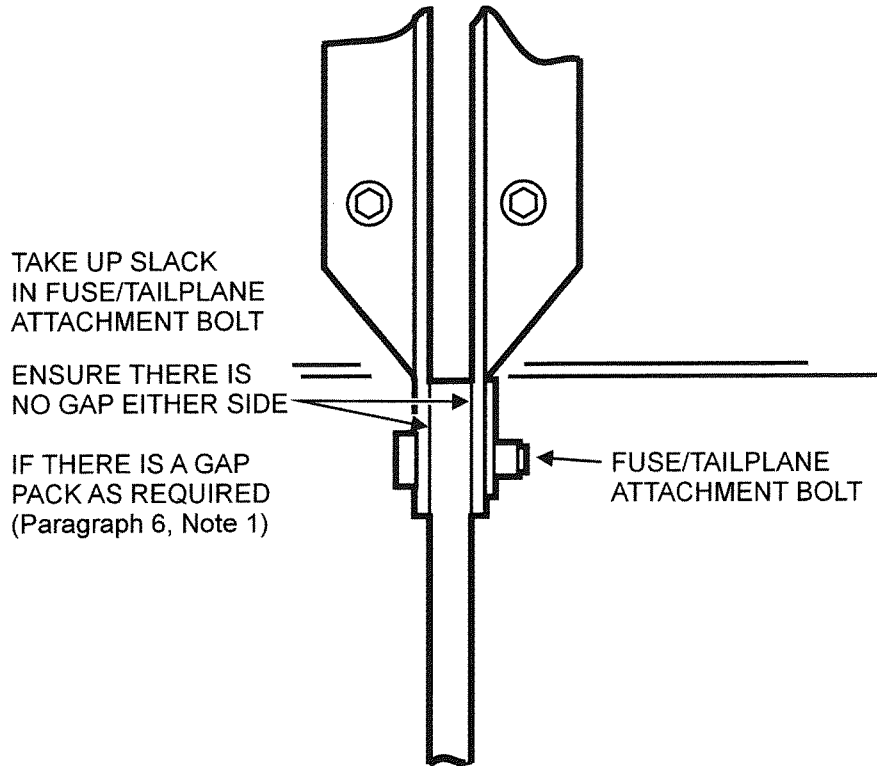
FIGURE 2

PORT ATTACHMENT SHOWN
STARBOARD SIMILAR
