Service Bulletin

S.B. No: 165

Title: INSPECTION FOR WATER IN LEADING EDGE OF RUDDER PLUS ADDITION OF DRAIN HOLE

Applicability: T67B, T67C, T67M, T67M-MkII, T67M200, T67M260 and T67M260-T3A

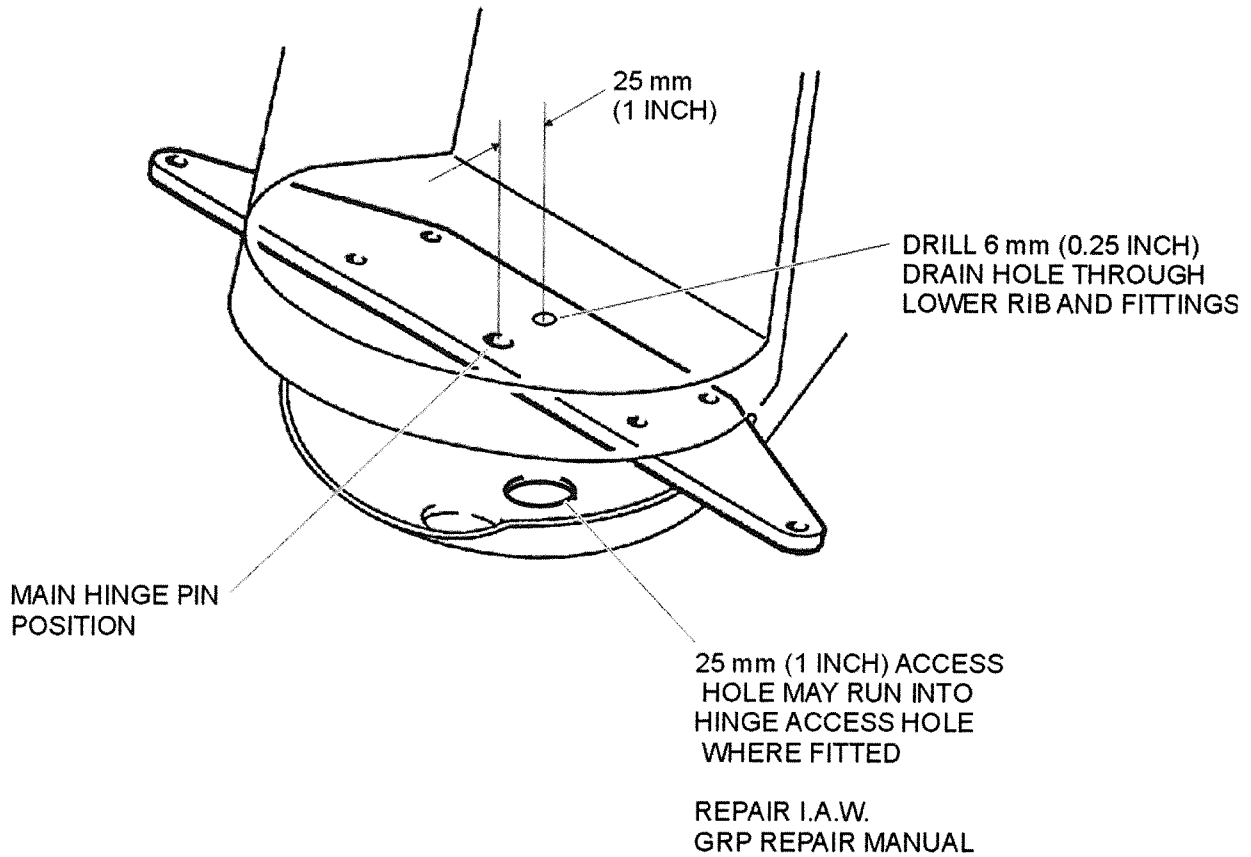
FIG 1
RUDDER LOWER HINGE

A case has been reported of water accumulation in the lower 'D' box of the leading edge of the rudder.

1. Remove rudder from aircraft in accordance with Maintenance Manual.
2. Mark position of 6mm (.25 inch) drain hole on the rudder horn. Carefully form a 25mm (1 inch) diameter access hole in the rudder lower fairing on centreline. Ref Fig. 1. This hole to be as directly under proposed drain hole as possible.

3. Carefully drill 6mm (.25 inch) diameter hole in the leading edge of the lower rib as shown in Figure 1.
Note 1: Drill through rudder horn fitting.
Note 2: Drill will also penetrate tapping plate 1.2mm (.048 inch) thick sandwiched in rib lay-up.

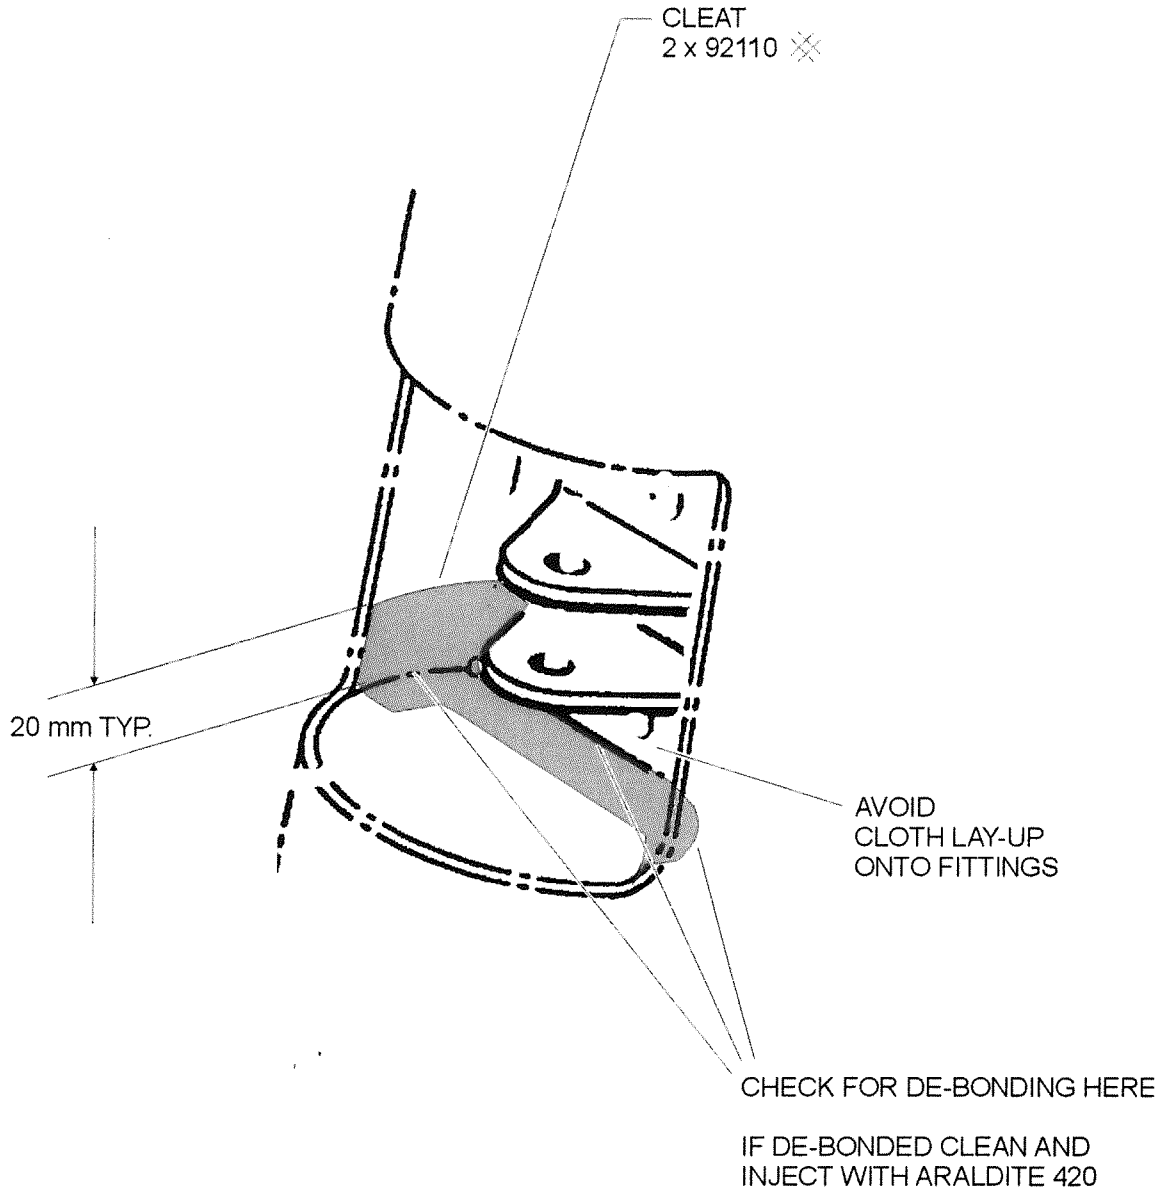
FIG 2
RUDDER TOP HINGE

4. Drain out any water that may be present and allow to dry.
5. Inspect the upper rudder hinge lower closing rib bond, both to the rudder skin and spar for signs of bond failure Ref Figure 2. If a debond is found use a suitable feeler gauge to establish extent of failure.

6.
 - i) If bond has failed then clean joint and inject with Araldite 420. Allow to cure. Continue as per paragraph 7.
 - ii) If joint is sound then continue as per paragraph 7.

7. Refer to Figure 2 and prepare area for laminating. Laminate 2 layers 92110 ✖ cloth over area shown, allow to cure. Laminate in accordance with T67 GRP Repair Manual.

Note: Ensure fitting is laminated around and that fitting has release agent or tape on it to prevent laminate contaminating hinge.
8. Paint resin into drain hole created at paragraph 3 and repair 25mm (1 inch) hole in rudder lower l/edge i.a.w. T67 GRP Repair Manual. Ensure existing access hole/drain hole is not blocked.
9. Refinish repaired areas in accordance with T67 GRP Repair Manual.
10. Annotate logbook "SB 165 complied with, Mod M906B incorporated".
