SERVICE BULLETIN

INSPECTION OF SLINGSBY T67 FIREFLY PROPELLER SPINNER SUPPORT DISC FOR RUBBER CONDITION

Slingsby T67M, T67M-MkII, T67M200 and T67M260 Firefly Variants

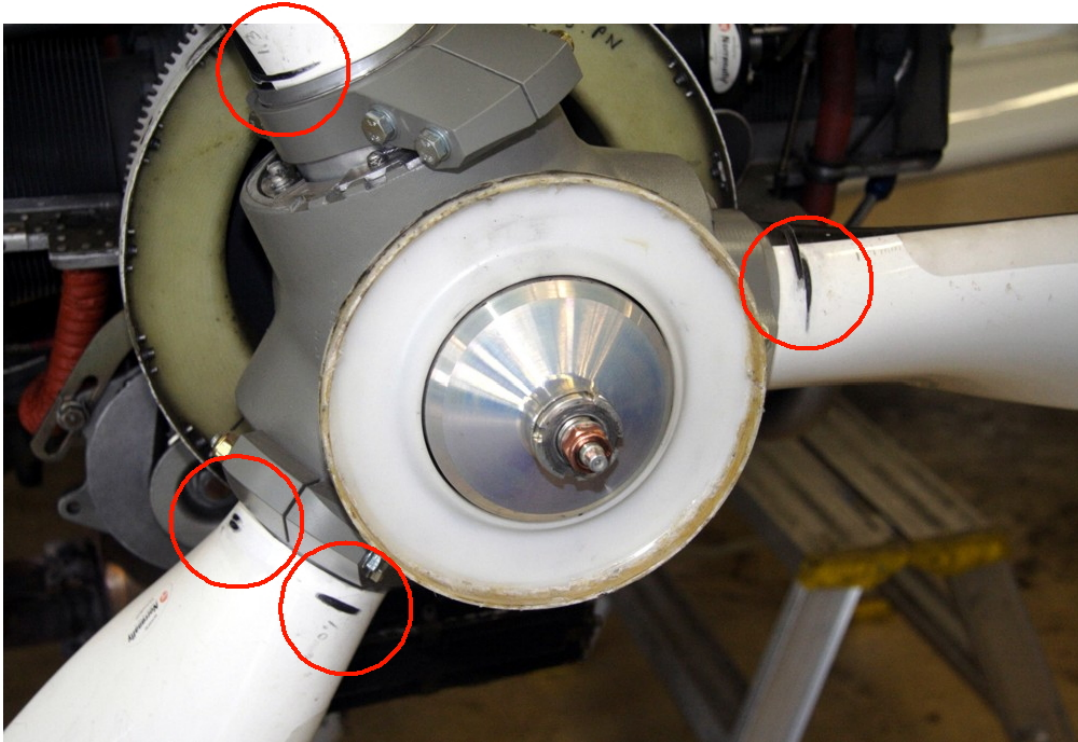
Figure 1 Areas of inspection

A maintenance company noted grooves in the root of the aircraft's propeller blades when performing the 150 flying hour check on a T67M200. Further investigation noted movement in the spinner cone and when the spinner was removed, it was seen that the spinner cone's supporting disc rubber had broken free, allowing excessive movement of the spinner cone, such that cone contacted the blade roots creating the grooves.

- (1) Inspect the roots of the propeller blades, for spinner contact, Figure 1 shows.
- (2) For any blade showing contact, evidenced by paint removal down to the blade structure, the propeller is to be removed and returned to Hoffmann or Hoffmann approved agent, for further inspection/repair. Remove propeller iaw aircraft Maintenance Manual paragraph 8.1.1 (4), (5) plus for the T67M260 paragraph (6).
- (3) Check condition of spinner support disc rubber for perishing (cracks and brittleness), rubber bond integrity to the support disc and rubber wear, Figure 2 shows (T67M200 and T67M260).

AREA OF GROOVING ON PROPELLER

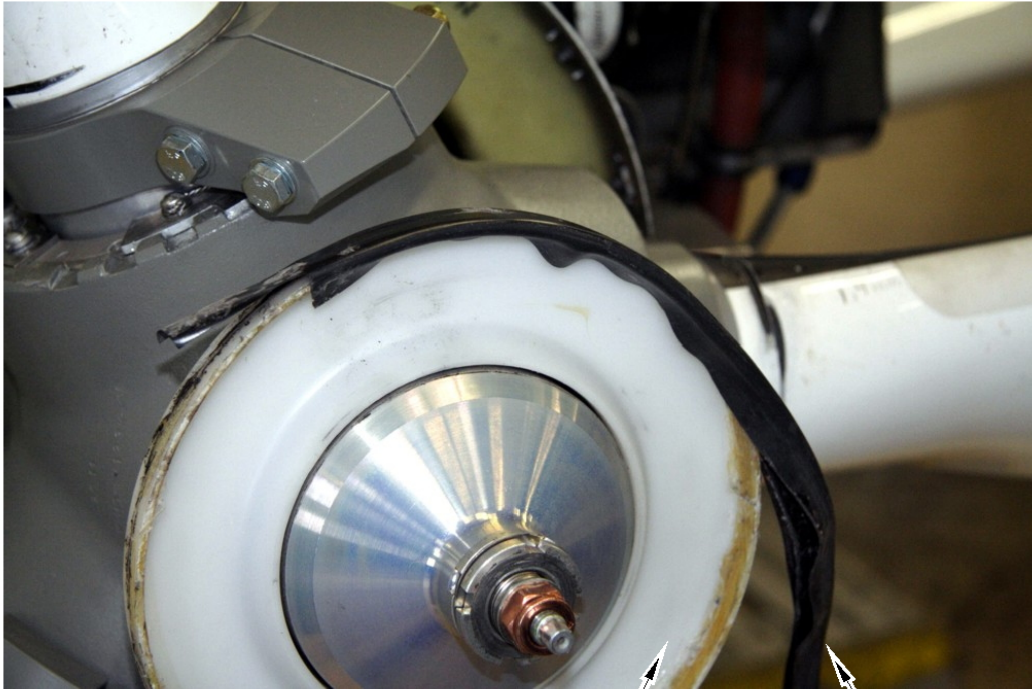
Figure 2 De-bonded rubber strip (T67M200)

SPINNER SUPPORT DISC

RUBBER STRIP
DE-BONDED

- (4) Should rubber exhibit any defect as described in (3) above it should be removed and replaced.

NOTE For T67M and T67M-MkII; use MSAC code number 126-15-116, and for T67M200 and T67M260; use MSAC code number 126-15-131. Ensure surfaces are free from rubber and adhesive, degrease and remove any dust from surfaces to be bonded. Apply adhesive 126-51-211 (3M PR 1300L) iaw manufacturer's instructions and allow to cure.
