SERVICE BULLETIN

SB No. 41 Issue No. 1

TITLE
SPECIAL INSPECTION OF THROTTLE CABLE - T67 GRP AIRCRAFT EXCEPT T67C

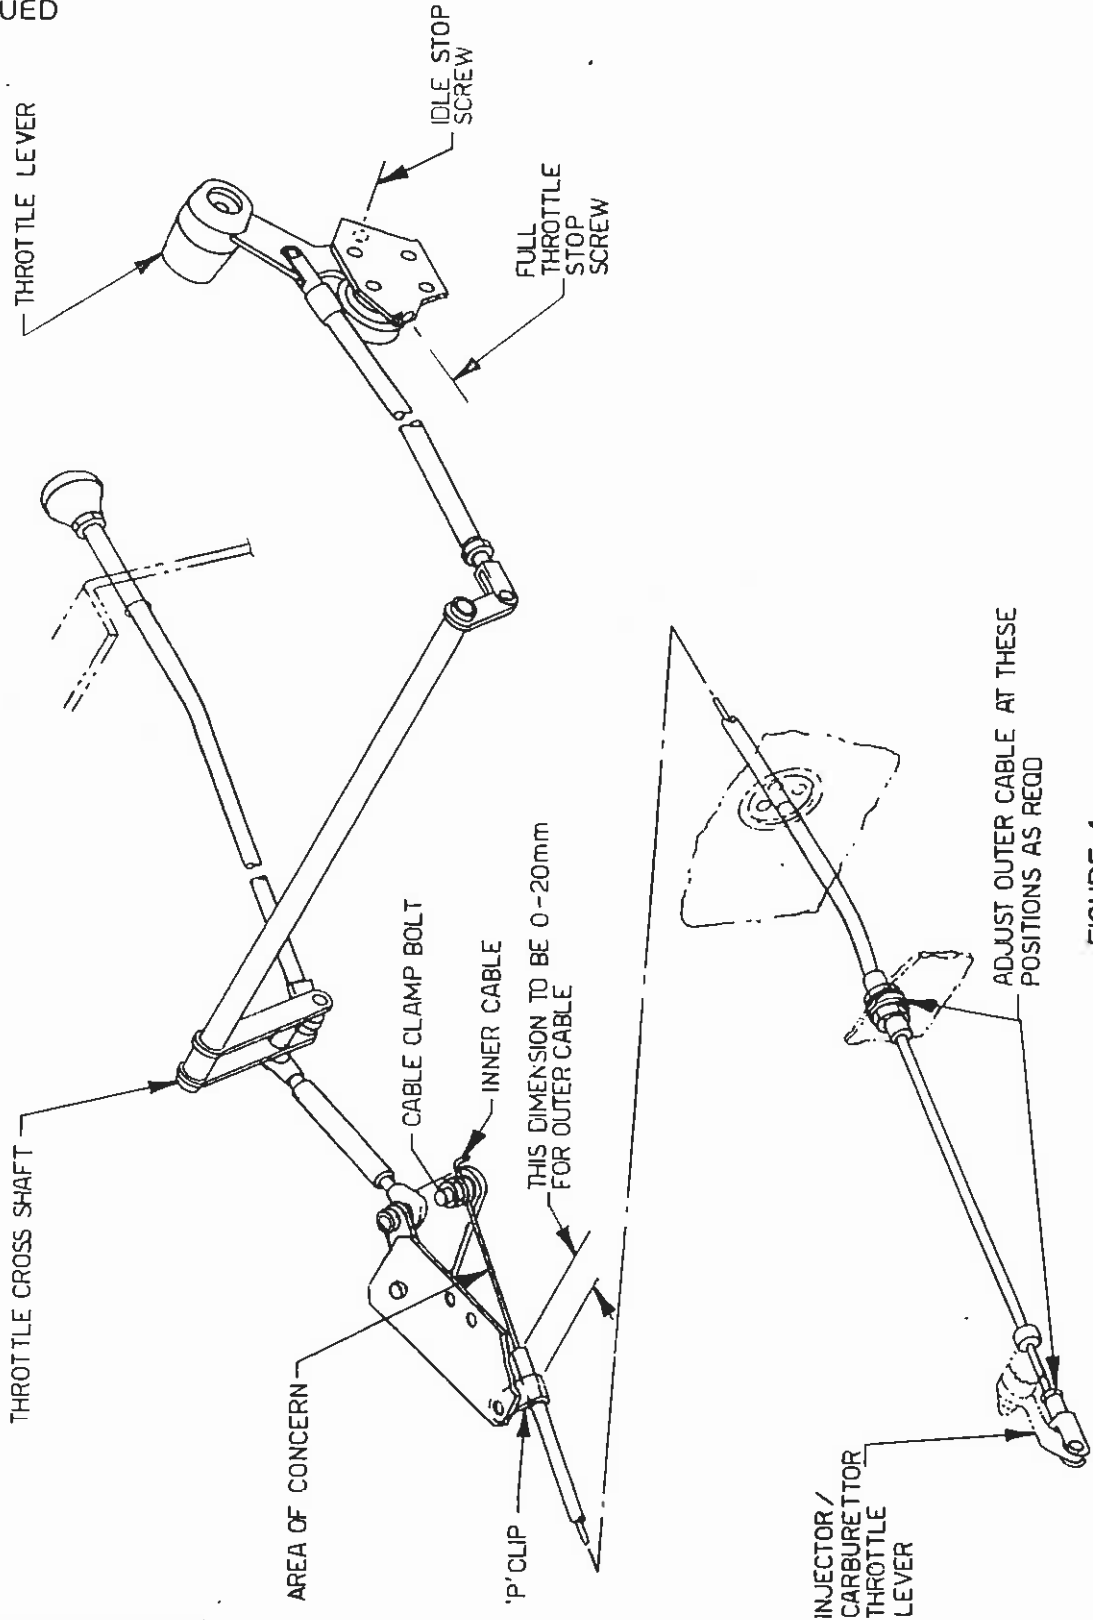
FIGURE 1
(POST MOD M326 DRN)
(T67M & T67M MK II SIMILAR)

There have recently been cases of breakage of the throttle cable on T67 g.r.p. aircraft. In these cases the cable has broken at the cockpit end at a point where the inner cable emerges from the outer cable, see Figure 1.

3. Withdraw the cable about 2 cm. - this ensures that all the affected part of the inner cable will be visible.
4. Visually examine the inner cable for evidence of kinking or cracking - if either is found the cable must be replaced.

5. Check that the length of the outer cable which extends aft beyond the "P" clip, is between 0 and 2 cm. If necessary, adjust the cable position to lie within this tolerance by slackening the "P" clip, repositioning the cable, and retightening the "P" clip. It may be necessary to also adjust the outer cable clamp position at the engine end of the cable. When retightening the "P" clip, ensure that it is angled to equalize sideways bending of the inner cable during operation.
