# SERVICE BULLETIN

SB No. 51 Issue No. 1

**TITLE**
**INSPECTION OF RUDDER CABLE TO LINK PLATE SOCKET HEAD CAP SCREW**
**CLASSIFICATION**

All T67 GRP series aircraft Post Mod 95.

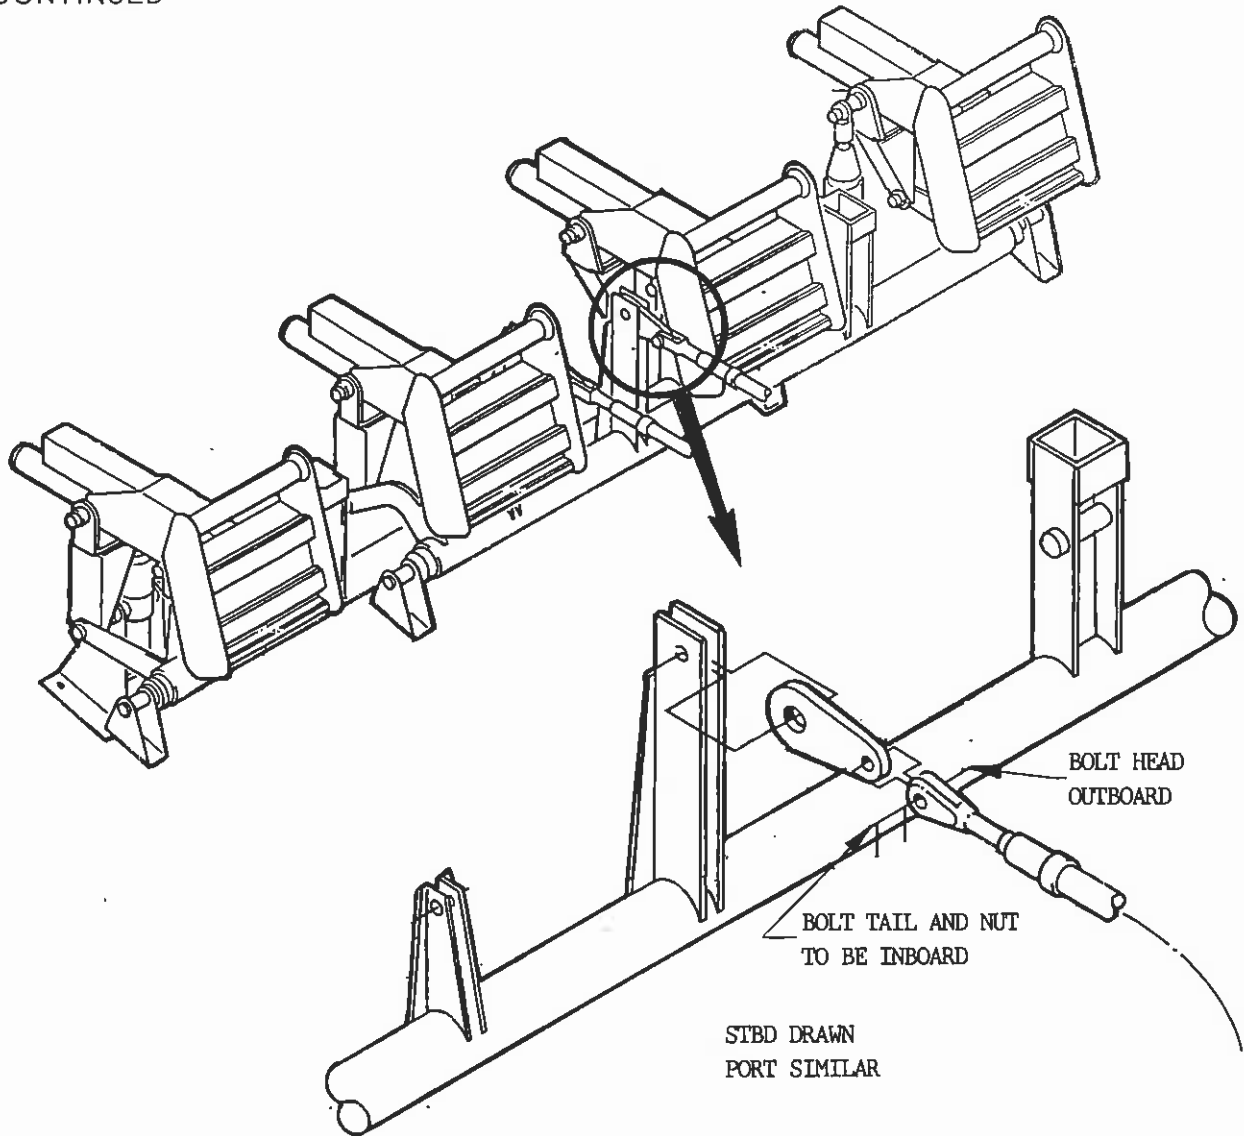
Fig 1

Following an incident whereby the rudder pedal fouled on the rudder cable link plate bolt tail, subsequent inspection found that the bolt was incorrectly assembled.

1. Refer to Fig. 1. Check the direction of the head of the bolt. It must be outboard, ie towards the No.3 pedal and a minimum clearance of 8mm from the pedal must be present after taking up any slack or backlash in the rudder pedal system.
2. If it is not in the correct orientation, remove and replace it with the bolt head adjacent to the rudder pedal.
3. Some aircraft have a socket head cap screw fitted pre Mod M471. SAL Mod M471 is available to fit a pan head bolt which increases the clearance to the rudder pedal, if required.
4. If the required clearance is not achieved through correct orientation and implementation of Mod M471, contact SAL Product Support Department for further information.
