MARSHALL AEROSPACE AND DEFENCE GROUP SERVICE BULLETIN SBM 200

MARSHALL AEROSPACE AND DEFENCE GROUP BRAKE MASTER CYLINDER PIVOT PIN
EXAMINATION

Slingsby T67 Firefly T67B, T67C Series, T67M, T67M MkII, T67M200, T67M260.

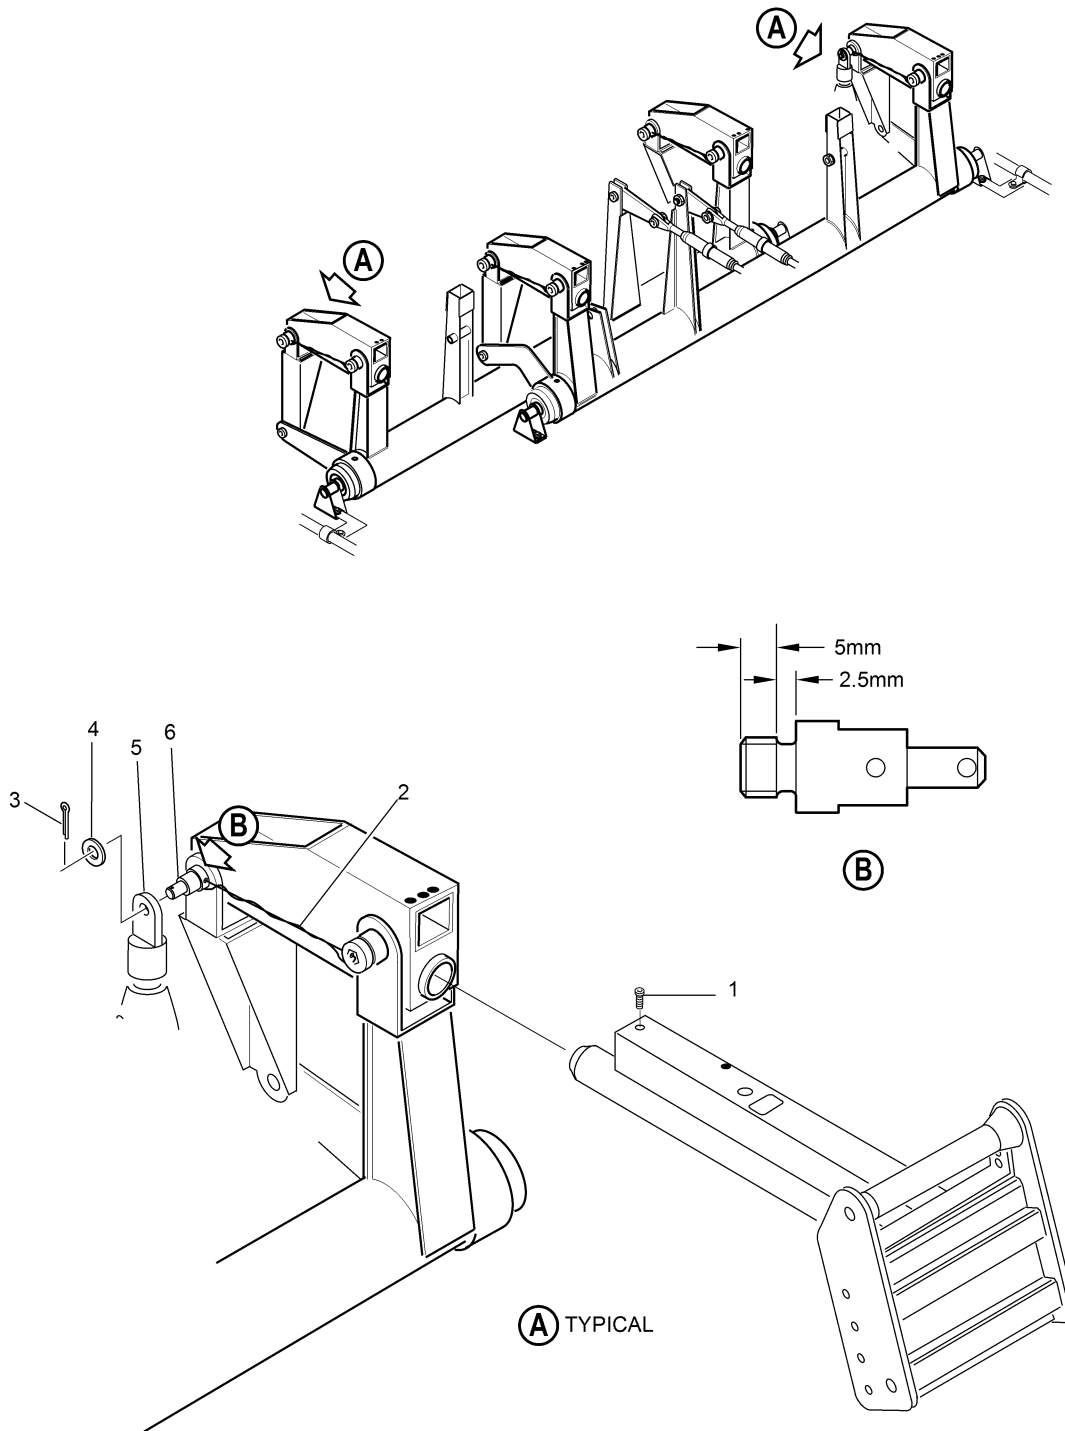
Examination - Brake Master Cylinder Pivot Pin
Figure 1

A case has been reported of the failure of a brake master cylinder pivot pin part number T67M-45-539 (Figure 1). Two of these pivot pins are fitted per aircraft, one to the #1 pedal assembly and one to the #4 pedal assembly. The operator reported hearing a breaking noise from the rudder pedal area during taxiing. An investigation was carried out and it was discovered that the brake master cylinder pivot pin had broken on the #4 pedal assembly.

- (1) Rudder pedal assembly #1:
 - (a) Remove rudder pedal stop screw (1) and slide assembly aft from its housing.
 - (b) Remove and discard locking wire (2).
 - (c) Remove the split pin (3) and washer (4). Discard split pin.
 - (d) Slide off lower inner bracket from main brake cylinder pivot after removing bracket, attached with 2 off socket head screws.
 - (e) Displace brake cylinder (5) inboard to clear top pivot.
 - (f) Remove pivot pin (6) by unscrewing.

- (h) Carry out visual inspection of brake master cylinder pivot pin for damage, cracks or distortion (Reference Figure 1 and Figure 2).
- (i) Carry out visual inspection for dimensional accuracy of threaded portion of the brake master cylinder pivot pin (Reference Figure 1 and Figure 3). (Ensure that threaded portion is 5 mm in length, and adjacent shank is 2.5 mm in length).

- (k) If any damage, crack or distortion to the brake master cylinder pivot pin is discovered or the pivot pin fails the dimensional requirement then it is considered to be unserviceable and is to be replaced.

- (l) If no damage, crack or distortion to the brake master cylinder pivot pin is found and the pivot pin meets the dimensional requirements, re-assemble in reverse of the removal procedure, using a new split pin. It is important to ensure that the pivot pin is fully tightened against the rudder pedal carriage mechanism. The pivot pin (6) is bonded in position using Loctite 222. Ensure that wire-locking does not foul on any adjacent structure or components.

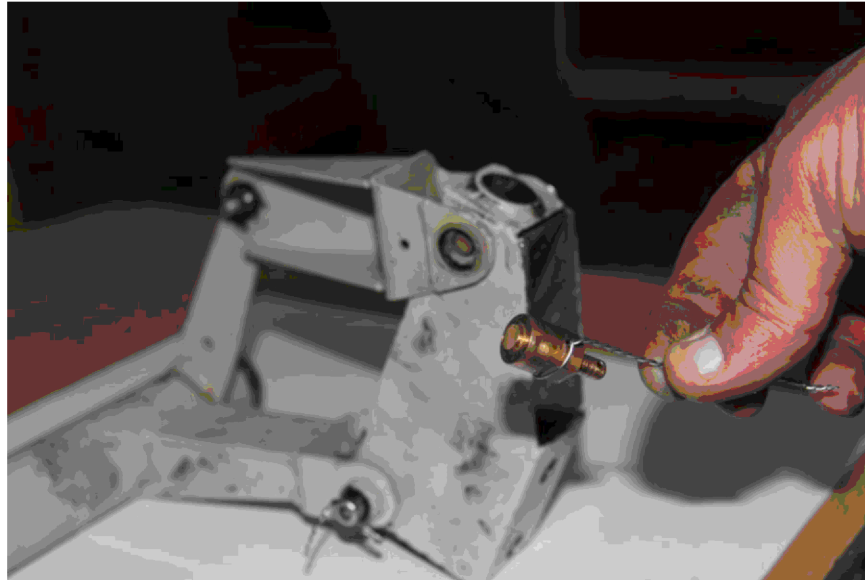
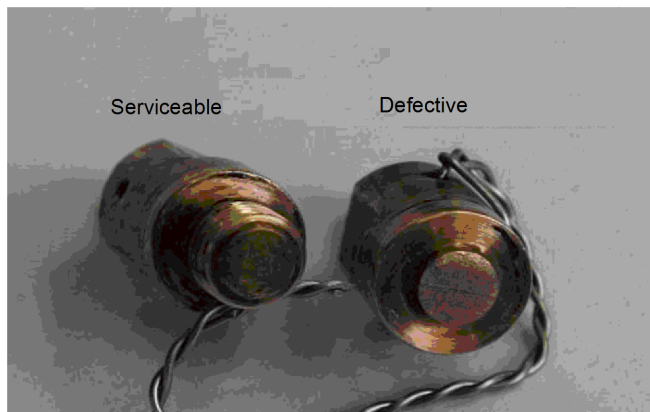
Pivot pin
Figure 2

The pin was broken between the threaded section and the larger central barrel (Figure 2). The surface of the broken material was found to be dull, indicating a possible fatigue related fracture.

- (j) Carry out NDI (fluorescent dye penetrant), using local regulations, of the brake master cylinder pivot pin threaded portion and shank where it enters the central barrel.

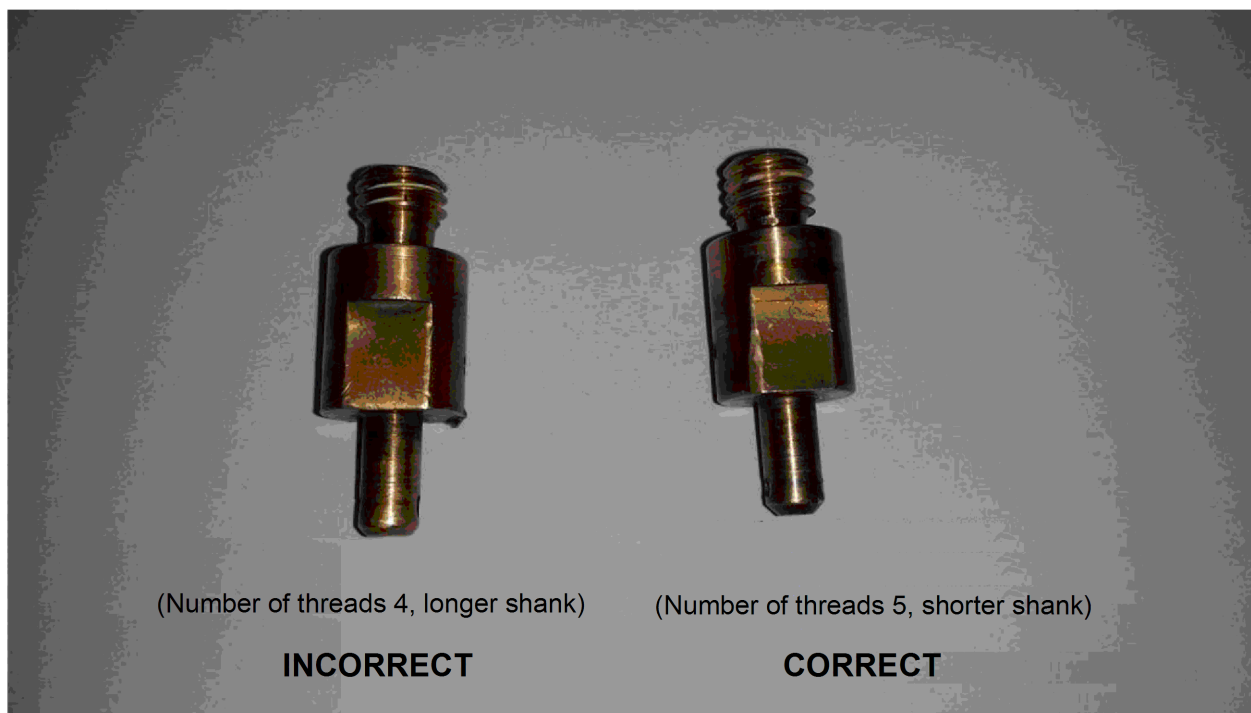
**Pivot pin threads
Figure 3**

Unrelated to the pivot pin failure instances of dimensional differences to the brake master cylinder pivot pin design have been discovered (Figure 3).
