Service Bulletin

S.B. No: 187

Title: INSPECTION FOR CLEARANCE BETWEEN RUDDER PEDAL AND MIXTURE/PROP. SPEED BRACKET AND FOR GROUND TOWING DAMAGE. ALSO INCLUDES GENERAL RUDDER PEDAL CLEARANCES.

Applicability: T67M200 (Works No. 2264 & 2265 only), T67M260 and T67M260-T3A.

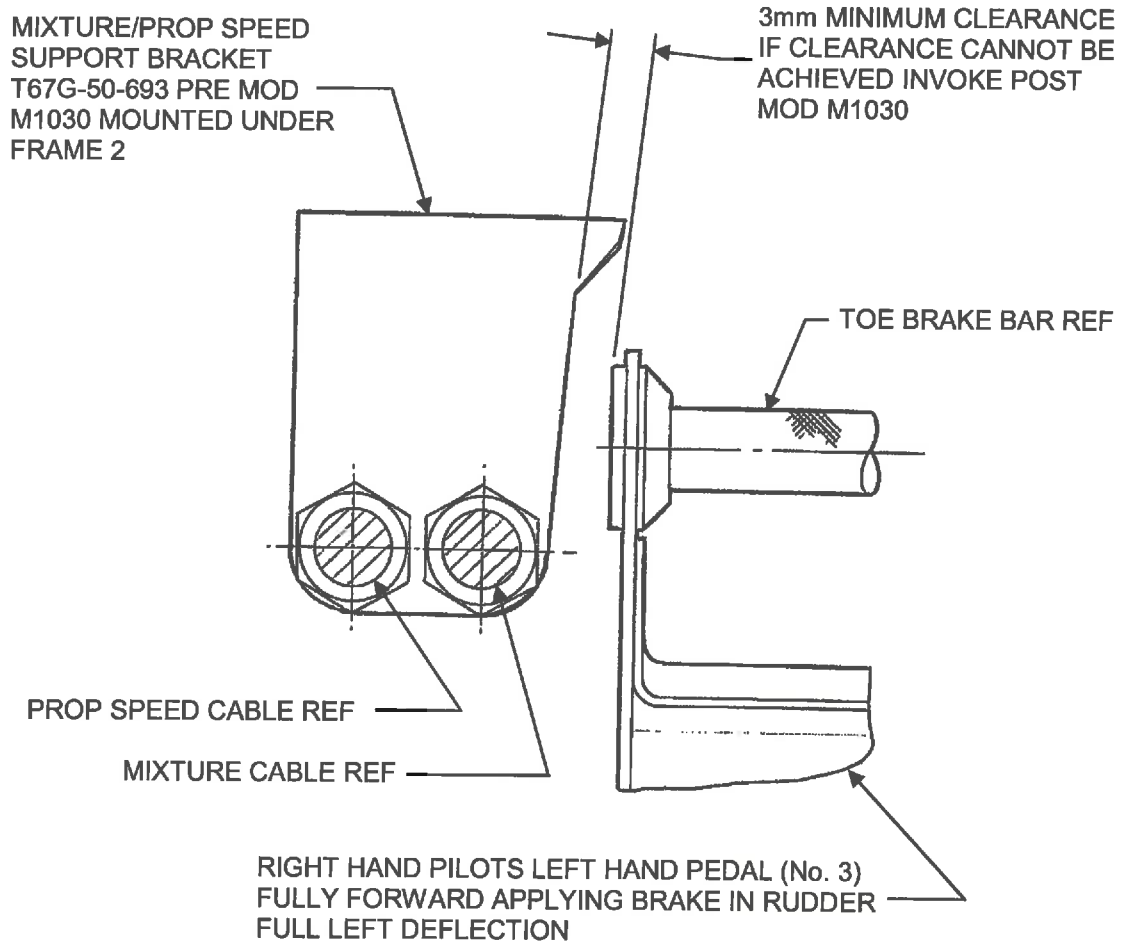
FIGURE 1A
SHOWING CLEARANCE TO PRE MOD M1030 MIXTURE/PROP SPEED BRACKET TO No. 3 PEDAL

2. With Right Hand pilots left pedal (Pedal No. 3) adjusted fully forward, with left rudder applied, apply brake together with a left hand side force – refer Figure 4 – on the pedal. Check for clearance on mixture/propeller speed cable support bracket. Refer Figure 1A or 1B.

3. Clearance should be a minimum of 3mm, Figure 1A refers, Pre Mod M1030, or minimum of 10mm, Figure 1B refers, if Post Mod M1030 incorporated.
 - 3.1 Pre Mod M1030: If the clearance is less than 3mm, then Change M1030 "Introduction of Revised Propeller Speed Bracket for Increased Rudder Pedal Clearance" shall be invoked and the following inspections and corrective actions, paragraphs 4 to 34, shall be carried out in order to ensure that the 10mm minimum clearance of Post Mod M1030 is obtained.

- 3.3 Pre Mod M1030: If the clearance is 3mm or greater, when first measured, the following inspections, paragraphs 4 to 34, must still be carried out to ensure the whole rudder pedal system is within required tolerances and free from defects. In any event Change Mod M1030 is to be invoked at next 300 flying hours or next Annual whichever is soonest.

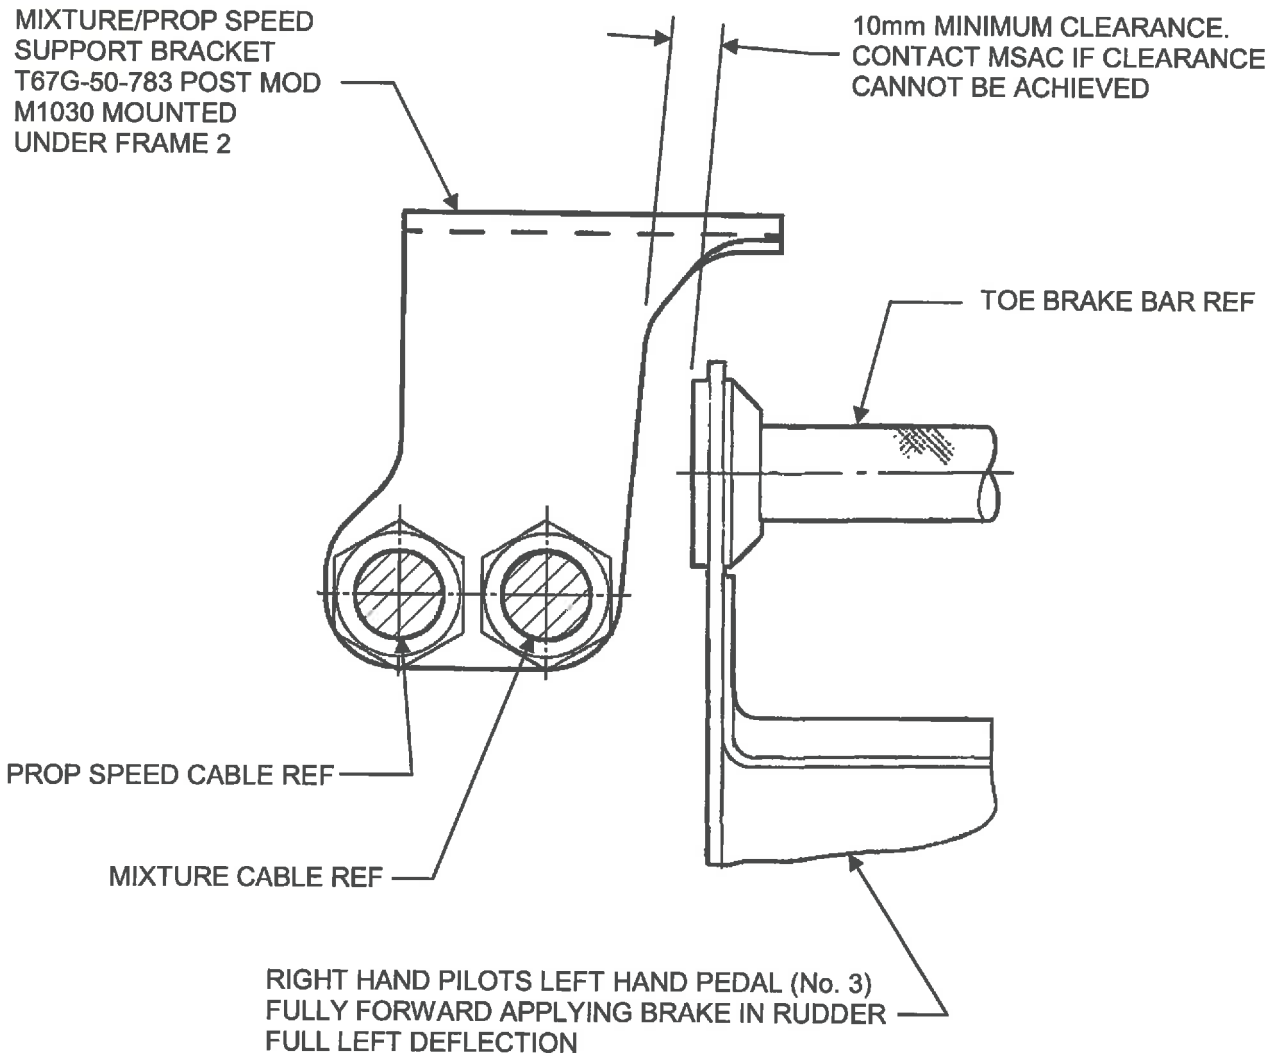
FIGURE 1B
SHOWING CLEARANCE TO POST MOD M1030 MIXTURE/PROP SPEED BRACKET TO No. 3 PEDAL

- 3.2 Post Mod M1030: If the clearance is less than 10mm, then the following inspections and corrective actions, paragraphs 4 to 34, shall be carried out in order to ensure the minimum clearance of 10mm is obtained.

- 3.4 Post Mod M1030: If the clearance is 10mm or greater, when first measured, the following inspections, paragraphs 4 to 34, must still be carried out to ensure the whole rudder pedal system is within required tolerances and free from defects.

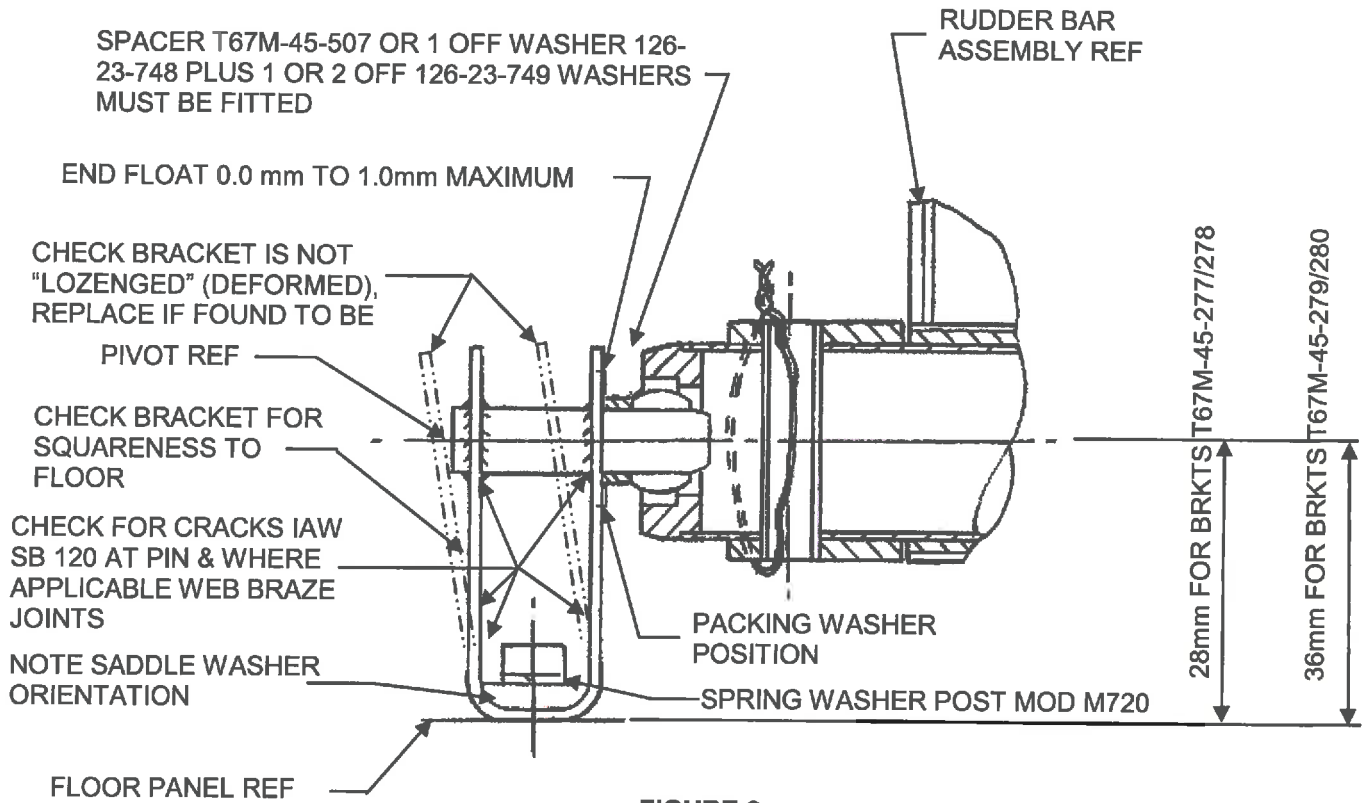
FIGURE 2

5. Check rudder pedal bar end float is no greater than 1.0mm. Acceptable end float is 0.0mm to 1.0mm. If end float is greater than 1.0mm then rectify IAW paragraph 16. Refer Figure 2.

6. Check that the Rudder Pedal bar port outboard support bracket, ref. Figure 2 and 4, is square to floor and not "lozenged", that there is no deformation to its base and ensure that the bracket is secure to the floor. Check floor under removable floor panel in area of bracket, inspect for cracking which could allow the bracket to lean. Remove the floor panel, and on Post Mod M945 aircraft fuel panel on lower fuselage front may be removed, check for signs of cracking in the floor around the anchor nuts on Pre Mod M919 aircraft or the anchor nut mounting plate Post Mod M919 aircraft, refer to Figure 3. Any GRP damage will be shown as a white shadow on the GRP, with cracking felt as a rough edge. A light shining up through the floor will show a shadow.

RUDDER BAR END FLOAT AND ITS SUPPORT BRACKET

10. Referring to paragraph 6, should Rudder bar support bracket be damaged, replace with a new item, refer paragraph 11 below. Ensure brackets are secured with a torque of 58lbf in (6.5Nm). Ensure spring washers are fitted; Mod M720 "Introduction of Spring Washers to Rudder Pedal Lay-shaft Mounting Bracket Screws" refers. Ensure when refitting brackets that the saddle washer, T67M-45-537, is re-fitted and is assembled with its corner radius into the brackets radius, refer Figure 2. Ensure that the shorter, (28mm), mounting brackets, T67M-45-277/278, are supporting Rudder Pedal Bar T67M-45-257, i.e. Port Rudder Bar, refer Figures 2 and 4.

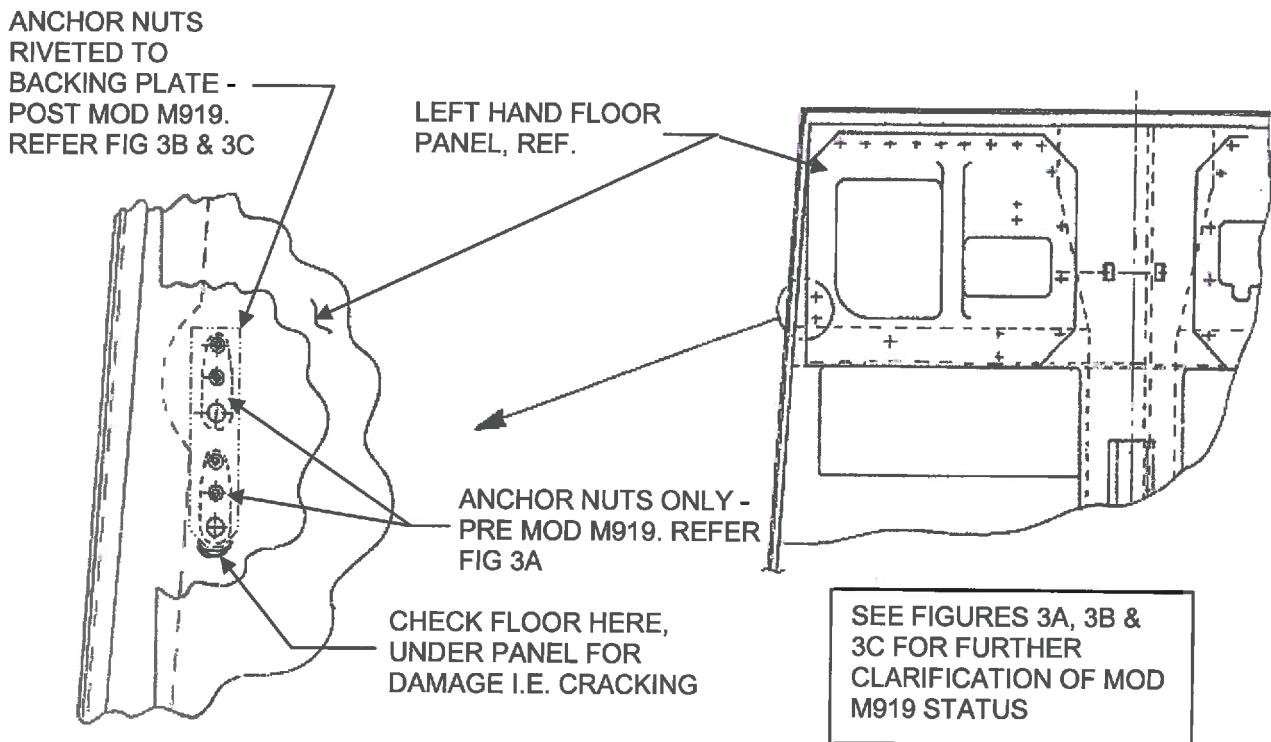
FIGURE 3

AREA OF FLOOR REQUIRING INSPECTION

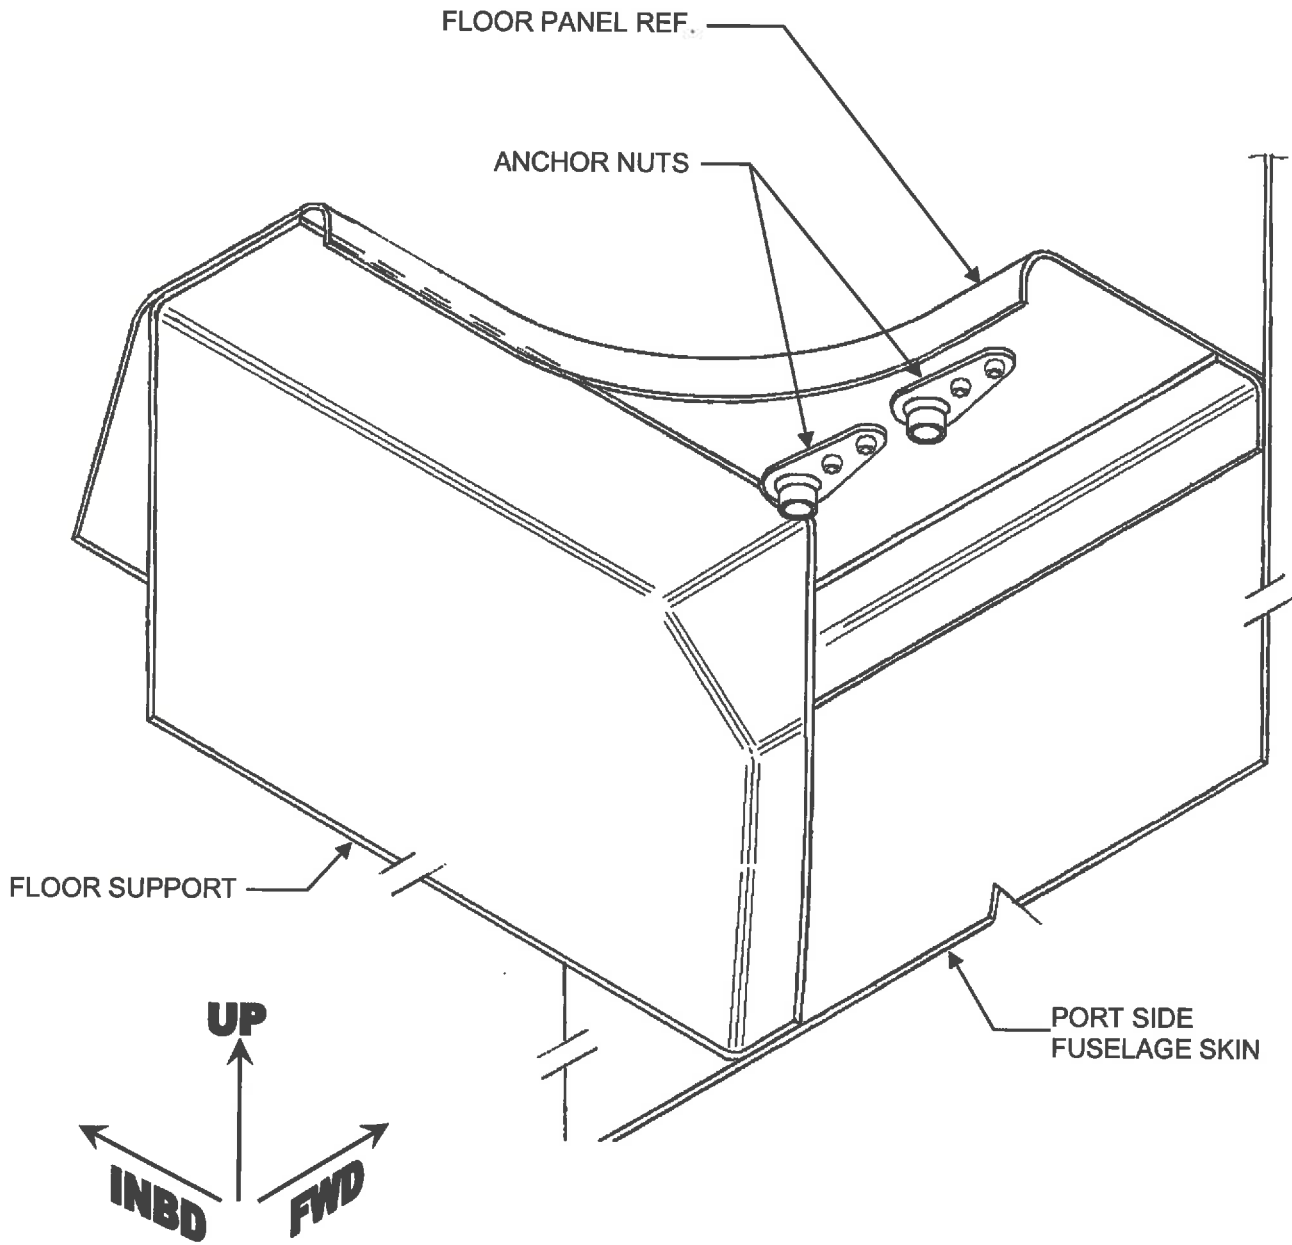
FIGURE 3A

7. Establish Mod status of floor with regards to whether full incorporation of Mod M919 has been implemented as per DOI T67C-149 issue 5, Figure 3C refers. Un-modified floor will be as shown by Figure 3A. Aircraft Modified IAW DOI T67C-149 issue 1, i.e. only doubler plate fitted, see Figure 3B. If T67C-149 issue 5 has been recorded incorporated, then there is no further requirement to remove panels with respect to this Service Bulletin unless damage is noted during course of the inspection, an incident or noted during normal maintenance.

**SHOWING PRE MOD M919 CONFIGURATION
REQUIRES MODIFICATION IAW DOI T67C-149 ISSUE 5 & SUBS, PROCEDURE D**

8. If floor under port outboard support bracket position is found to be cracked or broken or not modified IAW Mod M919 Figure 3C, then repair IAW DOI T67C-149 issue 5 and subsequent, to fully incorporate Mod M919. If the full Mod M919 has been previously incorporated i.e. to DOI T67C-149 issue 4 and floor is found to be damaged, inform MSAC.

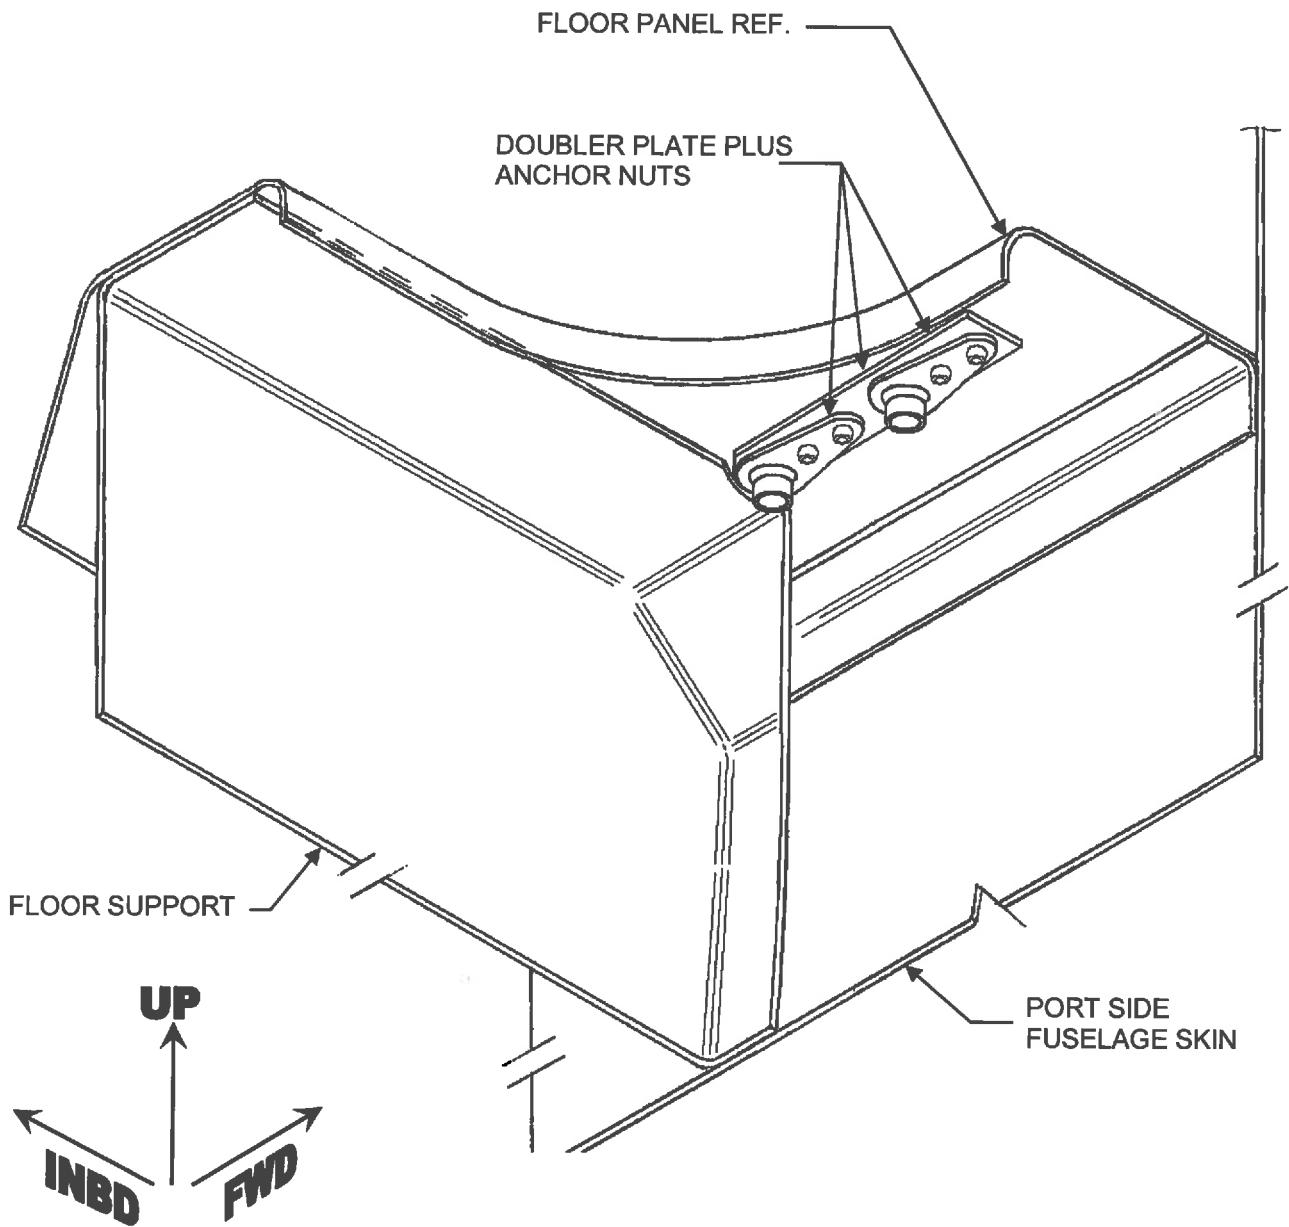
FIGURE 3B

SHOWING PART MOD M919 INCORPORATION
REQUIRES REPAIR MODIFICATION IAW DOI T67C-149 ISSUE 5 & SUBS, PROCEDURE D

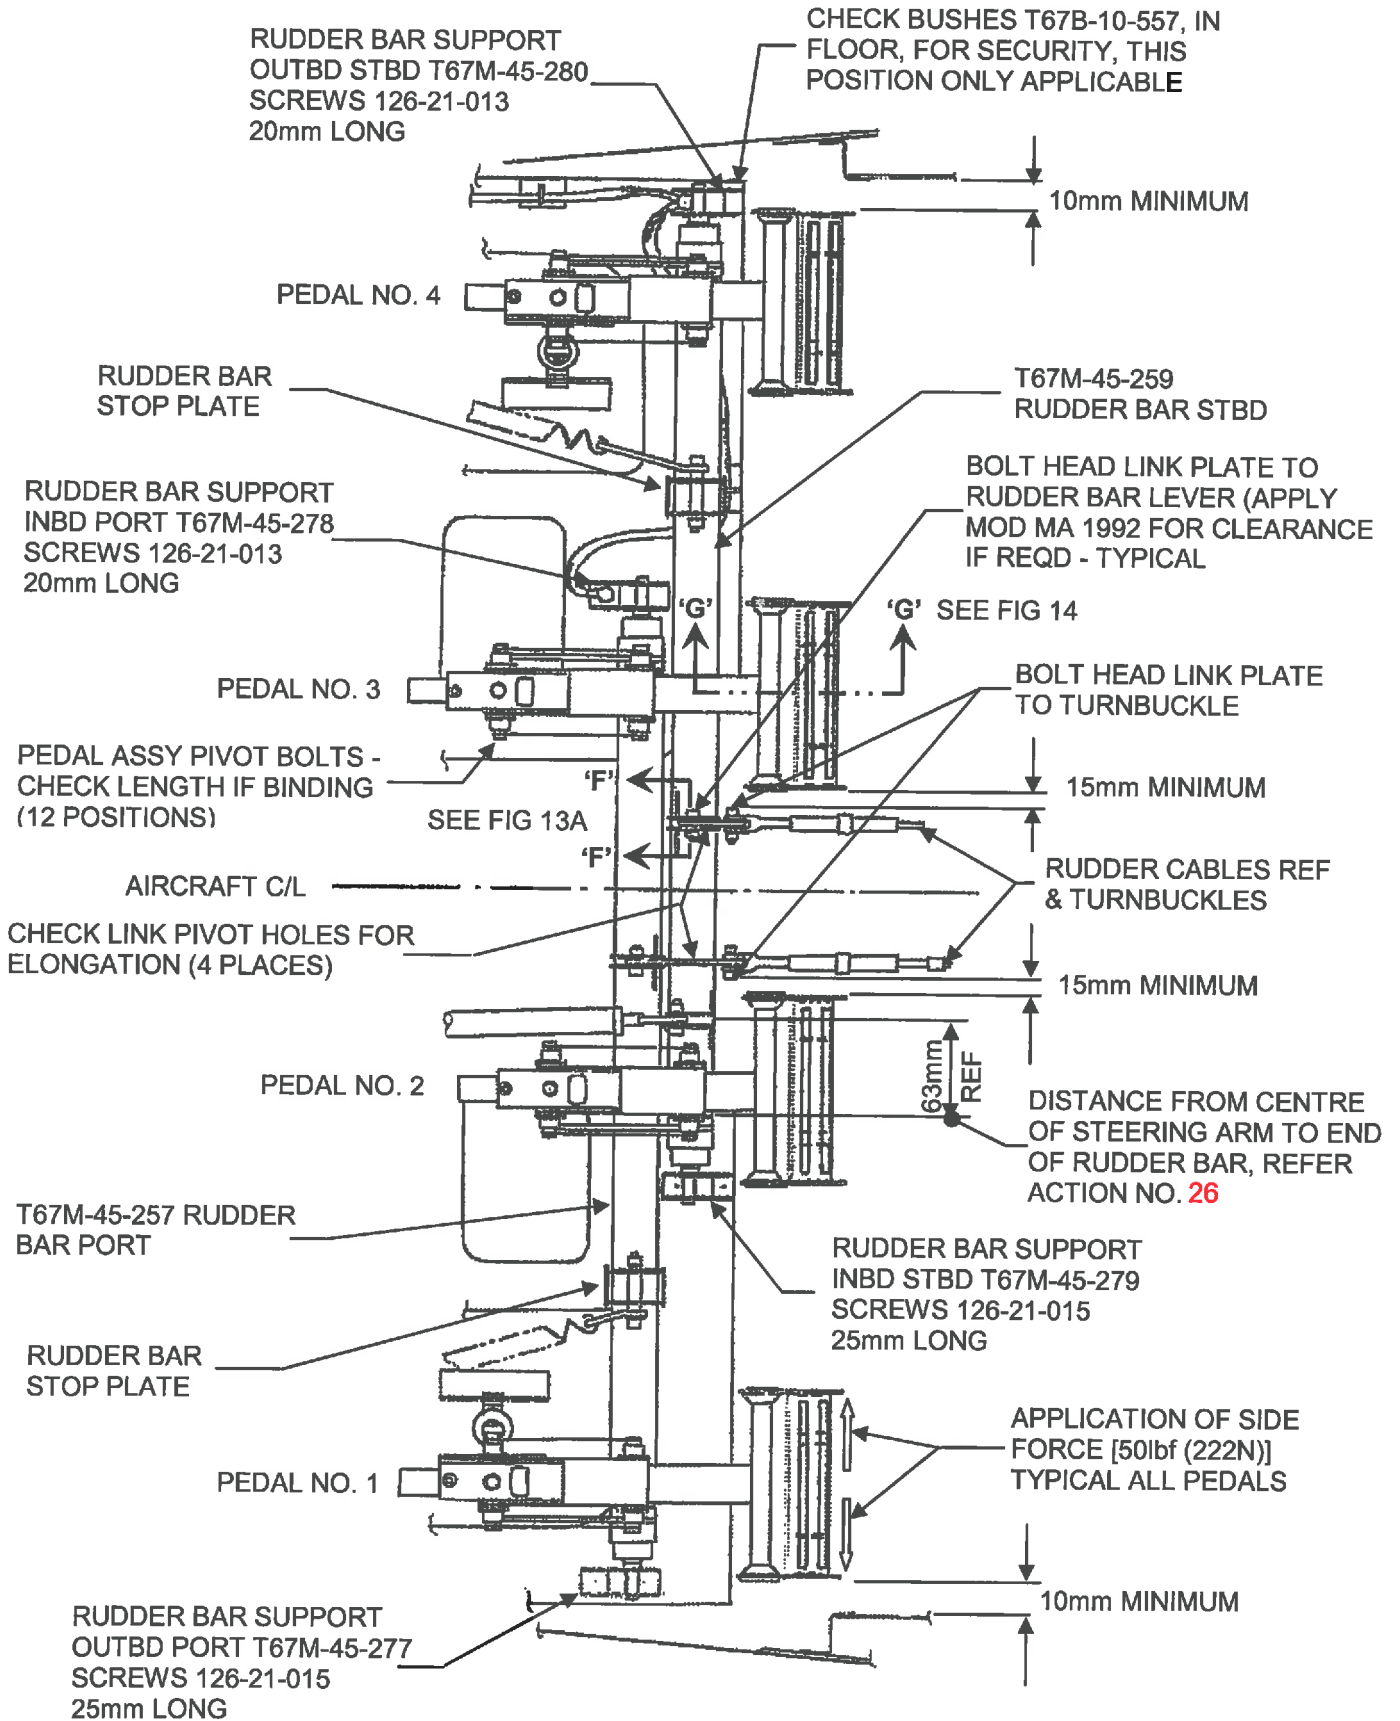
FIGURE 4

1. (a) Referring to Figures 4, 13A and 13B, check the Right Hand pilot's left pedal (Pedal No. 3) for clearances from: i) starboard rudder cable attachment bolts to link plate and ii) link plate to rudder bar lever post. Clearances should be a minimum of 15mm and 16.5mm respectively. Clearance checks to be performed at all four pedal adjusted positions, but especially; with pedal adjusted fully forward (or past last adjustment position), with full left rudder applied, together with a left hand side force applied to the pedal – refer Figure 4 – and that any slack in the rudder cable is taken up in the starboard direction - see notes below.

11. Check the remaining rudder bar support brackets, are square to floor and are not "lozenged", that there is no deformation to their bases and ensure that the brackets are secure to the floor, reference Figures 2 and 4. Check all rudder bar support brackets for cracks in accordance with Service Bulletin SB 120 "Inspection of Rudder Bar Support Brackets". If any bracket is found to be suspect replace with new item, i.e. T67M-45-277/278/279/280 reference Figure 4. Note these are welded brackets and invoke Mod M763 where they replace brazed brackets. Note some brackets may have web brazed, which is acceptable, but pin must be welded to bracket. Welding of the pin to the bracket constitutes Modification M763. Ensure upon replacement of any bracket/s that the aircraft is fitted with brackets to the same modification state i.e. Post Mod M763, if not then any Pre Mod M763 brackets are to be replaced. Check floor under any damaged support bracket by removing panel. Check security of bush T67B-10-557 under starboard rudder outboard support bracket, refer Figure 4. If bush is found to be suspect remove starboard floor access panel and if bush is loose, then repair IAW DOI T67B-414. Ensure washers and brackets are correctly assembled refer paragraph 10 above. Inform MSAC of any damaged bracket or additional floor damage. Assemble item as per paragraph 10 and ensure end float is as stated in paragraph 16. Ensure bonding leads are correctly fitted, carry out bonding check refer relevant aircraft's Maintenance Manual. Ensure correct length screws for attaching the rudder bar support brackets have been fitted in the correct positions, refer Figure 4.

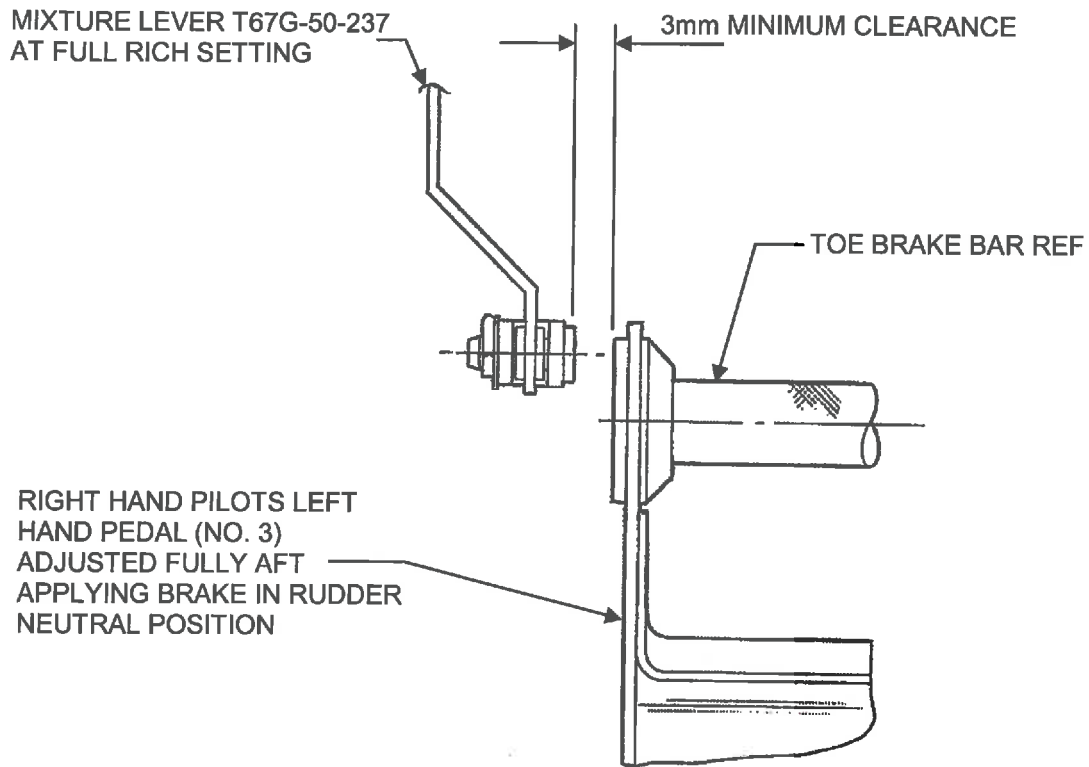
FIGURE 7

29. Ensure, that a minimum clearance of 3mm is achieved between Pedal No 3 and Mixture Lever operating arm, refer Figure 7. Ensure when Mixture Lever is operated its motion is parallel to aircraft centre line, if not rectify or replace Mixture Lever to correct motion. The clearance of 3mm is to be checked with Pedal No. 3 at all indented positions throughout the pedals range of movement and with a left hand side force – refer Figure 4 – applied to the pedal and the brake applied. Refer paragraph 16 for packing washers.

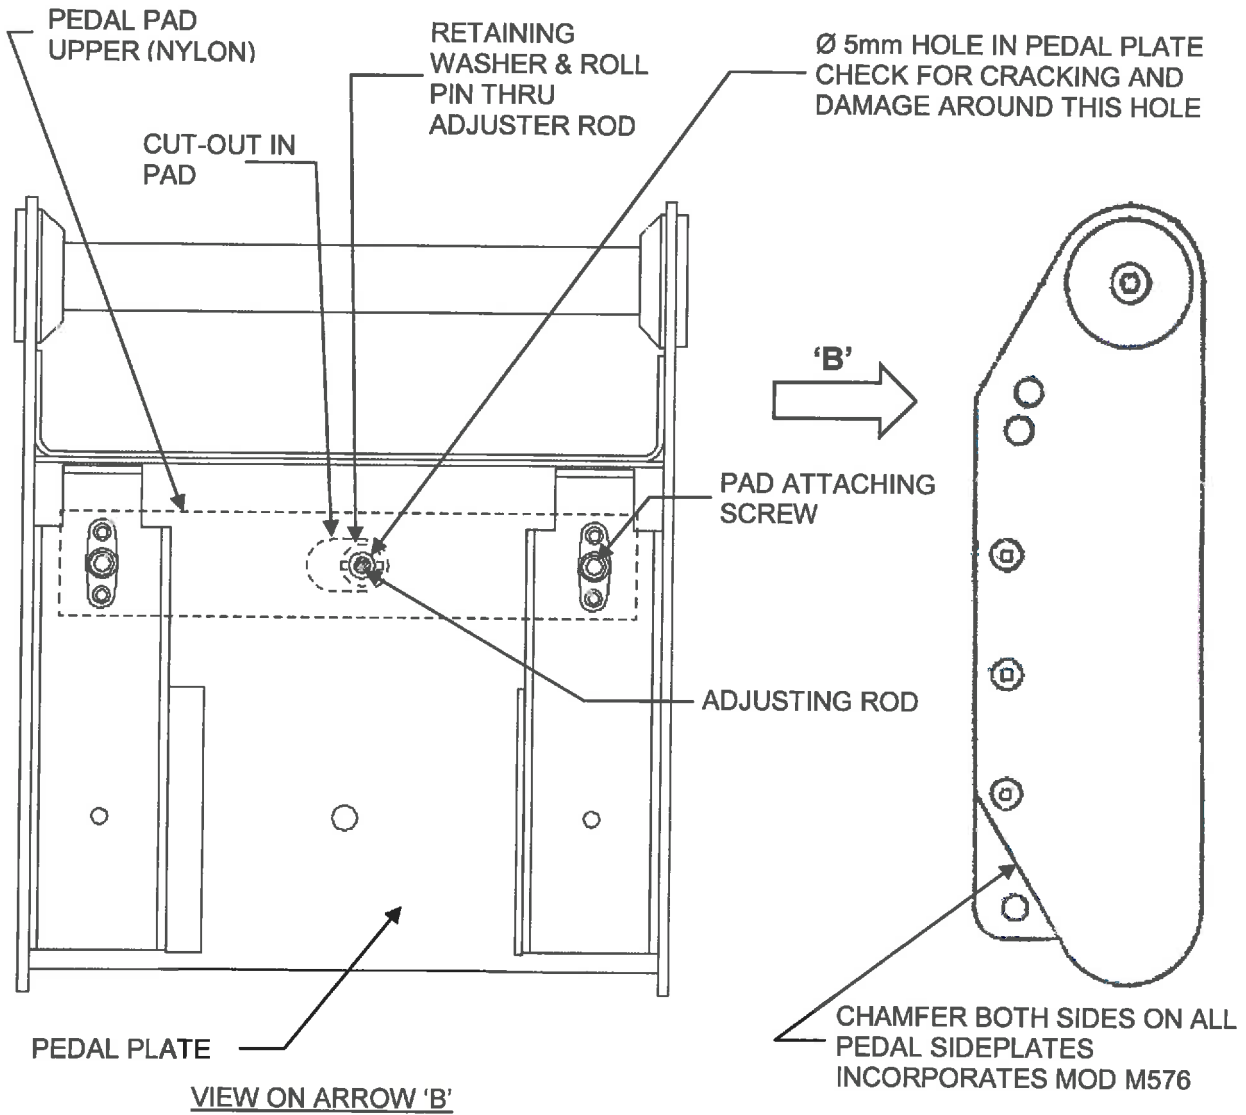
FIGURE 10

31. Check structural integrity of pedal pad assembly especially around adjuster pushrod hole pedal plate, Figure 10 View on Arrow 'B' refers, if plate is cracked or damaged the pedal pad is to be repaired. Ensure riveting is secure, if rivets are loose then they have to be rectified. Ensure that the pad pivots are not worn and that the nuts are tight, but allow pad to pivot, nuts to be retained with adhesive 126-51-067. Replace pedal pads if worn. Contact MSAC for new pedal pad assembly, materials and any applicable repair scheme.

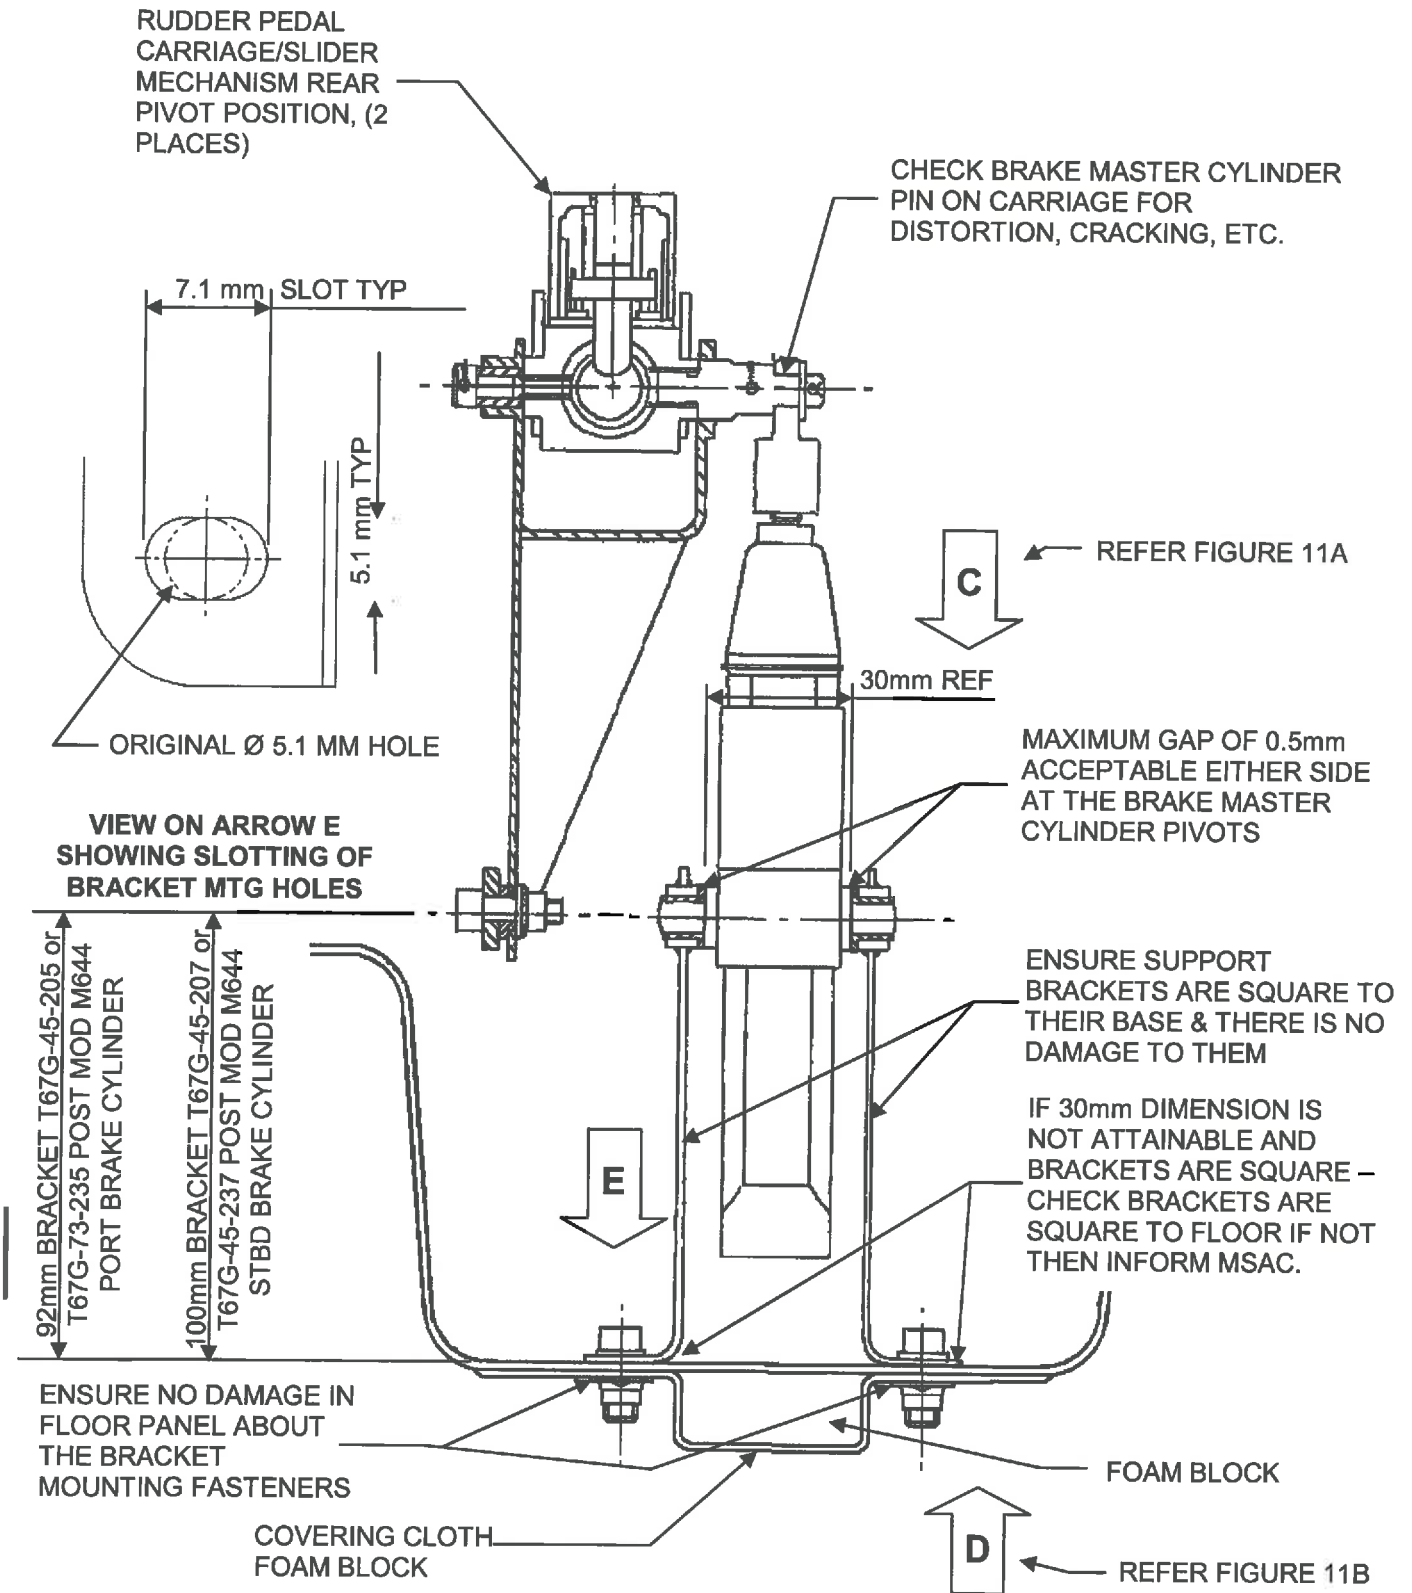
FIGURE 11
BRAKE MASTER CYLINDER SUPPORT BRACKETS

12. Referring to Figure 11, ensure that there is either no gap or a gap either side no greater than 0.5mm, at the brake master cylinder pivot points and that the support brackets are securely mounted to the floor panel, i.e. not loose. Brackets should not deflect if base fastenings are sound. If bracket is seen to be suspect, i.e. out of square, twisted or bent, remove brackets and replace with new brackets if damaged. Check that there is no damage to the bracket anchorages in the removable floor panel. Damage will show as whitening in the laminate surrounding the anchor nuts and foam reinforcement block, ref. Figures 11A and 11B, if in doubt remove panel and check anchor nuts for security. Figure 11 refers. If the floor panel is found to be damaged it is to be repaired or new panel fitted, refer to MSAC Product Support Department. If damage found then proceed as indicated by paragraphs 13 and 14. When rectified ensure all clearances and checks are accomplished as related to in this Service Bulletin.

14. If damage is found ref. Paragraph 12, then brake master cylinder to rudder pedal carriage attachment pin is to be checked for deformation/cracking, Figure 11 refers.

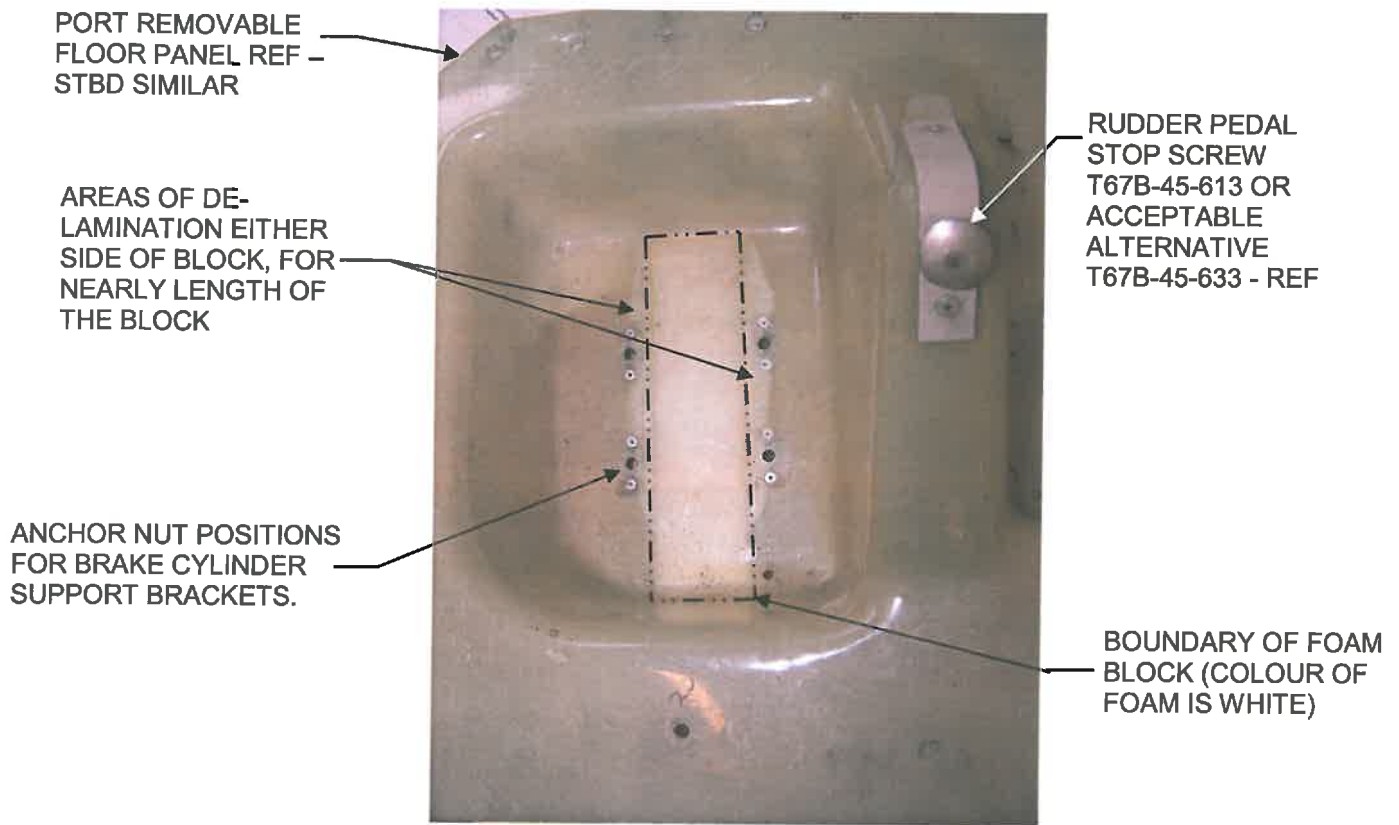
Further to issue 2 an incident has been reported of the brake master cylinder becoming detached from its support brackets causing de-lamination to the port GRP (Glass Reinforced Plastic) floor panel. This failure occurred during aircraft taxiing.

The investigation concluded that the most probable cause of the problem was the result of exceeding the vehicular towing angle and/or incorrect positional assembly of the brake cylinder support brackets. It should be noted that the port cylinder support brackets are shorter than their counterparts on the starboard side and they must NOT be interchanged.

FIGURE 11A
PHOTOGRAPH ON ARROW C
VIEW INTO TOPSIDE OF REMOVABLE PANEL SHOWING EXTENT OF DE-LAMINATION

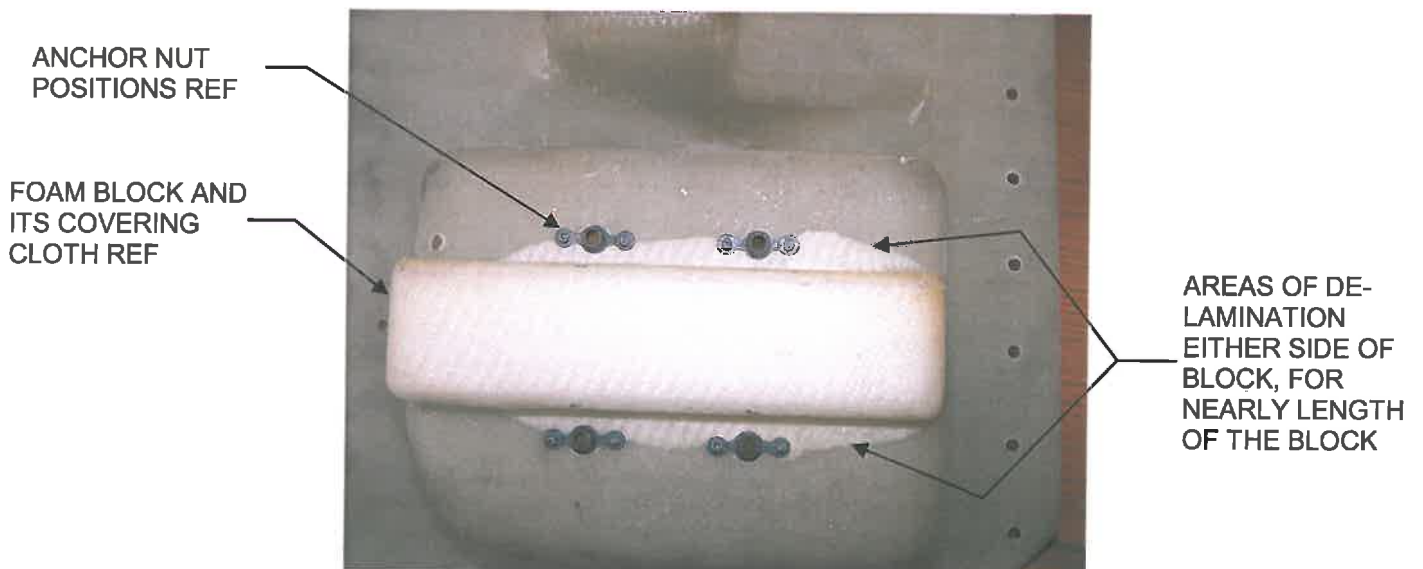
FIGURE 11B
PHOTOGRAPH ON ARROW D
VIEW ON UNDERSIDE OF REMOVABLE PANEL SHOWING EXTENT OF DE-LAMINATION

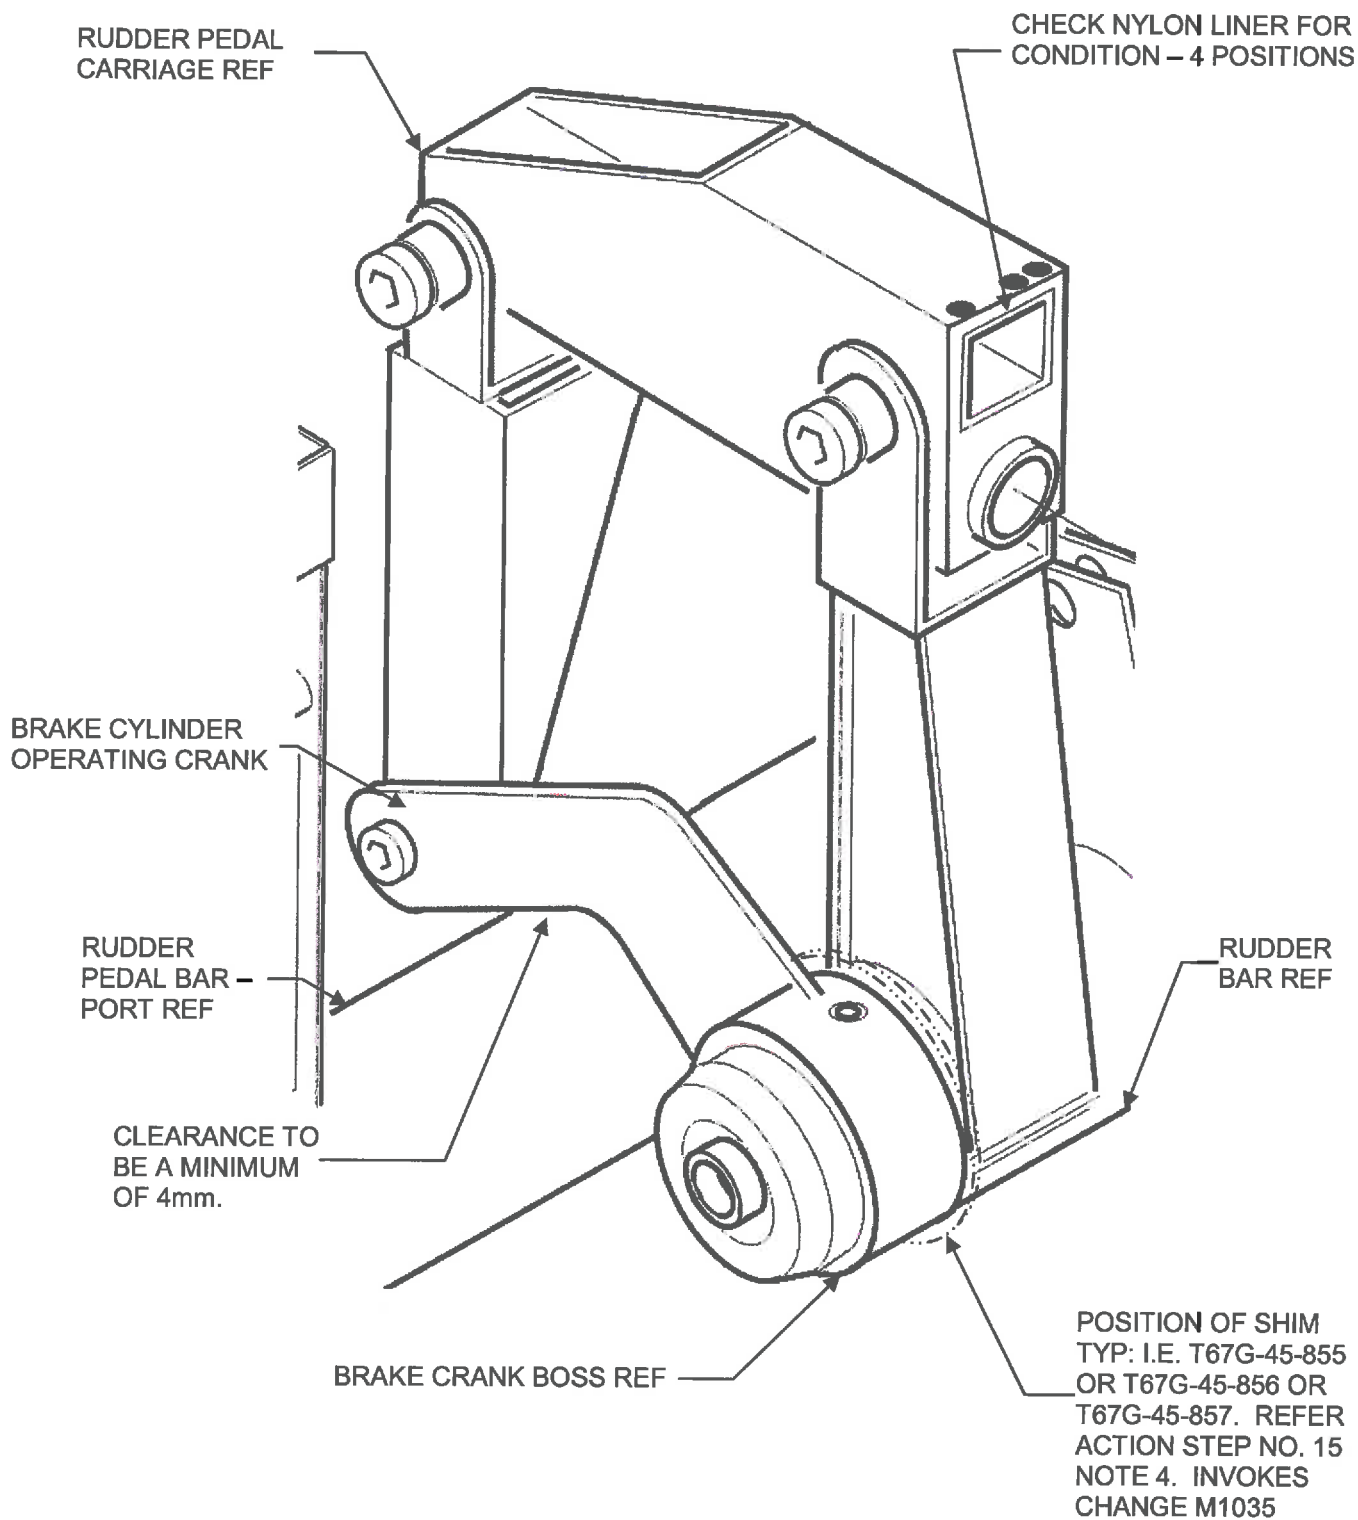
FIGURE 12

28. Ensure the nylon liners in the rudder pedal carriages are in good condition and not worn, Figure 12 refers, replace liners if unsatisfactory. Return carriages to MSAC for replacement of liner.

32. Ensure that the brake operating crank, as shown at Figure 12, has a minimum clearance of 4mm relative to the rudder pedal bar following all checks and rectifications. Allow for various brake conditions, refer paragraph 33.2. Should bar show signs of chaffing check depth of groove. If depth is 0.0mm to 0.5mm, remove rudder bar, blend out groove, repaint and refit. If the groove is to a depth greater than 0.5mm, remove rudder bar and return to MSAC for repair or replacement.
