Service Bulletin

S.B. No: 187

Title: INSPECTION FOR CLEARANCE BETWEEN RUDDER PEDAL AND MIXTURE/PROP. SPEED BRACKET AND FOR GROUND TOWING DAMAGE. ALSO INCLUDES GENERAL RUDDER PEDAL CLEARANCES.

Applicability: T67M200 (Works No. 2264 & 2265 only), T67M260 and T67M260-T3A.

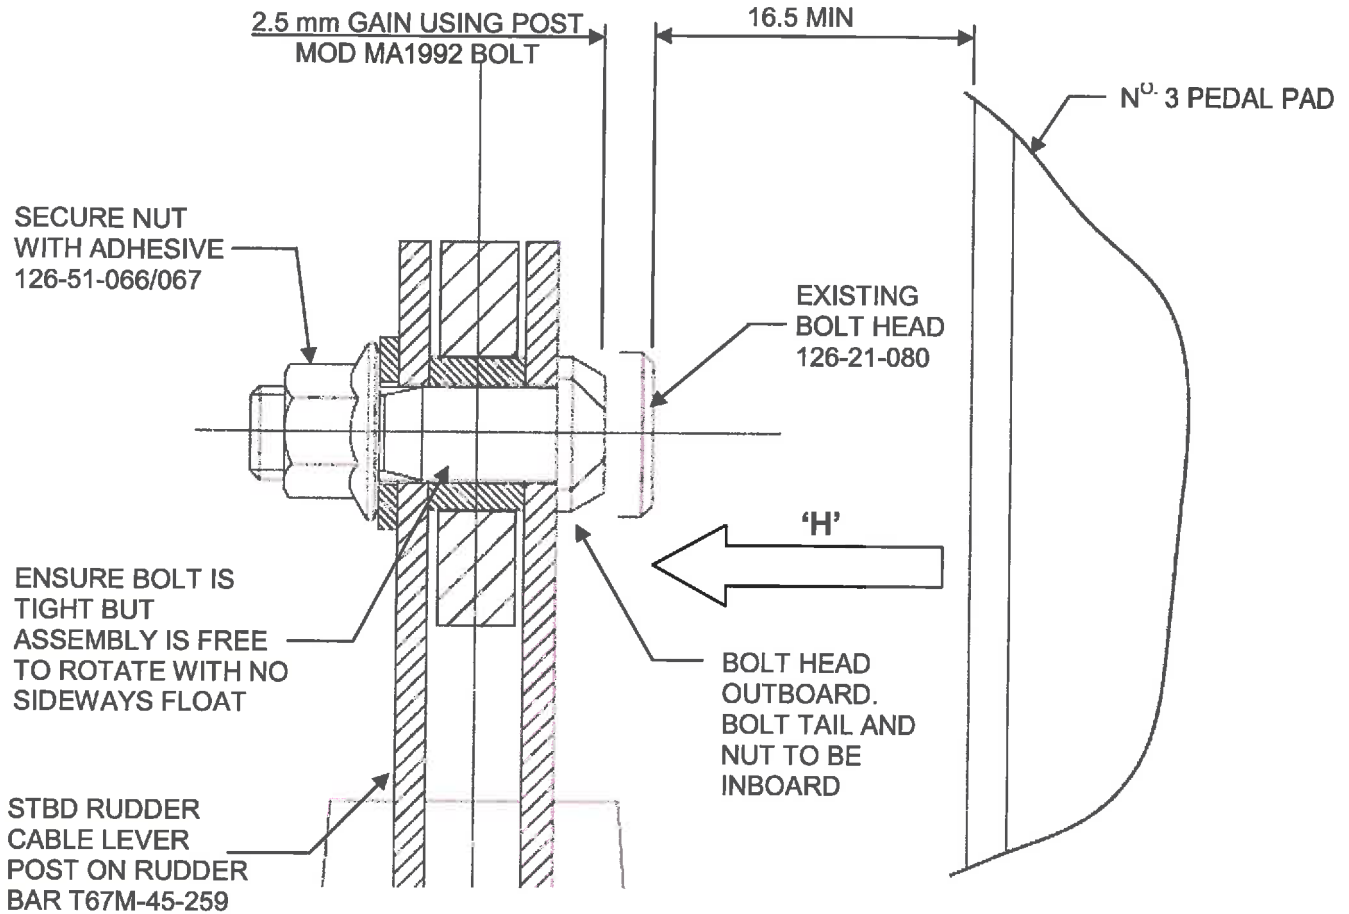
FIGURE 13A
SECTION 'F-F' (REFER FIGURE 4)

1. (a) Referring to Figures 4, 13A and 13B, check the Right Hand pilot's left pedal (Pedal No. 3) for clearances from: i) starboard rudder cable attachment bolts to link plate and ii) link plate to rudder bar lever post. Clearances should be a minimum of 15mm and 16.5mm respectively. Clearance checks to be performed at all four pedal adjusted positions, but especially; with pedal adjusted fully forward (or past last adjustment position), with full left rudder applied, together with a left hand side force applied to the pedal – refer Figure 4 – and that any slack in the rudder cable is taken up in the starboard direction - see notes below.

Note 2: ensure there is no end float in the bolts, i.e. that they are tight but not tight enough to restrict rotation. Ensure Loctite is applied to stiffnut after adjustment or replacement, MSAC code 126-51-066 or 067, Figure 13A Section F-F refers.

**STBD RUDDER CABLE BOLT HEAD TO PEDAL NO. 3 CLEARANCE
(PORT RUDDER CABLE OPPOSITE)**

Note 3: if clearance of 16.5mm cannot be achieved then fit special low head bolt T67M-45-0579 thus invoking Mod MA1992. Mod kit T67A-05-1992 to be obtained from MSAC Product Support.

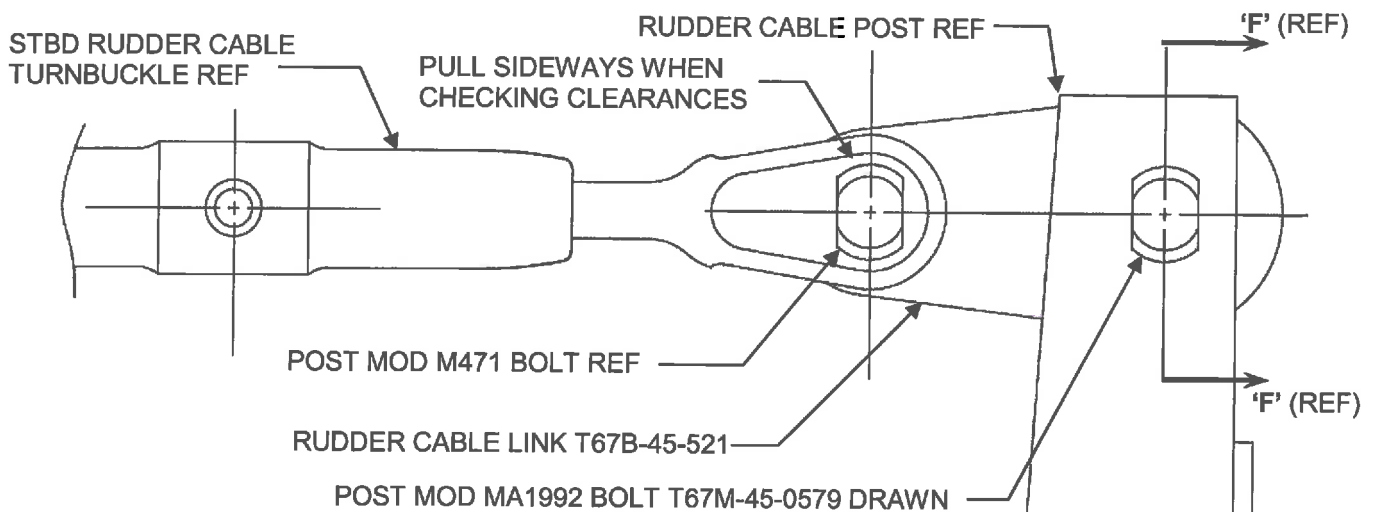
FIGURE 13B
VIEW ON ARROW 'H' (REFER FIGURE 13A)

This issue 6 of this Service Bulletin 187 has been actioned in response to an incident reported by a customer where the number 3 pedal inboard sideplate jammed behind the head of the forward screw attaching the starboard rudder cable link to rudder bar, this followed a rapid application of the pedal to the fully forward position, i.e. left rudder, refer Figure 13A Section F-F. The aircraft then entered a spin, recovering when the jam was freed. Paragraph 1(a) and (b) have been introduced by this incident. During the course of investigating this latest incident it was noted that the rudder bar pedal pad support plates were found to be distorted, refer Figure 15 and 16, this re-issue of this SB requires these items to be checked and rectified.

**SHOWING STBD RUDDER CABLE TO LINK ATTACHMENT
(PORT RUDDER CABLE OPPOSITE)**

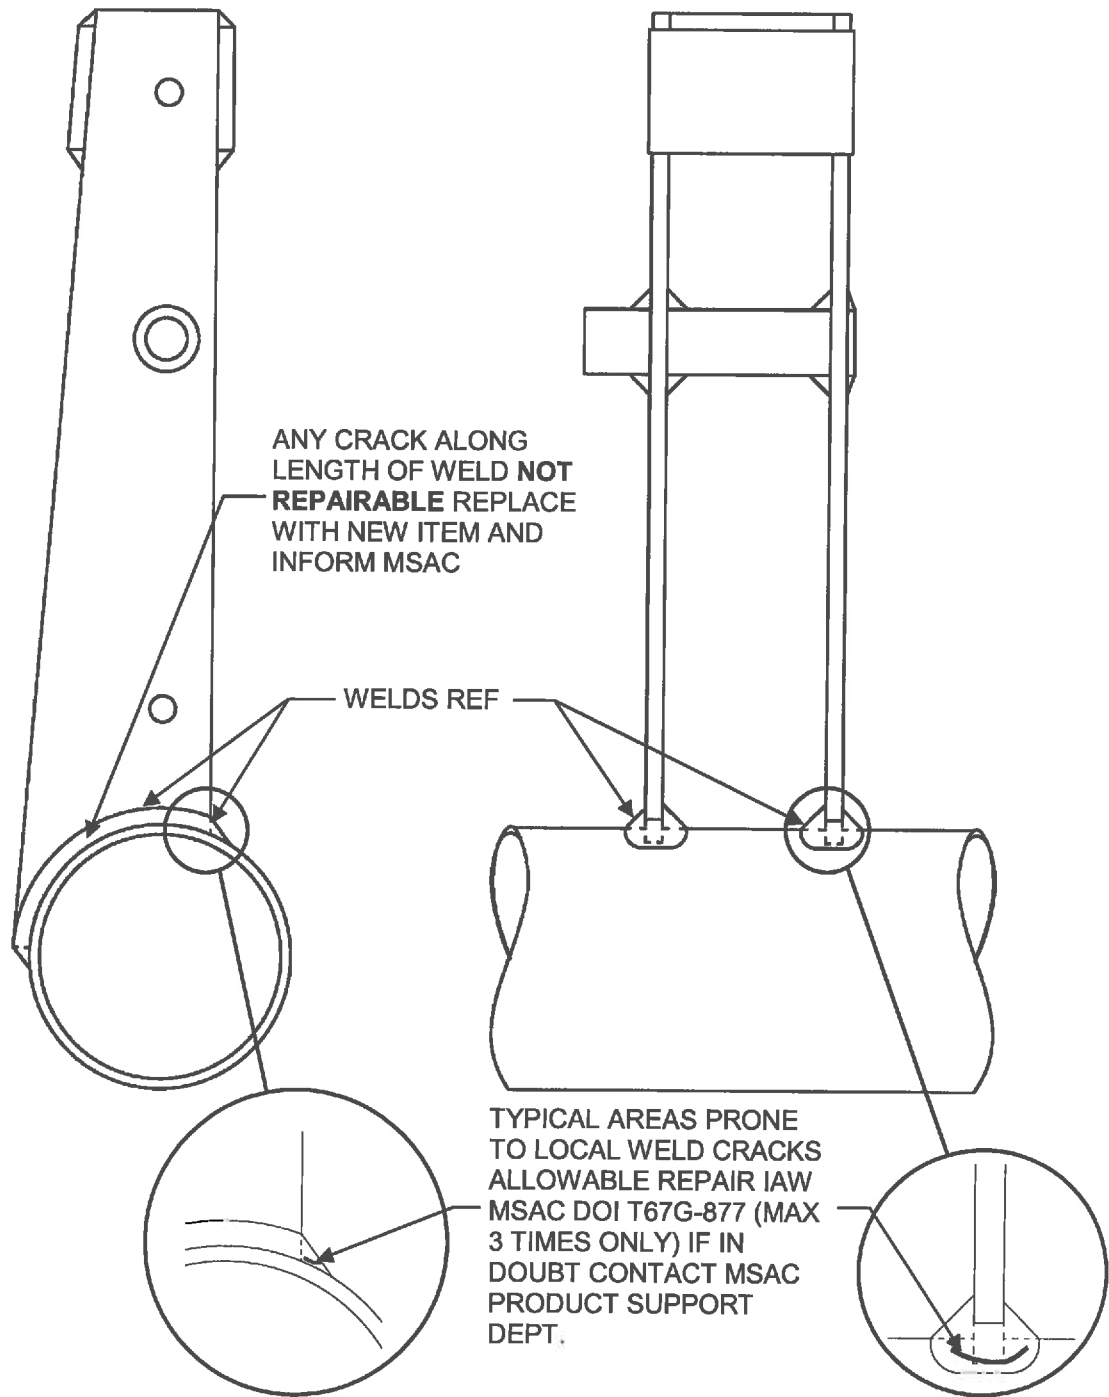
FIGURE 17

Note rudder bars may have minor cracks in the welds at the bases of the various lever positions Figure 17 refers. This is a known condition and can be returned to MSAC for repair or repaired IAW with DOI T67G-877 latest issue. Note each individual crack can only be repaired up to a maximum of 3 times. Record to be kept of weld repairs. Replacement bars T67M-45-257 and T67M-45-259 are available from MSAC product support.

**GENERAL PART VIEW ON RUDDER BAR T67M-45-257
OR T67M-45-259 TYPICAL LEVER POST POSITION
SHOWING POSITION OF POSSIBLE CRACKING AND
PERMITTED REPAIR**
