Service Bulletin

S.B. No: 162

Title: INSPECTION OF PITOT TUBE INLET PIPE

Applicability: T67B, T67C Series, T67M, T67M-MkII, T67M200, T67M260 and T67M260-T3A

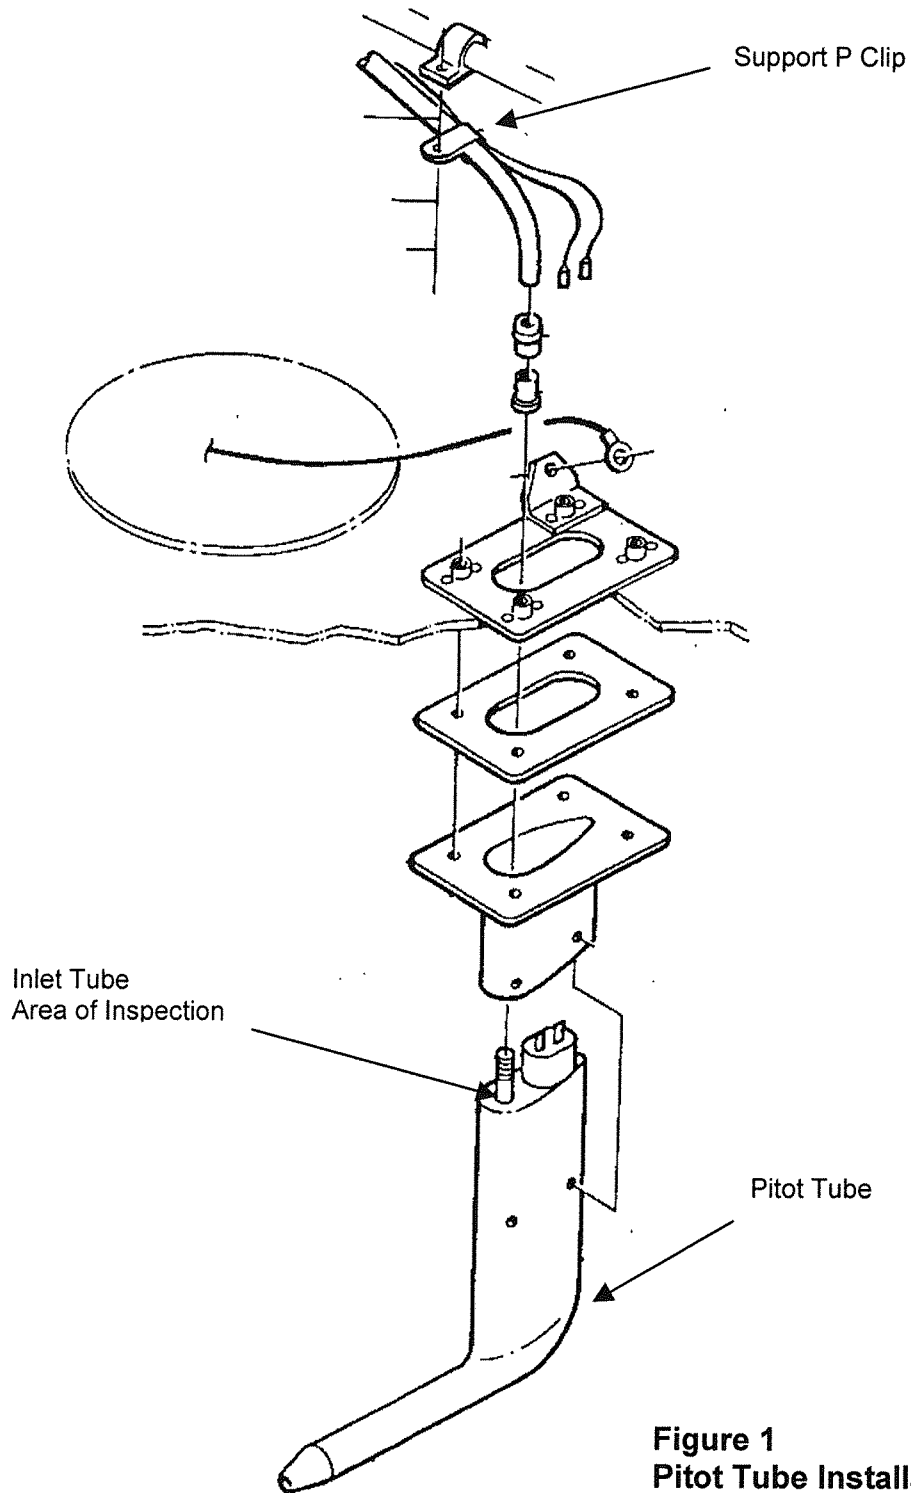
Figure 1
Pitot Tube Installation

A number of cases have been reported of the Pitot tube inlet pipe cracking at its entry point to the Pitot head, resulting in a loss of indicated air speed. This Service Bulletin requires an inspection, and if necessary replacement of the Pitot tube.

1. Carefully remove Pitot tube from lower wing surface.
2. Perform visual check for cracks in the inlet tube in the area shown in Fig. 1.
3. If no visual sign of cracking exists, refit Pitot tube.
If in doubt, perform leak check.
4. If signs of cracking exist, replace Pitot tube with a new item. For purchase, please contact SAL Product Support Department.
5. Ensure pipe is properly supported (ref P-clip, Figure 1), and care is to be taken that inlet pipe is not stressed during installation and future maintenance. Note to this effect will be added to Maintenance Manual.
6. Annotate in aircraft logbook "SB 162 complied with".
