SERVICE BULLETIN

SB No. 98 Issue No. 1

TITLE INSPECTION AND RECTIFICATION OF AIR CONDITIONING COMPRESSOR ALIGNMENT
CLASSIFICATION

T67M260-T3A Nos 2109, 2110, 2123 to 2158. ⁶⁹
INTRODUCTION:

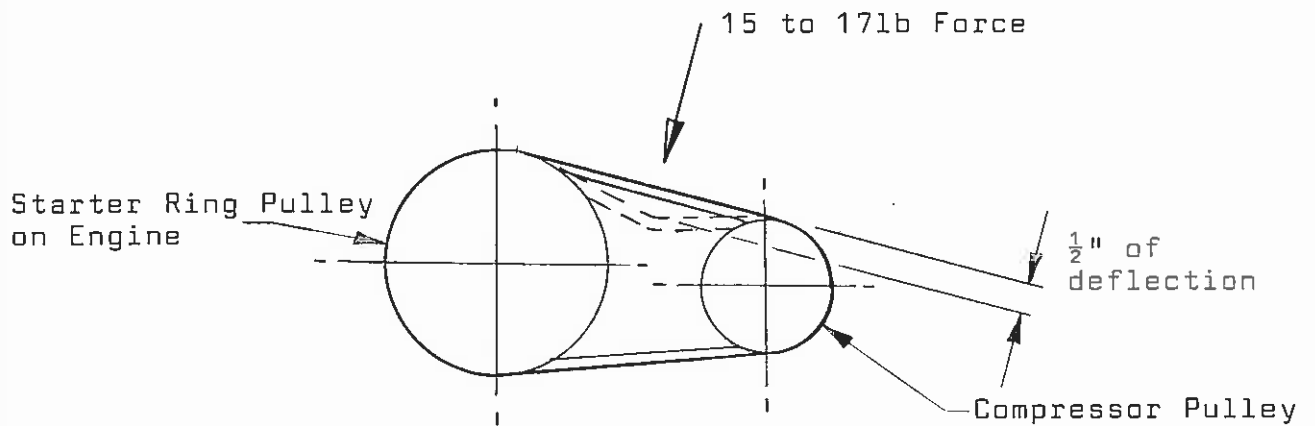
Fig 1
View on Front of Engine

Reports have been received of air conditioning compressor belts showing varying degrees of mis-alignment which could cause belt wear. Upon investigation it was noted that the compressor mounting was subject to weld distortion. Fitting an angled shim behind the mounting bracket brings the belt back to an acceptable alignment.

1. Prior to checking alignment of compressor, the belt tension and mounting bracket should be set up as follows. Set drive belt tension to give 1/2" deflection at mid span on top side of belt with a force of 15 to 17lb. Refer to paragraph 4 for tensioning instructions. Ref. Fig. 1.
2. Check behind compressor mounting bracket for shim Pt No. T67G-74-521. If fitted, record in log book SB 95 complied with. If no shim is fitted, proceed as paragraph 4 and subsequent.
3. Check compressor alignment as follows:

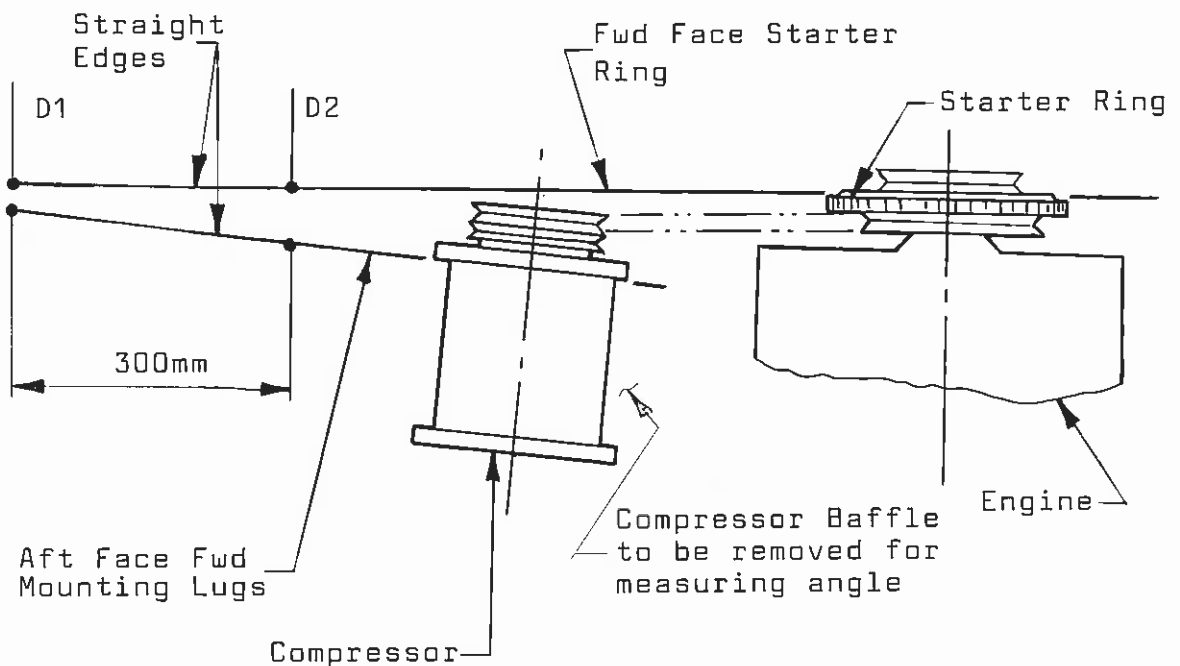
Fig 2
Plan View on Engine

The maximum compressor mis-alignment allowed is $1^{\circ}-08'$ or $D2-D1 = 6\text{mm}$ maximum. (D1 & D2 measured over 300mm). Ref. Fig. 2.

The above compressor mis-alignment is acceptable and will not give any undue belt wear in normal operation.

With the belt correctly tensioned, Ref paragraph 1, measure the angular alignment of the compressor using straight edges, Ref. Fig. 2.

If the angle is greater than $1^{\circ}-08'$ or dimension greater than 6mm then angled shim Part No. T67G-74-521 should be fitted as shown in Fig. 3.

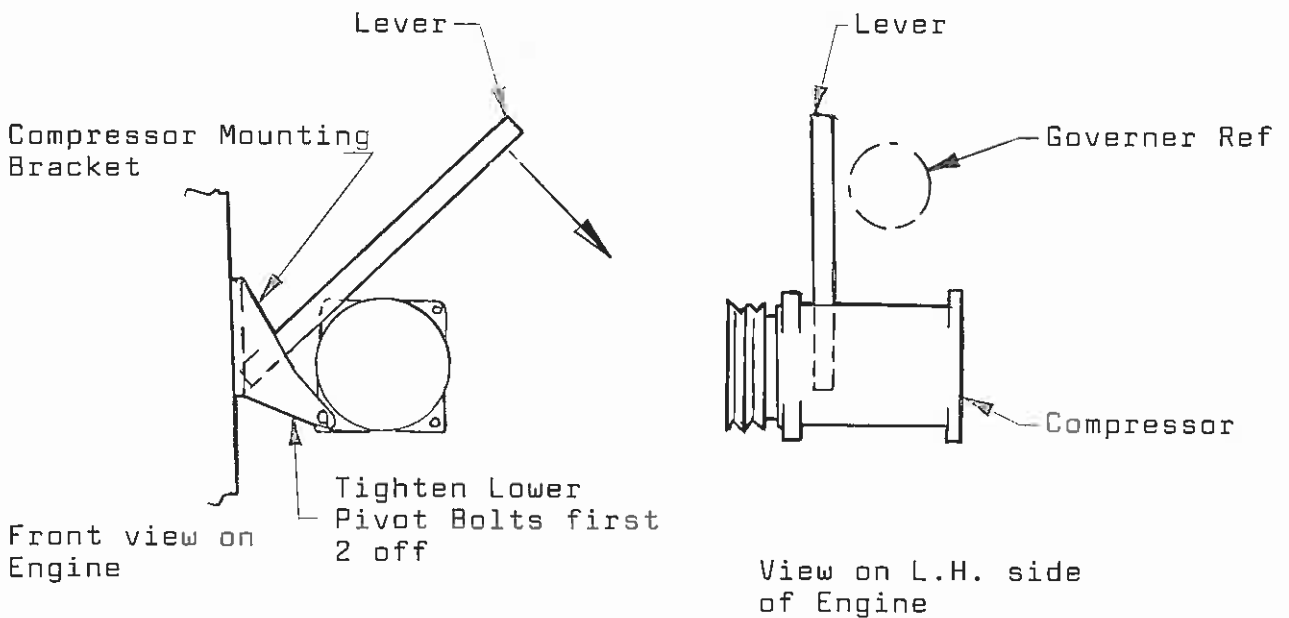
Fig 4
Showing Method of Tensioning

With the belt correctly tensioned, the compressor will be pulled approximately 0°-23' (2mm over 300mm) out of alignment in addition to any other mis-alignment.

Insert a suitable size piece of wood between the compressor mounting bracket and the compressor body towards the front of the compressor. Lever the compressor outwards to tension the drive belt. When the correct tension is achieved fully tighten the lower two pivot bolts. While maintaining the tension with the wood lever, tighten the pivot arm bolt on the compressor. Check the tension on the belt and if adjustment is required re-tension as described above. Re-check tension and ensure all fasteners are secure. Ref. Fig. 4.
