# Service Bulletin

S.B. No: 163

**Title:** INSPECTION OF FUEL VALVE TORQUE SHAFT UNIVERSALS

**Applicability:** T67C (Post Mod M156), T67M-MkII, T67M200, T67M260 (Pre Mod M945) and T67M260-T3A (Pre Mod M830). This inspection is not applicable to Aircraft works numbers 2267 thru to 2284.

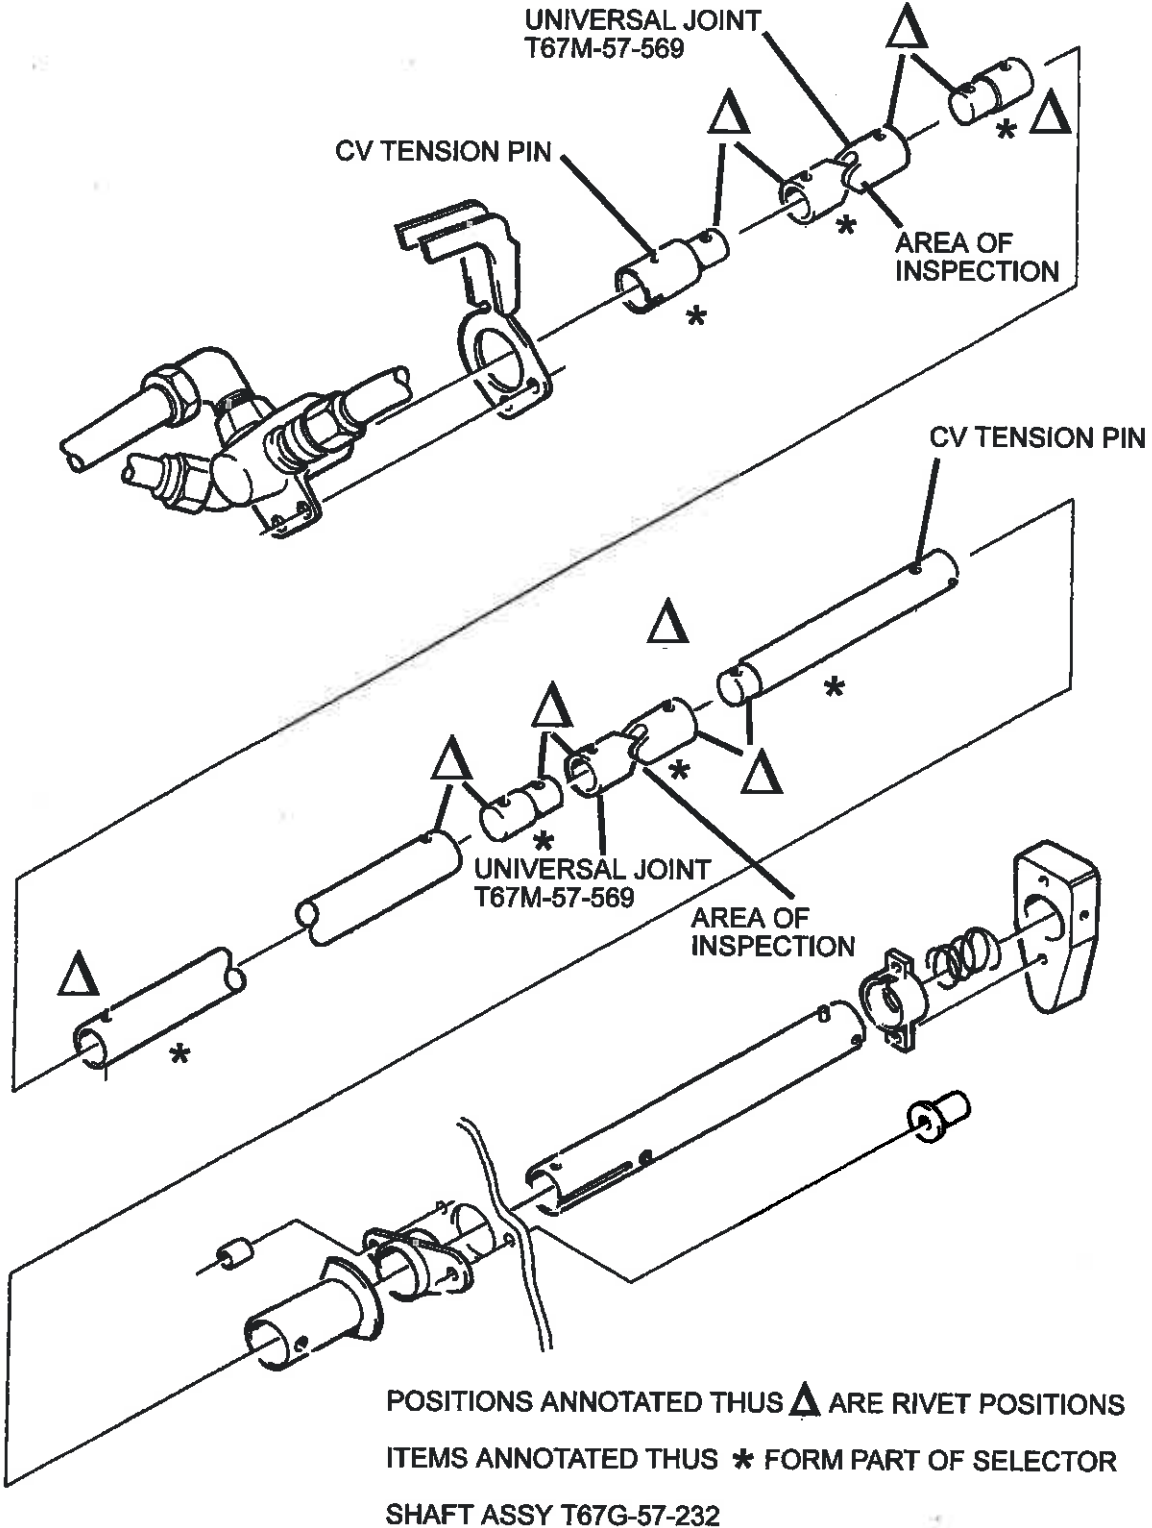
**FIG. 1 FUEL SELECTOR VALVE SHAFT DETAIL**  
 [T67M200 (Post Mod M915), T67M260 (Pre Mod M945), T67M260-T3A (Pre Mod M830)]

There have been several cases found of "worn" universal joints in the fuel selector valve torque shaft on the T67M260 type aircraft. There are 2 universal joints per shaft.

4. a. T67M200 (Post Mod M915), T67M260 (Pre Mod M945) and T67M260-T3A (Pre Mod M830), Figure 1:

If there is any evidence of wear or physical damage to the universal joint/s, then remove the torque shaft assembly T67G-57-232 and replace either the torque shaft assembly or the relevant universal joint (T67M-57-569) on the shaft. Reassemble torque shaft assembly back into the aircraft.

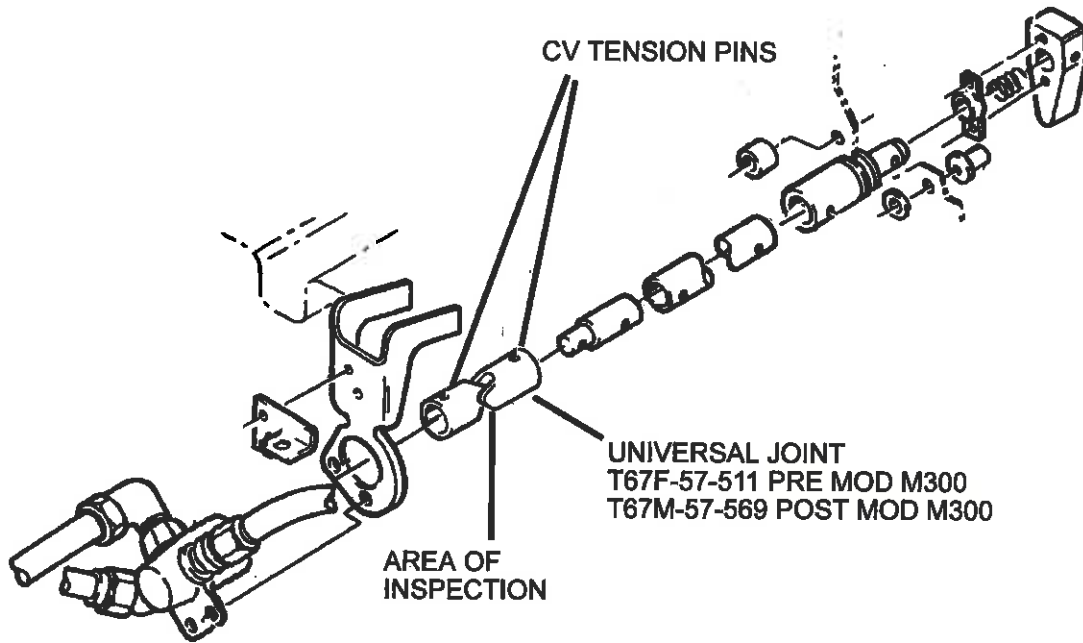
**FIG. 2 FUEL SELECTOR VALVE SHAFT DETAIL**  
[T67C POST MOD M156, T67M-MKII, T67M200 (Pre Mod M915)]

This universal joint is also used on the T67C Post Mod M156 (wing tank) T67M-MkII and T67M200 type aircraft. Though the torque shaft on these aircraft only uses one universal joint as opposed to two per shaft on the T67M260.

7. The assembly and reassembly cautions contained in paragraph 5 are to be added to the relevant aircrafts Maintenance Manual at next amendment.
8. T67C Post Mod M156, T67M-MkII and T67M200 only: IPC is incorrectly drawn ref universal joint. Figure 2 shows correct configuration. IPC will be amended in due course.

- b. T67C Post Mod M156, T67M-MkII and T67M200 (Pre Mod M915) Figure 2:

If there is any evidence of wear or physical damage to the universal joint then remove the universal joint, (T67F-57-511 Pre Mod M300, T67M-57-569 Post Mod M300) from fuel selector valve and shaft adapter assembly. Reassemble back into aircraft new relevant universal joint.
