Service Bulletin

S.B. No: 184

Title: INSPECTION AND WIRELOCKING OF FWD QUADRANT ENGINE CONTROL SPINDLE CV TENSION PIN

Applicability: T67M200 Post Mod M915, T67M260 and T67M260-T3A aircraft.

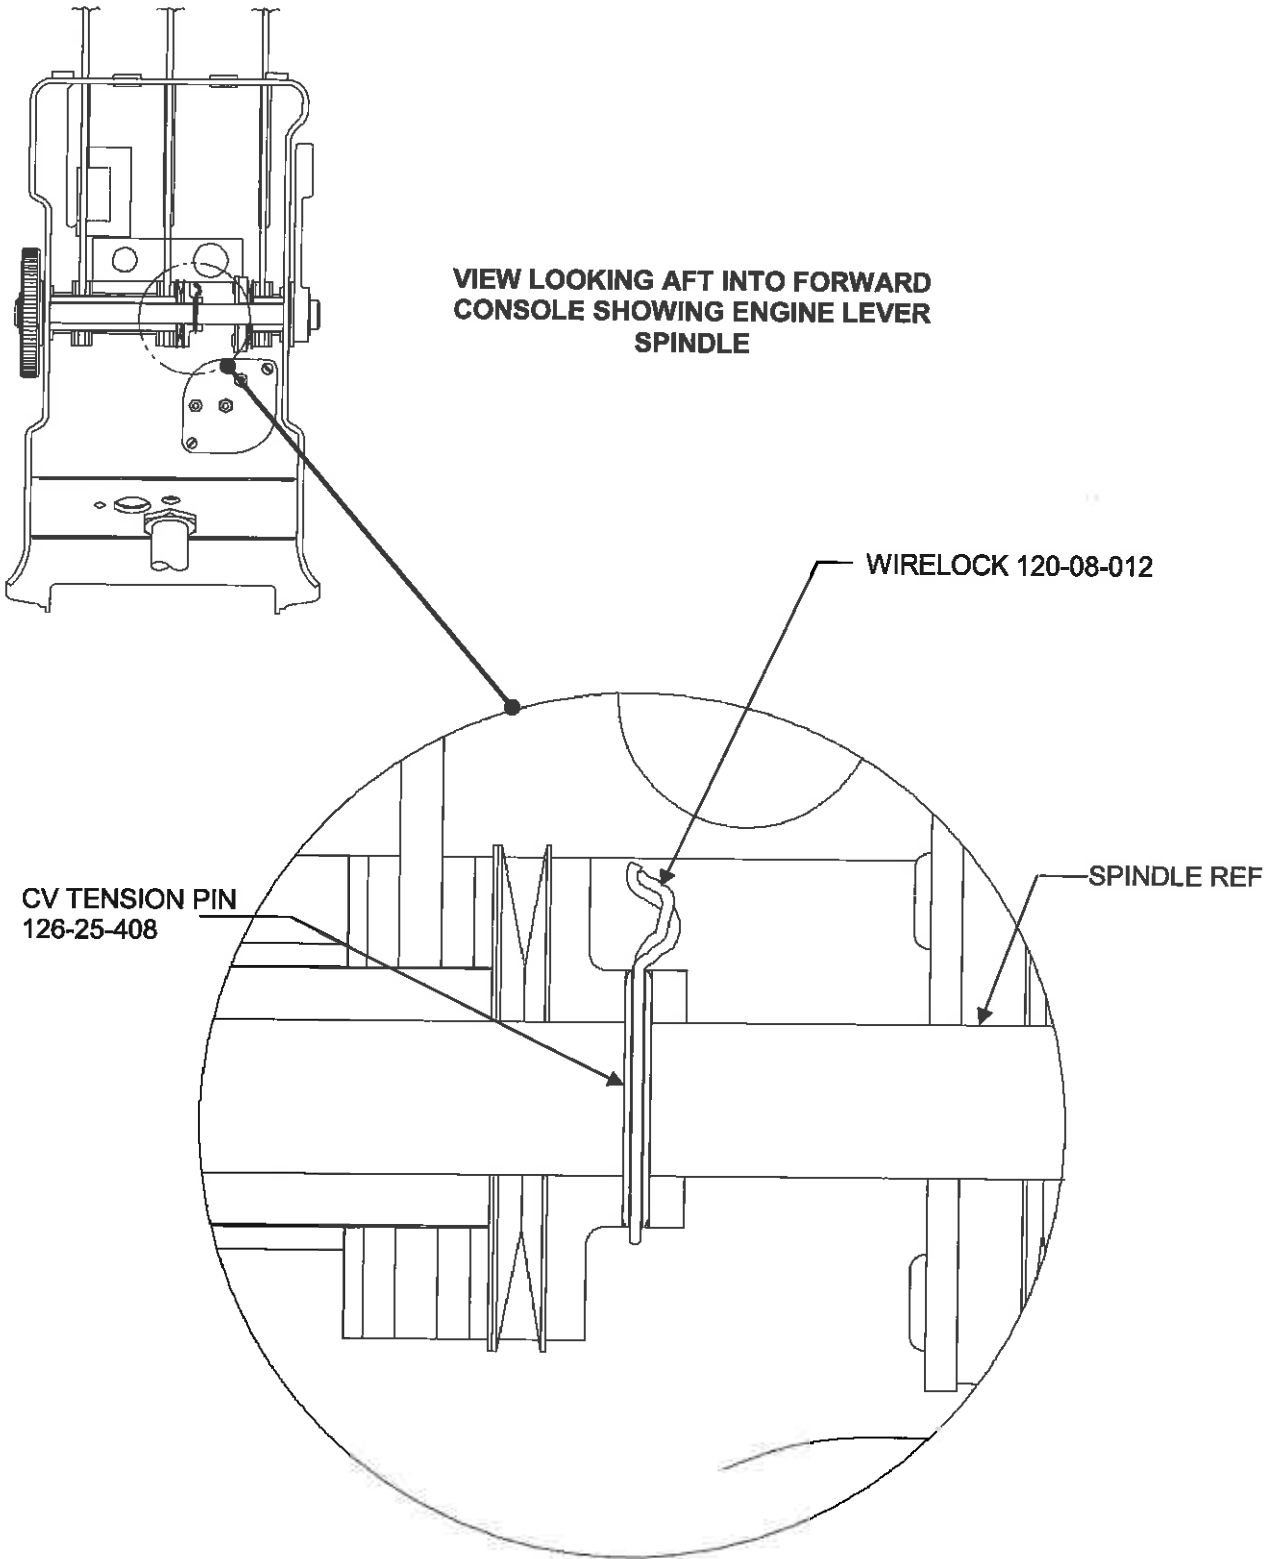
FIGURE 1

A case has been reported of the CV tension pin retaining the engine control spindle in position was found to be loose, ref figure 1.

DETAIL SHOWING CV TENSION PIN AND WIRELOCK

- 1 Gain access to behind quadrant console.
- 2 Check integrity of CV tension pin.
- 3 If CV tension pin found to be loose, replace with new item SAL stores code 126-25-408. Proceed as per step 5.
- 4 If CV tension pin is secure then proceed as per Step 5.
- 5 Thread wirelock 120-08-012 through CV tension pin and lock IAW standard aircraft practice. Ensure wirelock does not interfere with operation of controls etc., or interfere with any wiring.
- 6 Annotate logbook "SB 184 accomplished, Mod M1024 invoked."
