**SERVICE BULLETIN**

SB No. 58 Issue No. 1

FAIREY UNDERCARRIAGE INSPECTION.

All T67C and T67M MKII Post Mod 468 and all T67M260/T3A aircraft.

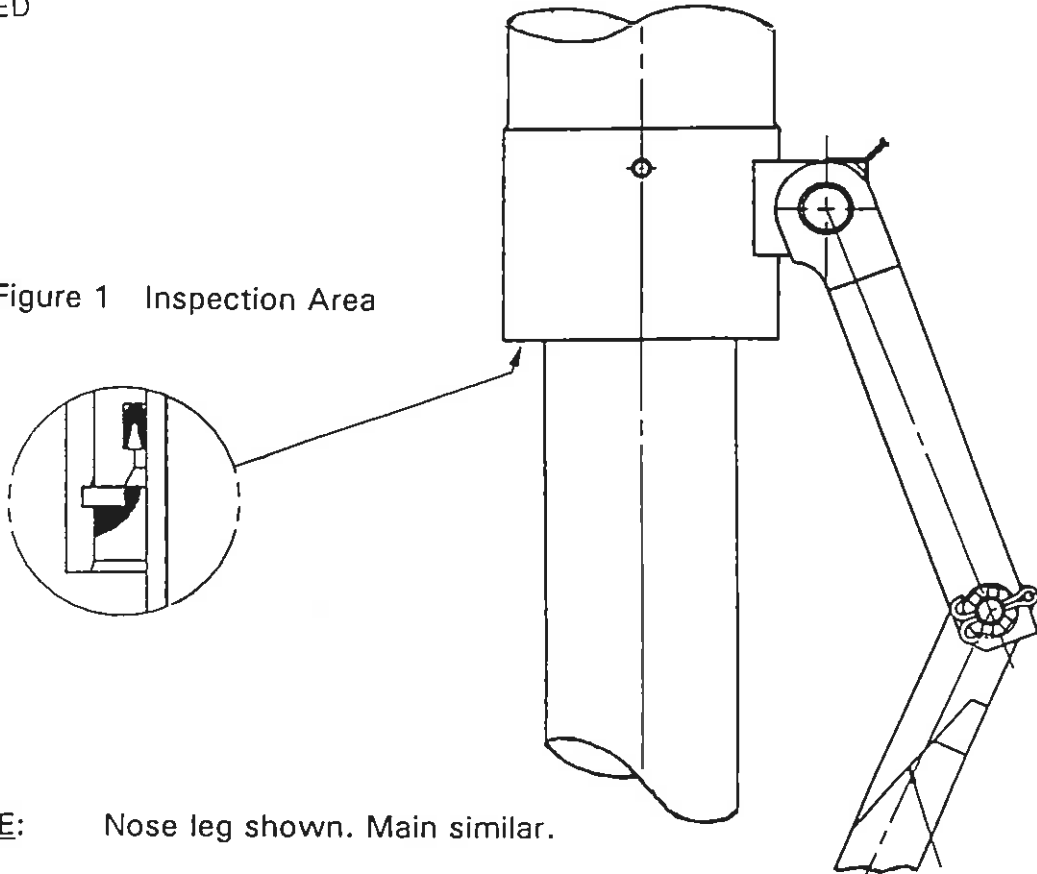
Figure 1 Inspection Area

There have been occurrences where the sealant applied to the lower end of the cylinder assembly and gland interface has become detached. The sealant also covers the circlip that retains the gland. See Fig 1.

Visual Inspection of all nose and main landing gear assemblies in the position indicated on Fig. 1 of this Service Bulletin.

- a. Using a mirror and torch if required, visually inspect the sealant in the recessed area around the lower part of the cylinder assembly that houses the gland and the circlip.

NOTE: Nose leg shown. Main similar.

- a. Remove any loose and defective sealant.
- b. Apply protective waterproof substance at the cylinder/gland interface and over the circlip.

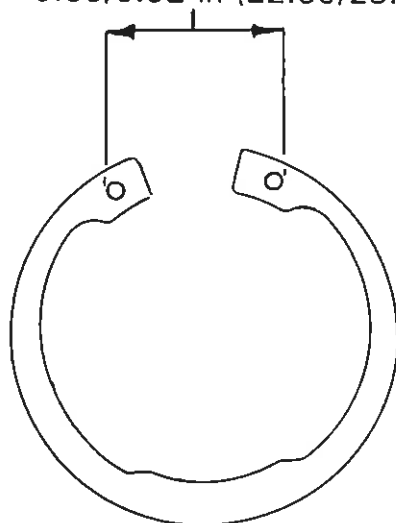
Figure 2 Circlip measurement

Main leg - 1.10/1.06 in (27.94/26.92 mm)

Nose leg - 0.88/0.92 in (22.35/23.37 mm)

- c. Remove circlip.
- d. Thoroughly clean the circlip, circlip groove and adjacent area.
- e. Refit circlip and make sure it has fully expanded in its groove. Refer to Fig. 2 of this bulletin and measure the distance between the holes in the circlip which must be:

Nose Leg - 0.88/0.92 in (22.35/23.37 mm)

Main Leg - 1.10/1.06 in (27.94/26.92 mm)
