## Service Bulletin

S.B. No: 177

**Title:** INSPECTION OF STARTER AND GROUND POWER SOCKET SOLENOIDS FOR CRACKING  
– FRAME 5 AVIONICS PANEL MOUNTED

**Applicability:** T67M200 and T67M260 Post Mod M860. (2261 to 2264, 2266 & 2267)

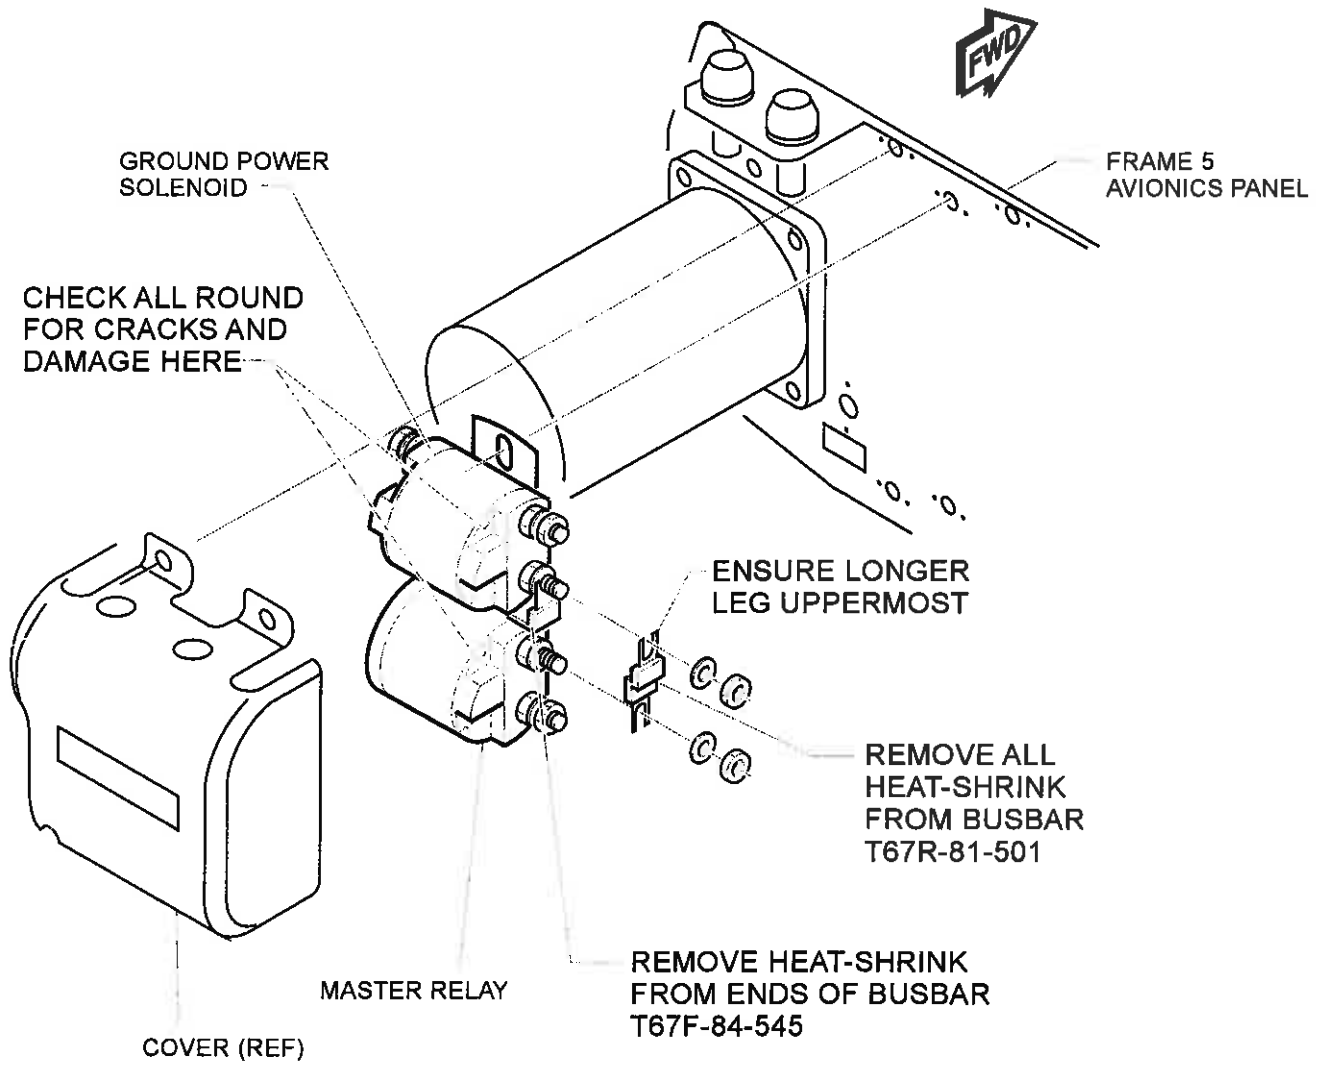
During manufacture it was noticed that the plastic casing on the starter master relay was cracked. The starter master relay is mounted below the ground power socket solenoid on the Avionics Frame 5 Panel located behind and to the port side of Frame 5.

Upon investigation it was found that the heatshrink on the busbars, linking the relays and solenoid together, fouled each other, which in turn causes the small busbar not to seat properly. Therefore, as the smaller busbar is bolted down onto the master relay, a possibility of cracking the casing exists.

1. Check master switch, ignition switch and fuel are OFF. Disconnect external power and hangar aircraft, if required.
2. Gain access to the back of Frame 5.
3. Remove the GRP cover from the avionics panel, then remove both busbars, Ref. Fig. 1.
4. Check in the areas indicated for cracking on the master relay, (most likely lower relay, possibly solenoid). Replace item if damage or cracking found.
5. Remove 10mm of heatshrink from each end of busbar T67F-84-545. Remove all the heatshrink, if fitted, from busbar T67R-81-501.
6. Reassemble busbars; ensure longer leg of busbar T67R-81-501 is uppermost.
