Service Bulletin

S.B. No: 187

Title: INSPECTION FOR CLEARANCE BETWEEN RUDDER PEDAL AND MIXTURE/PROP. SPEED BRACKET. ALSO INCLUDES GENERAL RUDDER PEDAL CLEARANCES.

Applicability: T67M200 (Works No. 2264 & 2265 only), T67M260 and T67M260-T3A.

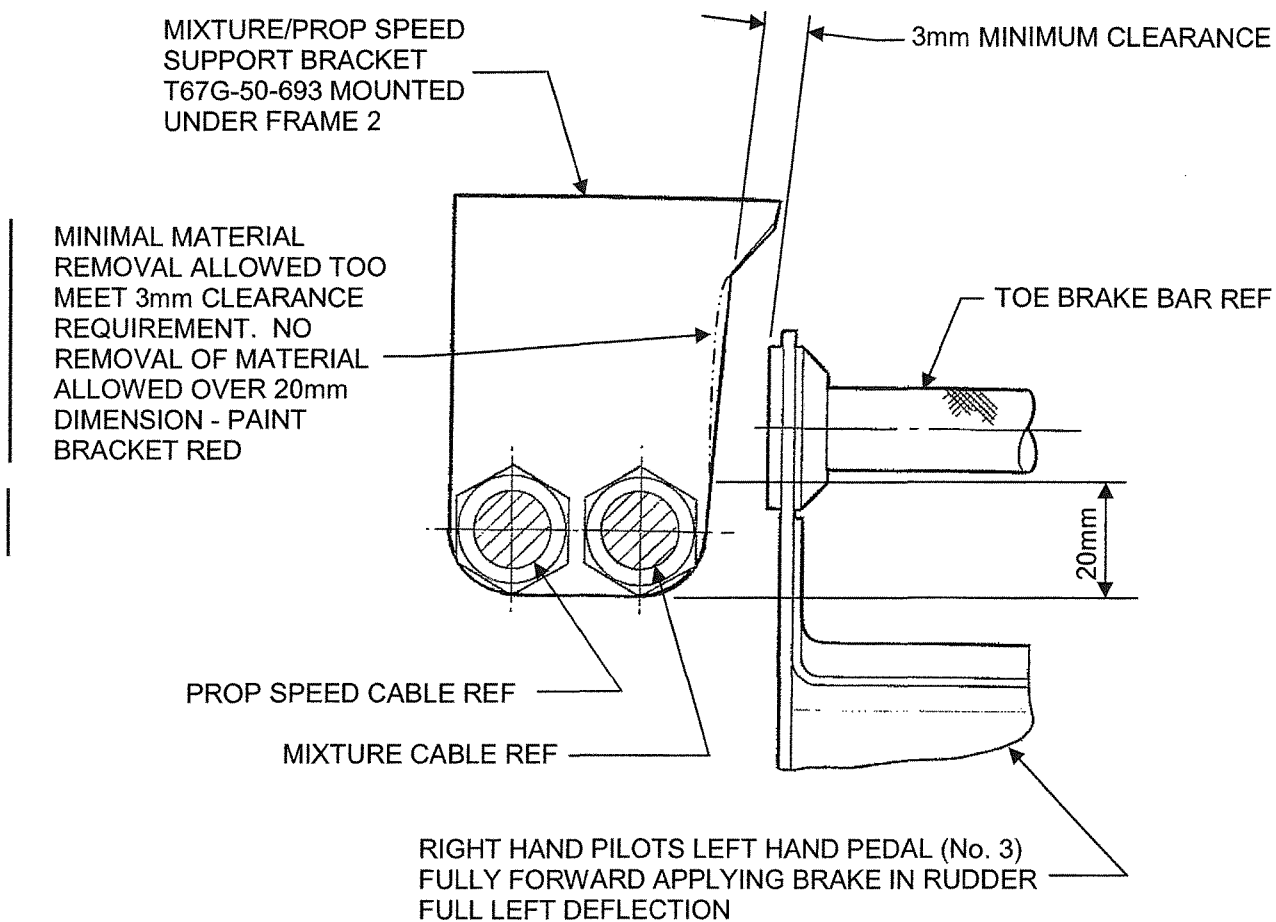
FIGURE 1
SHOWING CLEARANCE MIXTURE/PROP SPEED BRACKET TO No. 3 PEDAL

A case has been reported of the No. 3 Rudder Pedal fouling the Mixture/Prop. Speed Operating Cable Bracket during spin recovery. This foul may occur when the pedal is adjusted fully forward and with full left rudder applied. Upon further inspection it was observed that the floor was damaged allowing the rudder bar support bracket to distort and the bar and its pedal to float to the left greater than the limit allowable for safe operation.

1. With Right Hand pilots left pedal (Pedal No. 3) adjusted fully forward, with left rudder applied, apply brake together with a left hand side force on the pedal. Check for clearance on mixture/propeller speed cable support bracket. Refer Figure 1.

2. Clearance should be a minimum of 3mm. Figure 1 refers.
 - 2.1 If the clearance is less than 3mm, the following inspection and corrective actions, paragraphs 3 to 25, shall be carried out in order to increase the clearance up to the required minimum of 3mm.

16. Ensure correct clearance of No 3 pedal to Mixture/Prop. Speed bracket; refer Paragraph 2 above, has still been maintained. If clearance has still not been achieved then it is allowable to remove some of the bracket material to obtain the clearance, paint modified bracket red and annotate in log book, this is a non-preferred solution. Please inform SACL of the amount of material to be removed prior to removal. If this interim solution still does not achieve the required clearance then inform SACL. On applicable aircraft with interim solution applied, at next annual from the date of receipt of this Service Bulletin invoke Mod M1030 "Introduction of Revised Propeller Speed/Mixture Bracket and Mounting to Ensure Rudder Pedal Clearance".

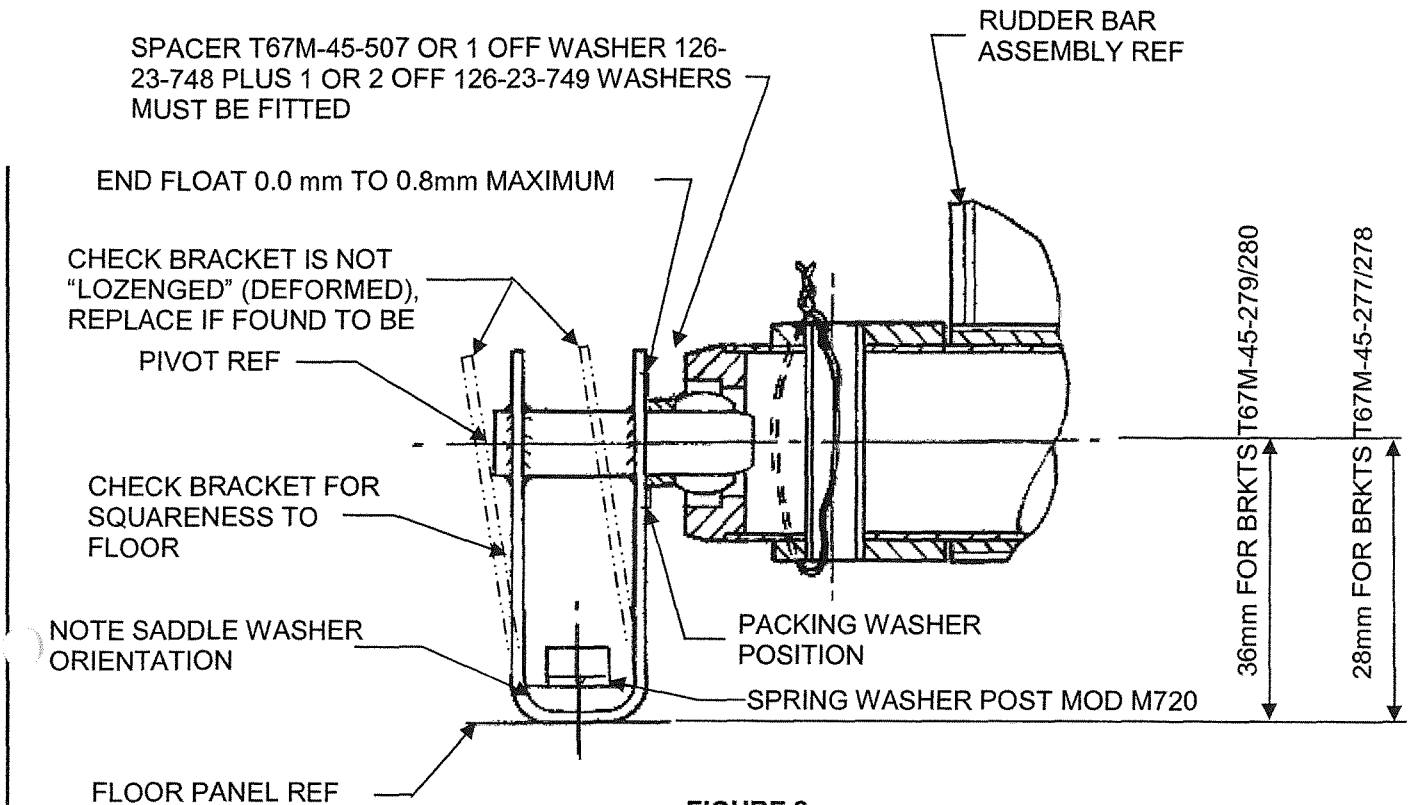
FIGURE 2

4. Check rudder pedal bar end float is no greater than 0.8mm. Acceptable end float is 0.0mm to 0.8mm. If end float is greater than 0.8mm then rectify IAW paragraph 9. Refer Figure 2.

5. Check that the Rudder Pedal bar port outboard support bracket, ref. Figure 2 and 4, is square to floor and not "lozenged" and there is no deformation to its base. Check floor panel under area of bracket, inspect for cracking which could allow the bracket to lean. If necessary remove floor panel and check for signs of cracking in the floor around the anchor nuts on Pre Mod M919 aircraft or the anchor nut mounting plate Post Mod M919 aircraft, refer Figure 3. Any GRP damage will be shown as a white shadow on the GRP, with cracking felt as a rough edge. A light shining up through the floor will show a shadow.

RUDDER BAR END FLOAT AND ITS SUPPORT BRACKET

7. Should Rudder bar support bracket be damaged, replace with a new item. Ensure brackets are secured with a torque of 58lbf in (6.5Nm). Ensure spring washers are fitted; Mod M720 "Introduction of Spring Washers to Rudder Pedal Lay-shaft Mounting Bracket Screws" refers. Ensure when refitting brackets that the saddle washer, T67M-45-537, is re-fitted and is assembled with its corner radius into the brackets radius, refer Figure 2. Ensure that the taller mounting brackets, T67M-45-277/278, are supporting Rudder Pedal Bar T67M-45-257, i.e. Port Rudder Bar, refer Figures 2 and 4.

9. Referring to Figure 2 ensure at each rudder bar pivot position that there is one spacer T67M-45-507 OR one off washer 126-23-748 and up to a maximum of two off washers 126-23-749, i.e. 3 washers maximum.

If end float greater than 0.8mm, then 1 off packing washer may be added at each pivot position as required, i.e. 126-23-105 washer or 126-23-748 washer or 126-23-749 washer.

If packing washers are required on the right hand rudder bar (T67M-45-259), then the packing washer, (or the thicker washer if a thick and thin washer are required) should be placed at the outboard pivot. When end float of 0.8mm maximum is achieved, ensure that the brake cylinders are not subject to undue side load. If in doubt, contact SACL.

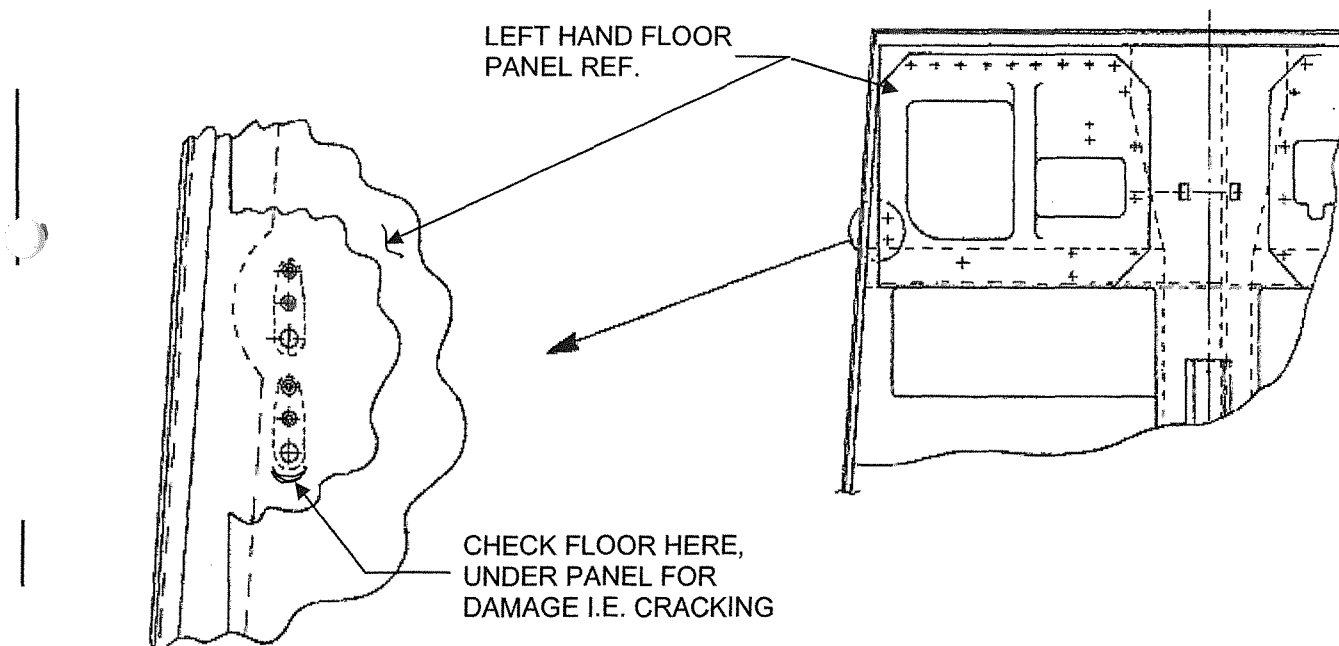
FIGURE 3

AREA OF FLOOR REQUIRING INSPECTION (PRE MOD M919 DRAWN)

6. If floor under port outboard support bracket is found to be cracked or broken then repair IAW DOI T67C-149 incorporating Mod M919. If Mod M919 has been previously incorporated and floor is damaged, inform SACL.

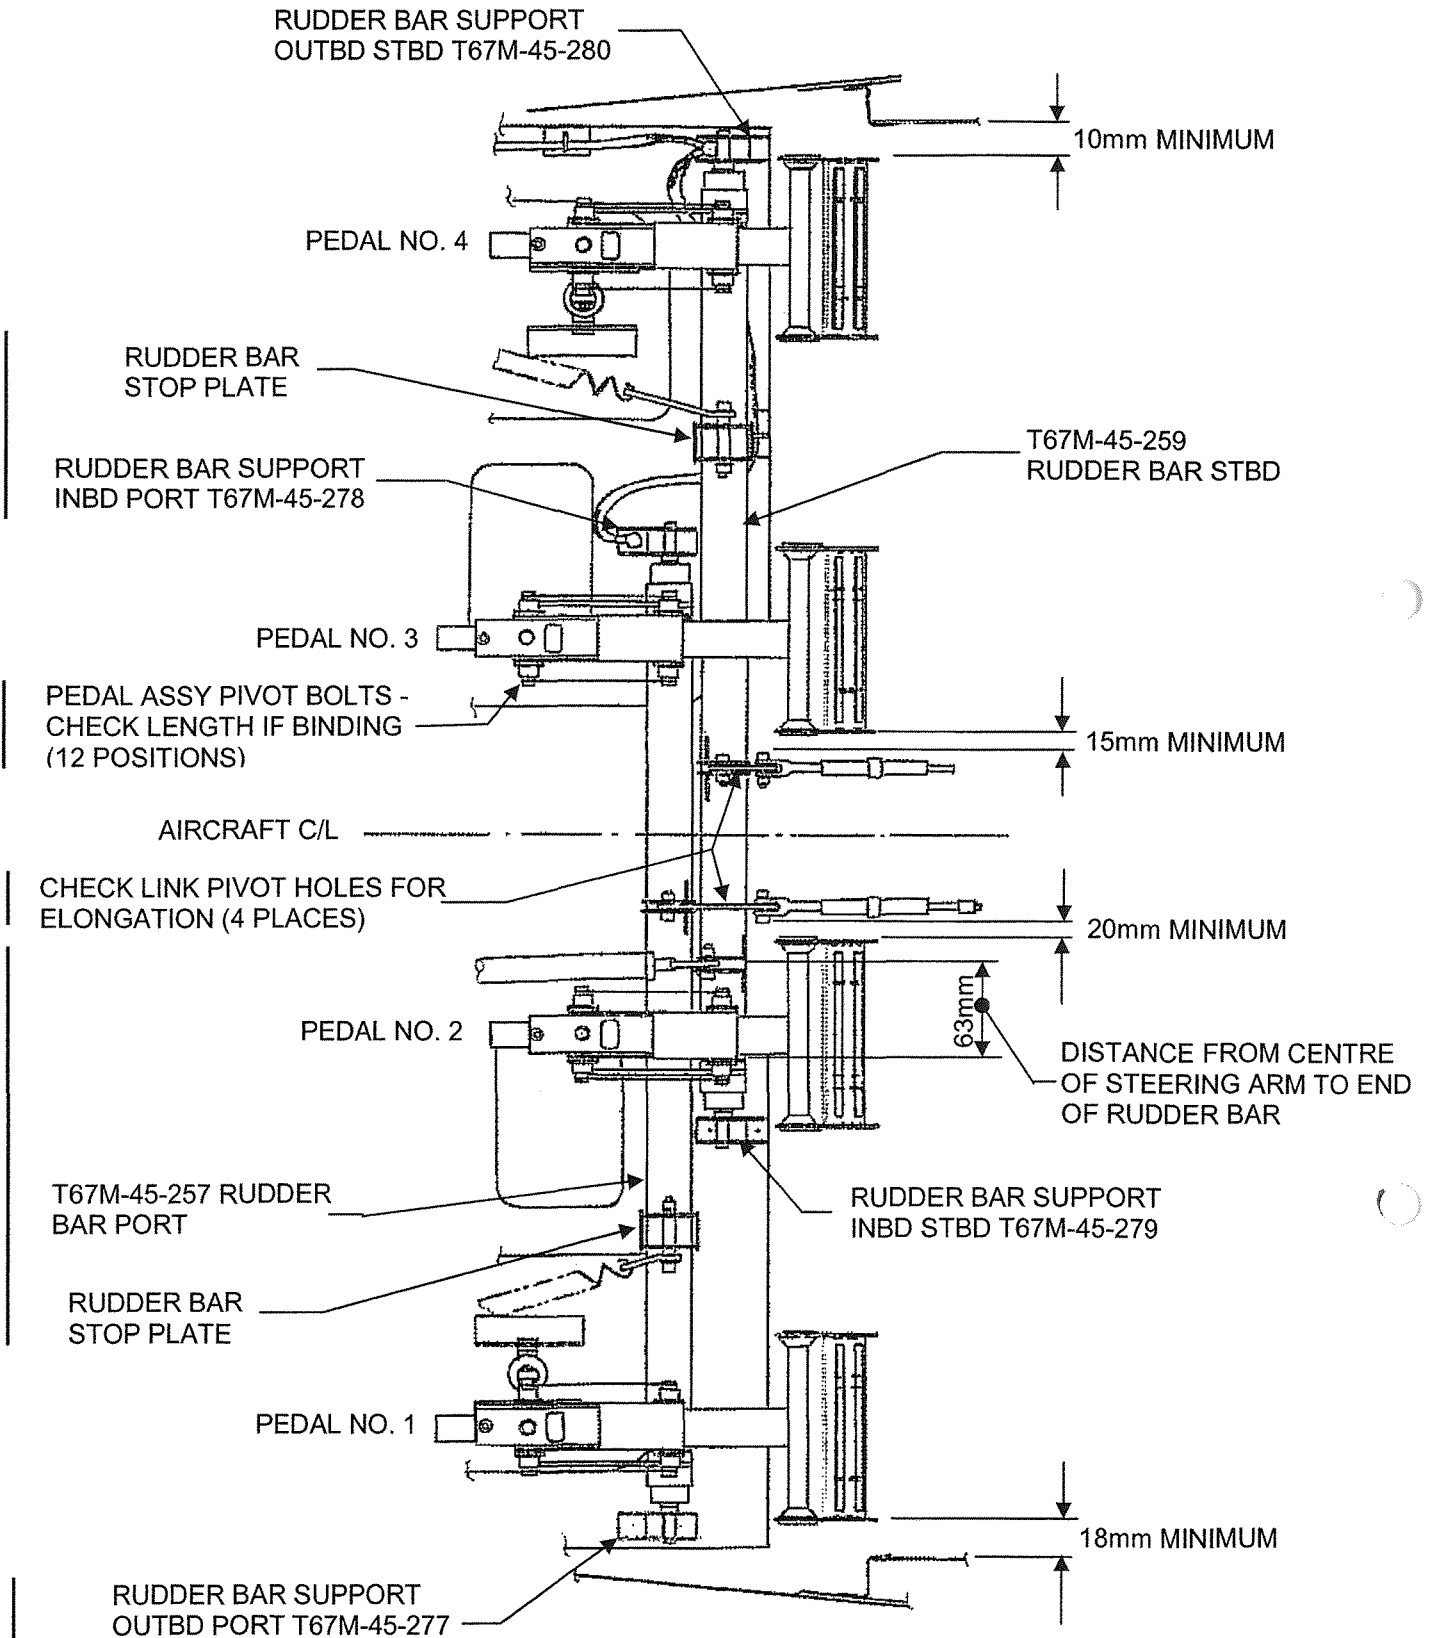
FIGURE 4

8. Check the remaining rudder bar support brackets, are square to floor and are not "lozenged" and there is no deformation to their bases, reference Figures 2 and 4. If any bracket is found to be suspect replace with new item. Check floor under any damaged support bracket by removing panel. Ensure washers and brackets are correctly assembled refer paragraph 7 above. Inform SACL of any damaged bracket or additional floor damage. Assemble item as per paragraph 7 and ensure end float is as stated in paragraph 9. Ensure bonding leads are correctly fitted, carry out bonding check refer relevant aircraft's Maintenance Manual.

Note 2: Note rudder stop plates, positions indicated on Figure 4, are permitted with deformation assuming full rudder movement and clearances have been achieved and there is no cracking in the welds supporting the stop plates, if in doubt return rudder bar to SACL for rework.

RUDDER PEDAL CLEARANCES TO SIDE PANEL AND RUDDER CABLES

14. Upon completion of rudder movement set-up ref. Paragraph 12 above, ensure minimum clearances of trim panel to pedal side plates and rudder cable to pedal side plates are met Refer Figure 4. Refer paragraph 9 for packing washers.

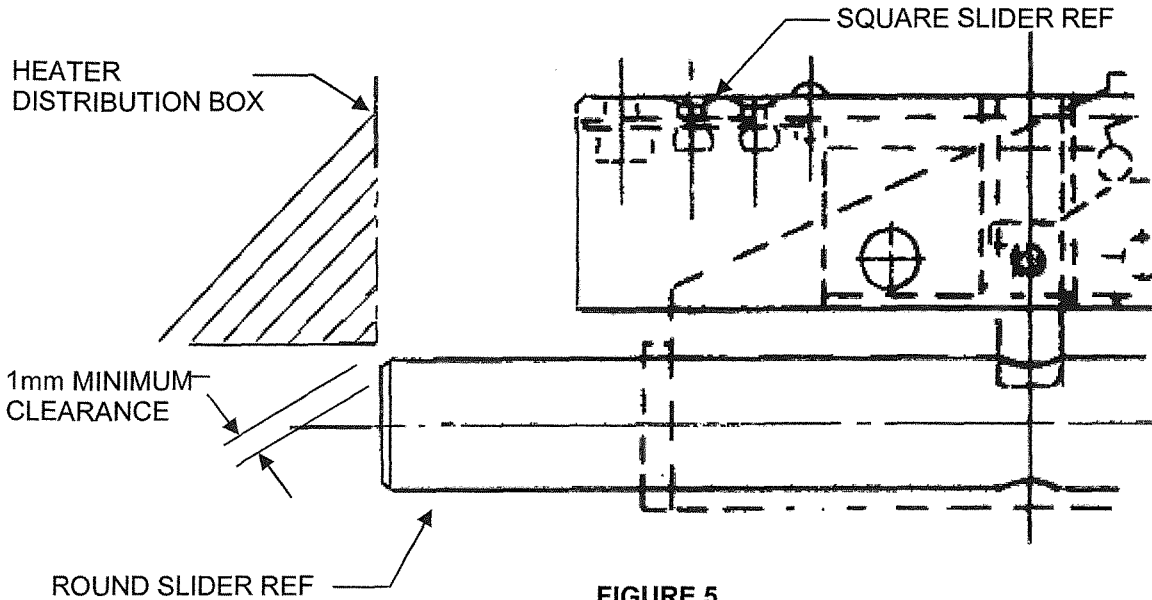
FIGURE 5

15. Ensure clearance of the no. 2 pedal slider to heater box clearance, is greater than 1mm, Figure 5 refers. Inform SACL if clearance is not achievable.

PEDAL NO. 2 TO HEATER BOX CLEARANCE

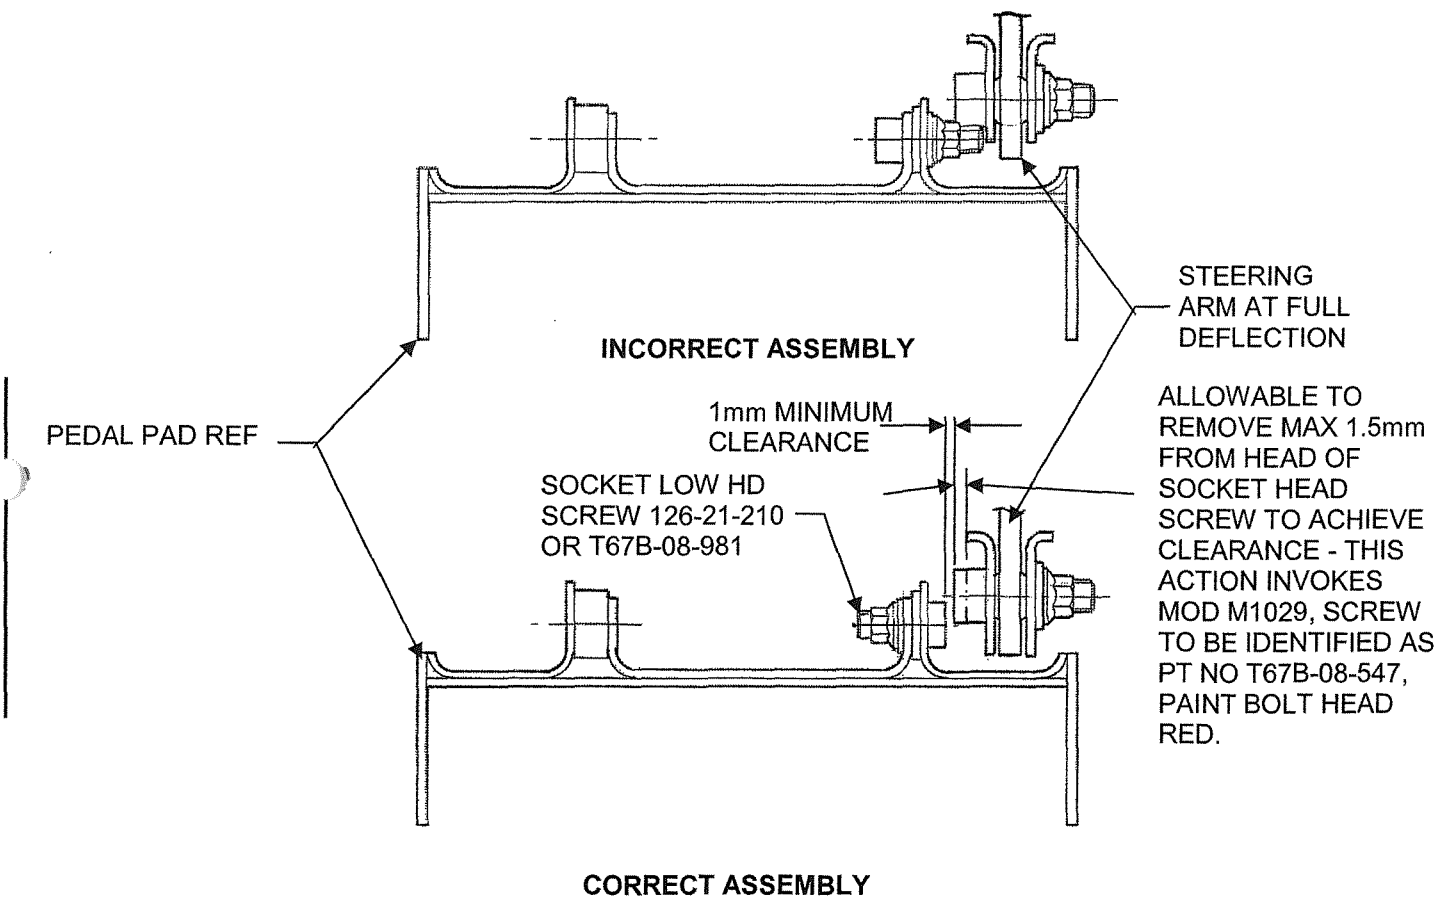
FIGURE 6

18. Ensure head orientation of rudder cable link low pan head bolt T67M-45-570 is outboard. T67M260 Maintenance Manual Figure 5-7 refers.
19. Ensure Pedal no 2 Pedal pad pivot bolt head height is less than 5mm and orientated, as shown in Figure 6. A minimum of 1mm clearance is required, if not, fit part no 126-21-210 or T67B-08-981, this invokes Mod M671 "Introduction of Low Head Rudder Pedal Pad Pivot Bolts – Pedal No. 2". If clearance is not still achieved check distance of steering arm from bar end, Figure 4 specifies. If the distance is incorrect, then return rudder bar to SACL for re-worked/new item. Alternatively if clearance of 1mm is still not achievable remove up to a maximum of 1.5mm from the steering arm screw this invokes Modification action M1029, Figure 6 refers, and paint modified screw head red.

PEDAL NO. 2 TO STEERING ARM INTERFACE

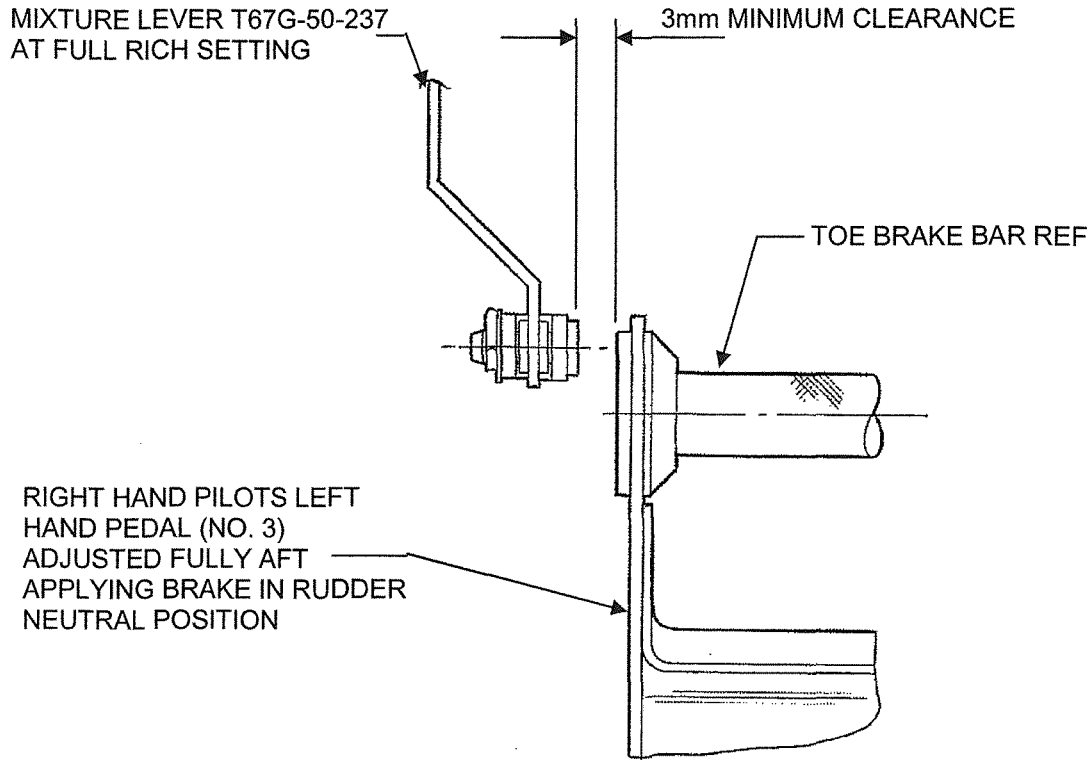
FIGURE 7

21. Ensure, that a minimum clearance of 3mm is achieved between Pedal No 3 and Mixture Lever operating arm, refer Figure 7. Refer paragraph 9 for packing washers.

VIEW LOOKING FORWARD ONTO NO.3 RUDDER PEDAL

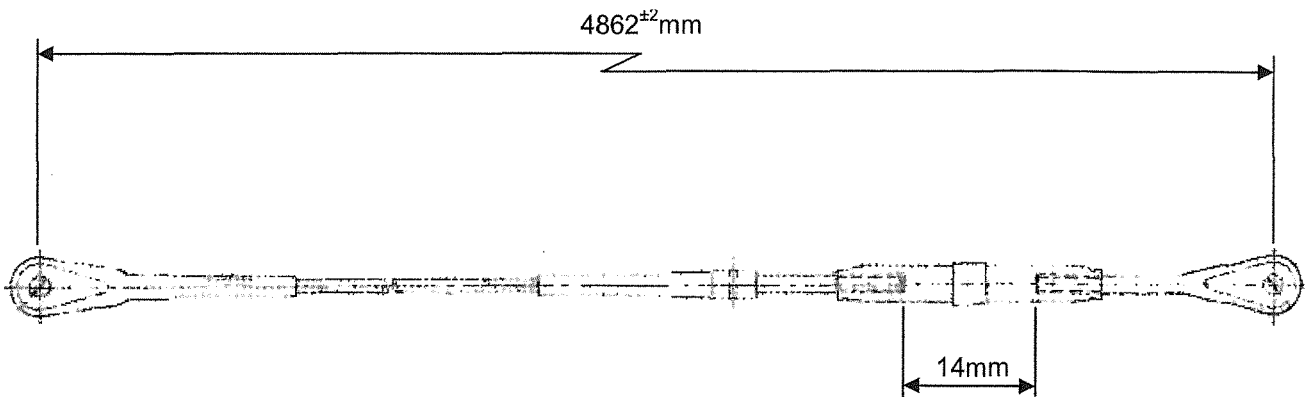
FIGURE 8

17. This paragraph is not applicable to aircraft with Post Mod M945 "Introduction of ISA +35°C Fuel System Improvements" incorporated. Ensure fuel pipe to rudder pedal slider clearance is met; refer T67M260 Maintenance Manual Paragraph, 5.6.5.1, the minimum acceptable clearance is now to be 5mm. If clearance cannot be achieved then; i) remove Rudder Cable and check length, length should be 4862 ± 2 mm, Figure 8 refers; ii) additionally check condition of rudder pedal assembly, refer paragraph 3.

RUDDER CABLE T67B-45-219
(ORIGINAL MANUFACTURED DIMENSIONS QUOTED)

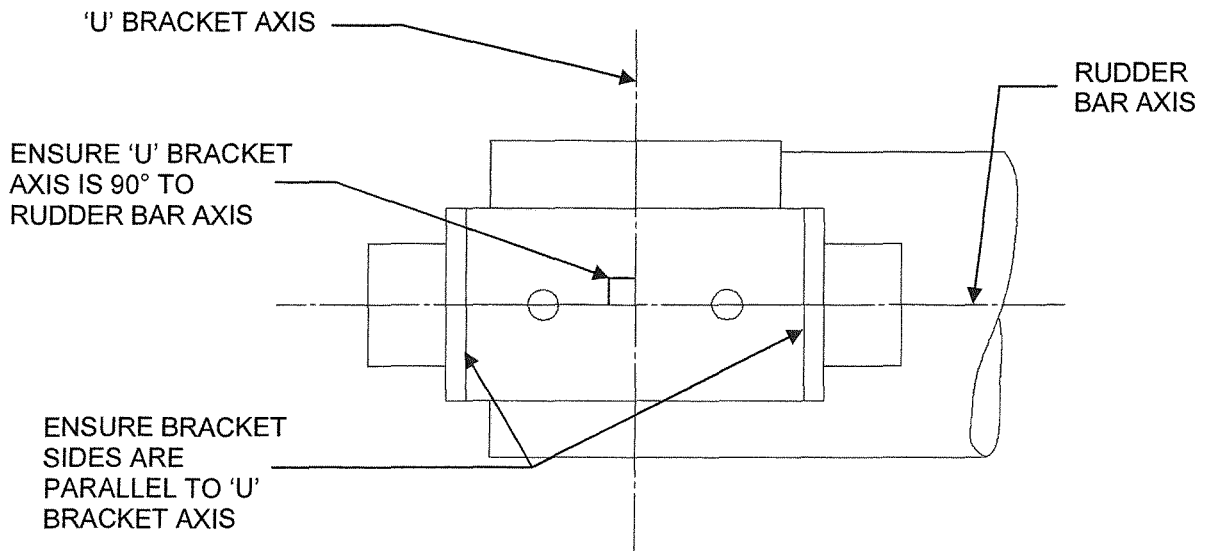
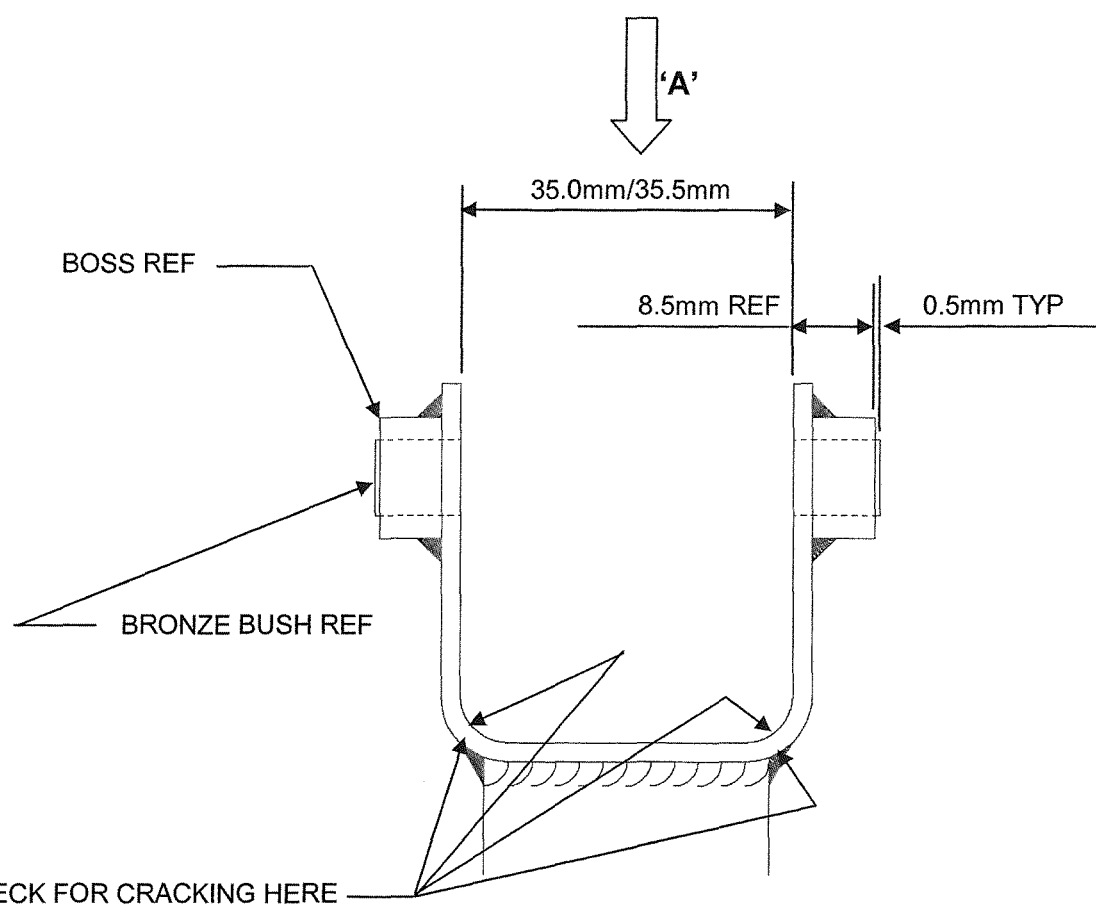
FIGURE 9

10. Ensure the rudder pedal carriages have full and free movement. If binding is suspected then check the 'U' bracket internal dimension. This should measure 35.0mm to 35.5mm, the bracket should also be parallel and square to the rudder bar axis, Figure 9 View on 'A' refers. Check that the pivot bush protrudes from its boss by 0.5mm. If the bracket internal dimension is greater or less, or if out of alignment then the bracket should be checked for cracking, refer Figure 9. If cracking is found then return rudder bar to SACL for rework. Finally check length of carriage pivot bolts, reference Figure 4, if binding is noted then replace bolts with bolt part number T67B-08-537 this introduces a bolt 15 mm long, measured from under head, and invokes Mod M808 "Introduction of Shortened Pivot Bolt to Rudder Pedal Slider Assembly Mounting". Also refer to SB130 Inspection of Rudder Pedals for Adjustment Restriction".

'U' BRACKET ON RUDDER BARS
(4 POSITIONS)

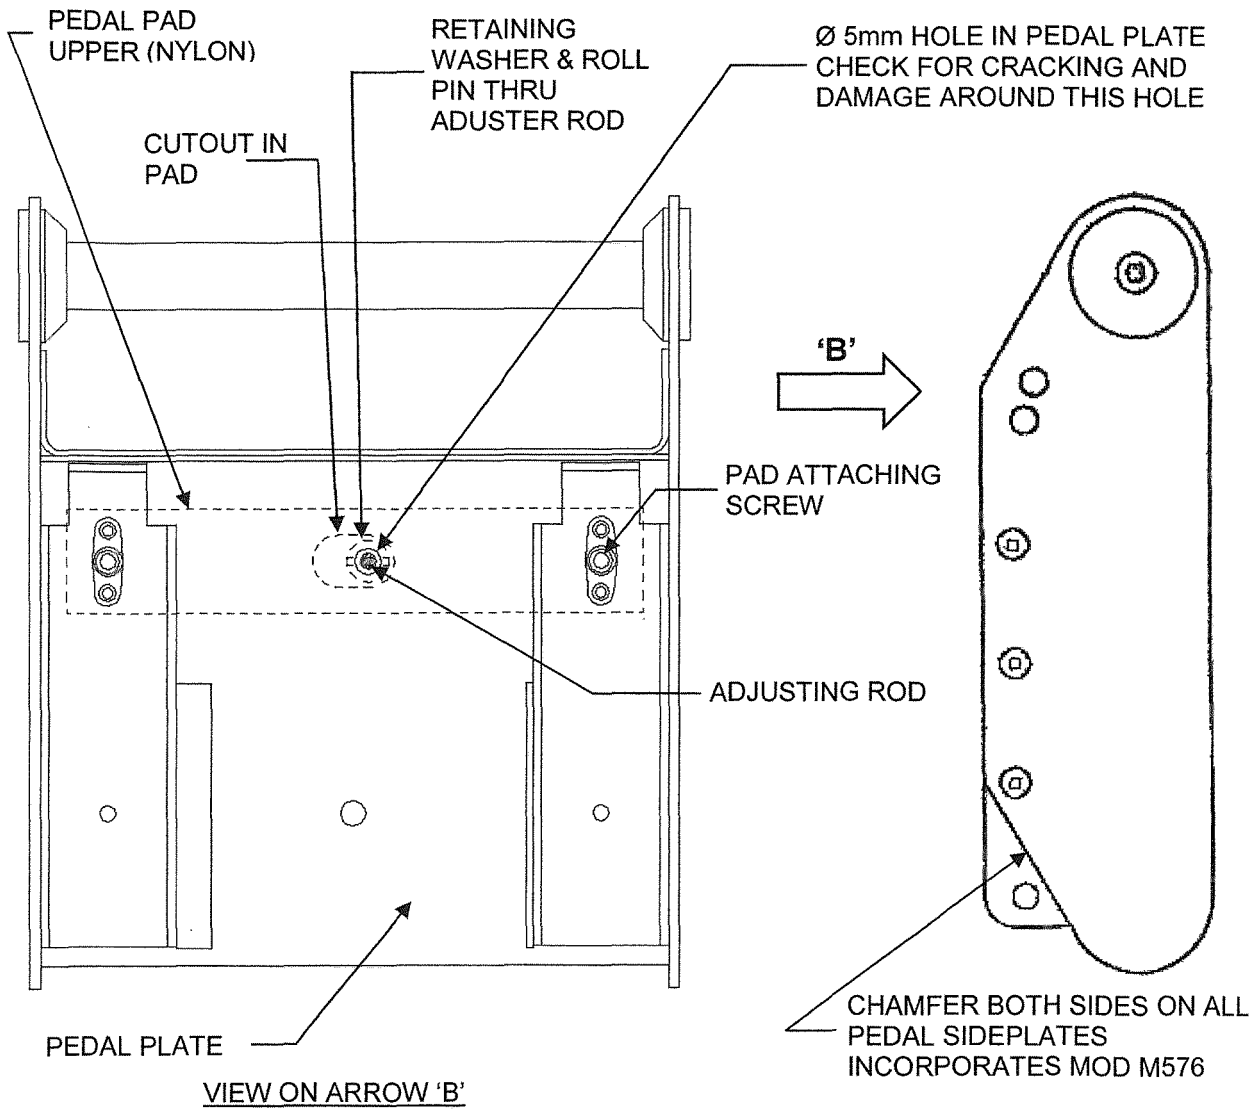
FIGURE 10

22. Ensure Mandatory Mod M576 has been invoked; AD 013-05-94 refers. Pedal side plate should be as Figure 10.
23. Check structural integrity of pedal pad assembly especially around adjuster pushrod hole pedal plate, Figure 10 View on Arrow 'B' refers, if plate is cracked or damaged the pedal pad is to be repaired. Ensure riveting is secure, if rivets are loose then they have to be rectified. Contact SACL for new pedal pad assembly, materials and any applicable repair scheme.

TYPICAL RUDDER PEDAL ASSEMBLY SHOWING SIDEPLATE CHAMFERING AND PEDAL ADJUSTER ROD ATTACHMENT
