# Service Bulletin

S.B. No: 188

**Title:** INSPECTION FOR RUDDER PEDAL CLEARANCES BETWEEN RUDDER PEDALS AND THE AIRCRAFT STRUCTURE AND COMPONENTS ALSO INSPECTION FOR GROUND TOWING DAMAGE.

**Applicability:** T67B, T67C series, T67M (excluding works no. 1999), T67M-MkII and T67M200 (excluding works no. 2264 & 2265).

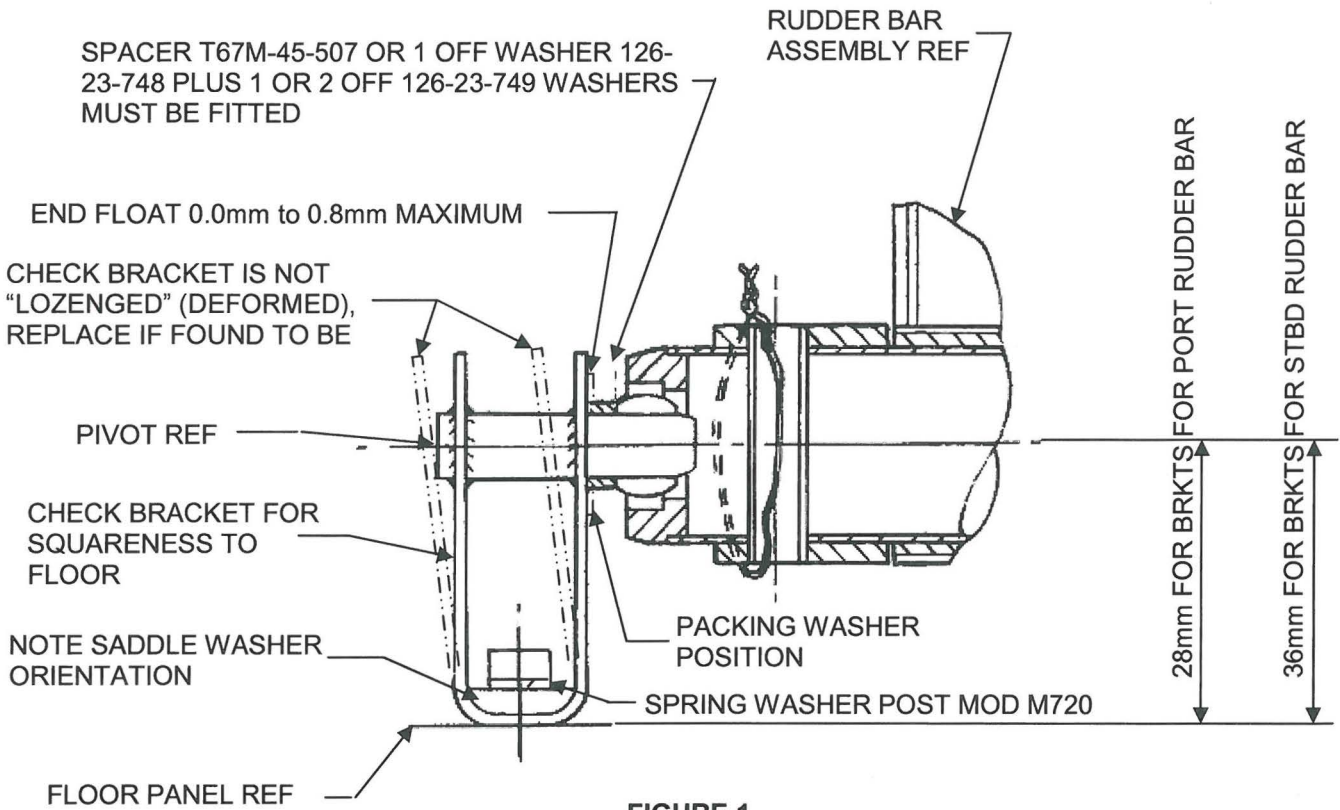
**RUDDER BAR END FLOAT AND ITS SUPPORT BRACKET**

3. Check rudder pedal bar end float is no greater than 0.8mm. Acceptable end float is 0.0mm to 0.8mm. If end float is greater than 0.8mm then rectify end float IAW paragraph 13. Refer Figure 1.

4. Check that the Rudder Pedal bar port outboard support bracket, ref. Figure 1 and 3 is square to the floor and not "lozenged" and there is no deformation to its base. Check floor panel under area of bracket, inspect for cracking which could allow the bracket to lean. Remove the floor panel and check for signs of cracking in the floor around the anchor nuts on Pre Mod M919 aircraft or the anchor nut mounting plate Post Mod M919 aircraft, refer Figure 2. Any GRP damage will be shown as a white shadow on the GRP, with cracking felt as a rough edge. A light shining up through the floor will show a shadow.

7. Should Rudder bar support bracket be damaged replace with new item. Ensure bracket is secured with a torque of 58lbf in (6.5Nm). Spring washers may be fitted; Mod M720 "Introduction of Spring Washers to Rudder Pedal Lay-shaft Mounting Bracket Screws" refers. See Figure 1. Ensure when refitting brackets that the saddle washer, T67M-45-537, is re-fitted and is assembled with its corner radius into the brackets radius, refer Figure 1. Ensure that the shorter, (28mm), mounting brackets are supporting Rudder Pedal Bar T67M-45-257, i.e. Port Rudder Bar, refer Figures 1 and 3.

13. Referring to Figure 1 ensure at each rudder bar pivot position that there is one spacer T67M-45-507 OR one off washer 126-23-748 and up to a maximum of two off washers 126-23-749, i.e. 3 washers maximum.

If end float greater than 0.8mm, then 1 off packing washer may be added at each pivot position as required, i.e. 126-23-105 washer or 126-23-748 washer or 126-23-749 washer.

If packing washers are required on the right hand rudder bar (T67M-45-259), then the packing washer, (or the thicker washer if a thick and thin washer are required) should be placed at the outboard pivot. When end float of 0.8mm maximum achieved ensure that the brake cylinders are not subject to undue side load. If in doubt contact SACL

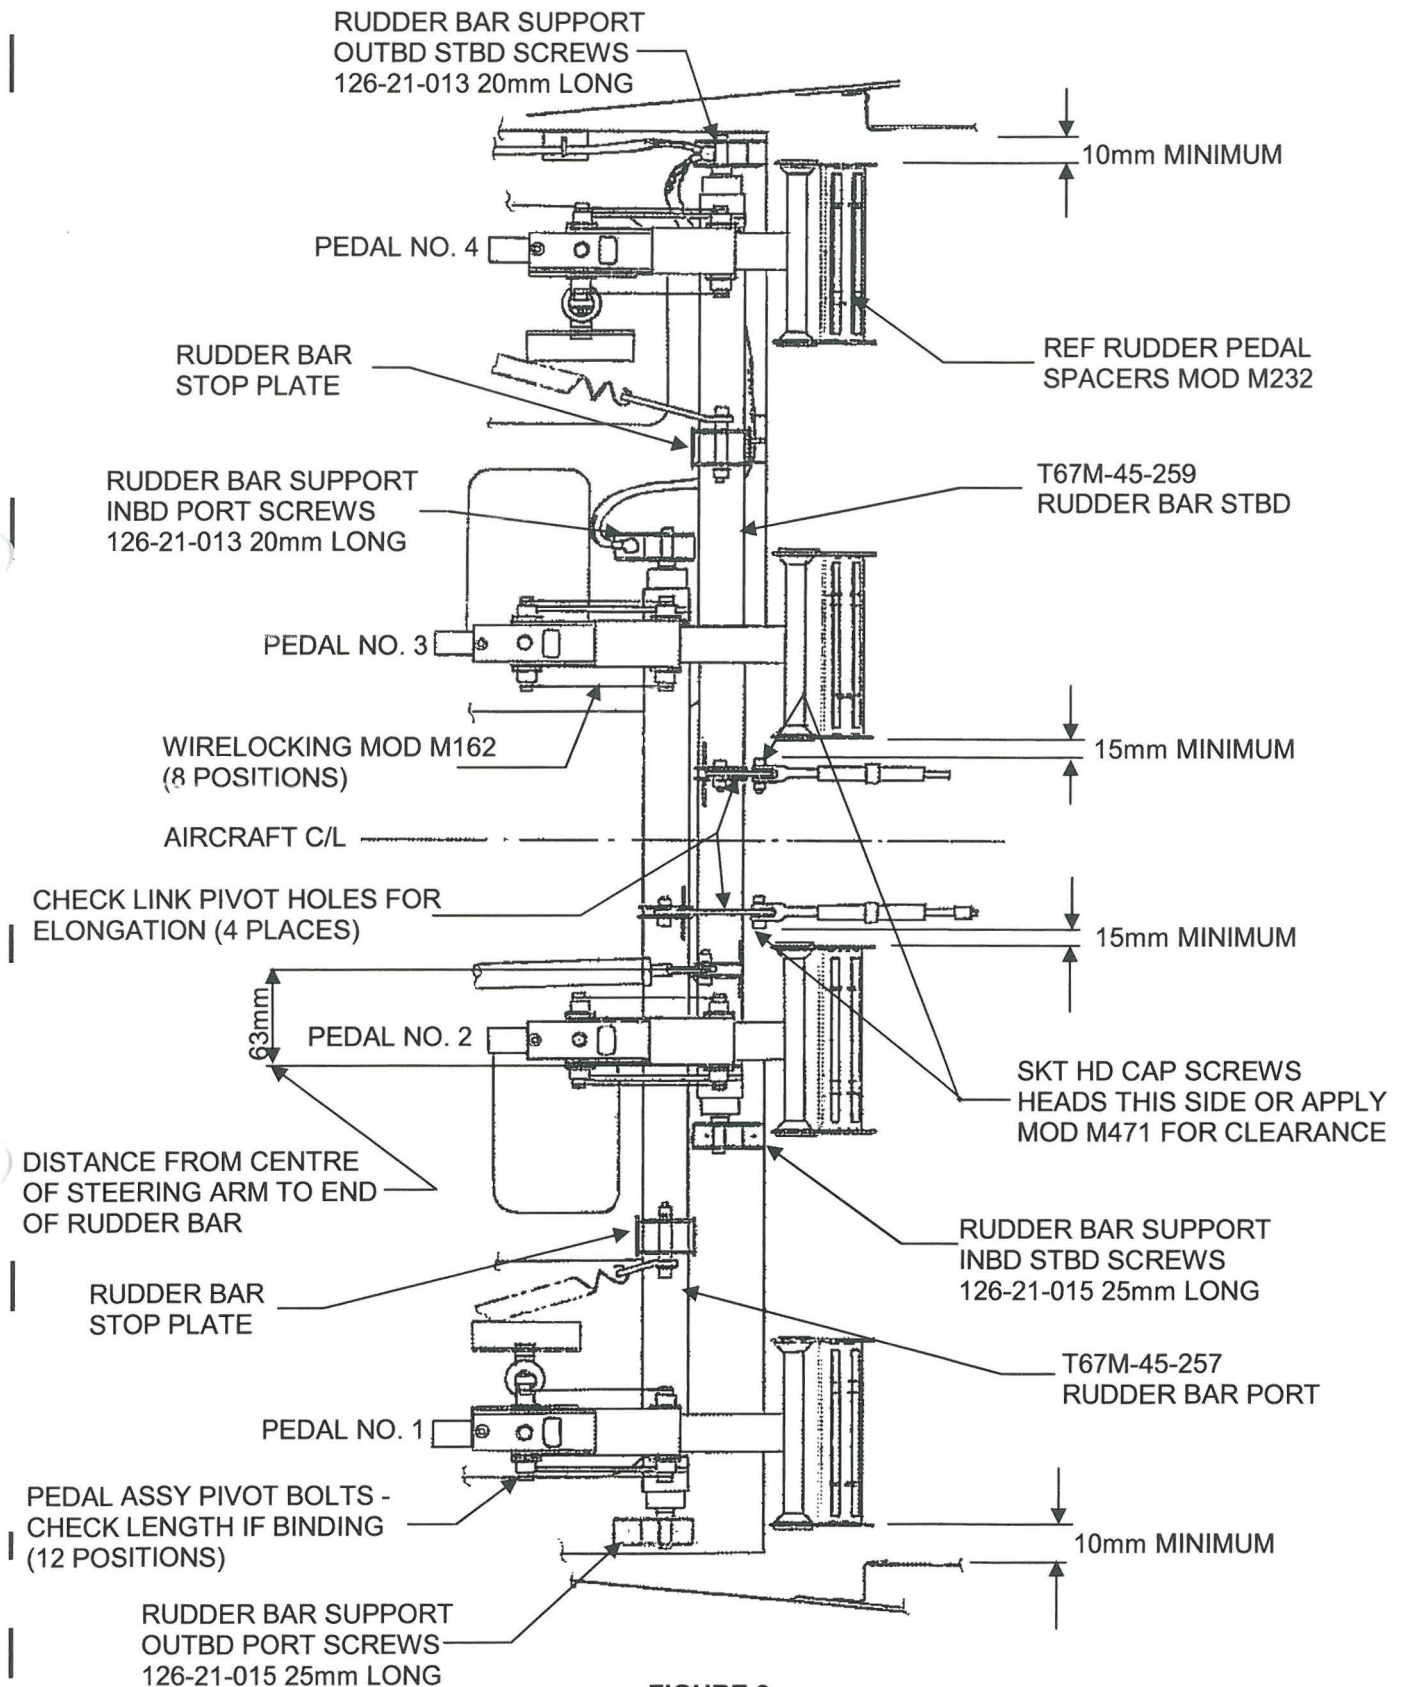
FIGURE 3

8. Check the remaining rudder bar support brackets, ref. Figure 3, are square to floor and are not "lozenged" and there is no deformation to their bases, reference Figure 1. If any bracket is found to be suspect replace with new item. Check floor under any damaged support bracket by removing panel. Ensure washers and brackets are correctly assembled refer paragraph 7 above. Inform SACL of any damaged bracket or additional floor damage. Assemble item as per paragraph 7 and ensure end float is as stated in paragraph 13. Ensure bonding leads are correctly fitted, carry out bonding check refer relevant aircraft's Maintenance Manual. Ensure correct length screws for attaching the rudder bar support brackets have been fitted in the correct positions, refer Figure 3.

Note 2: Note rudder stop plates, positions indicated on Figure 3, are permitted with deformation assuming full rudder movement and clearances have been achieved and there is no cracking in the welds supporting the stop plates, if in doubt return rudder bar to SACL for rework.

18. Upon completion of rudder movement set-up ref. Paragraph 16 above. Ensure minimum clearances of trim panel to pedal side plates and rudder cable to pedal side plates are met Figure 3 refers. If necessary to obtain the required clearances, Mod M232 "Introduction of Rudder Pedal Packing for Increased Clearance of Surrounding Components" may be required to be invoked. Refer paragraph 13 for packing washers on rudder bar.

20. Ensure head orientation of rudder cable link bolt head is outboard, Figure 3 refers, this is a Low Pan Head bolt T67M-45-570 on Post Mod M471 "Introduction of Pan Headed Bolt on Rudder Cable Turnbuckles", aircraft.

27. Ensure rudder pedal carriage socket head caps screws are wire locked and bonded in with adhesive 126-51-024, use minimum amount, Mod M162 "Wire Locking of Rudder Pedals – Upper Pivots", refers. See Figure 3.

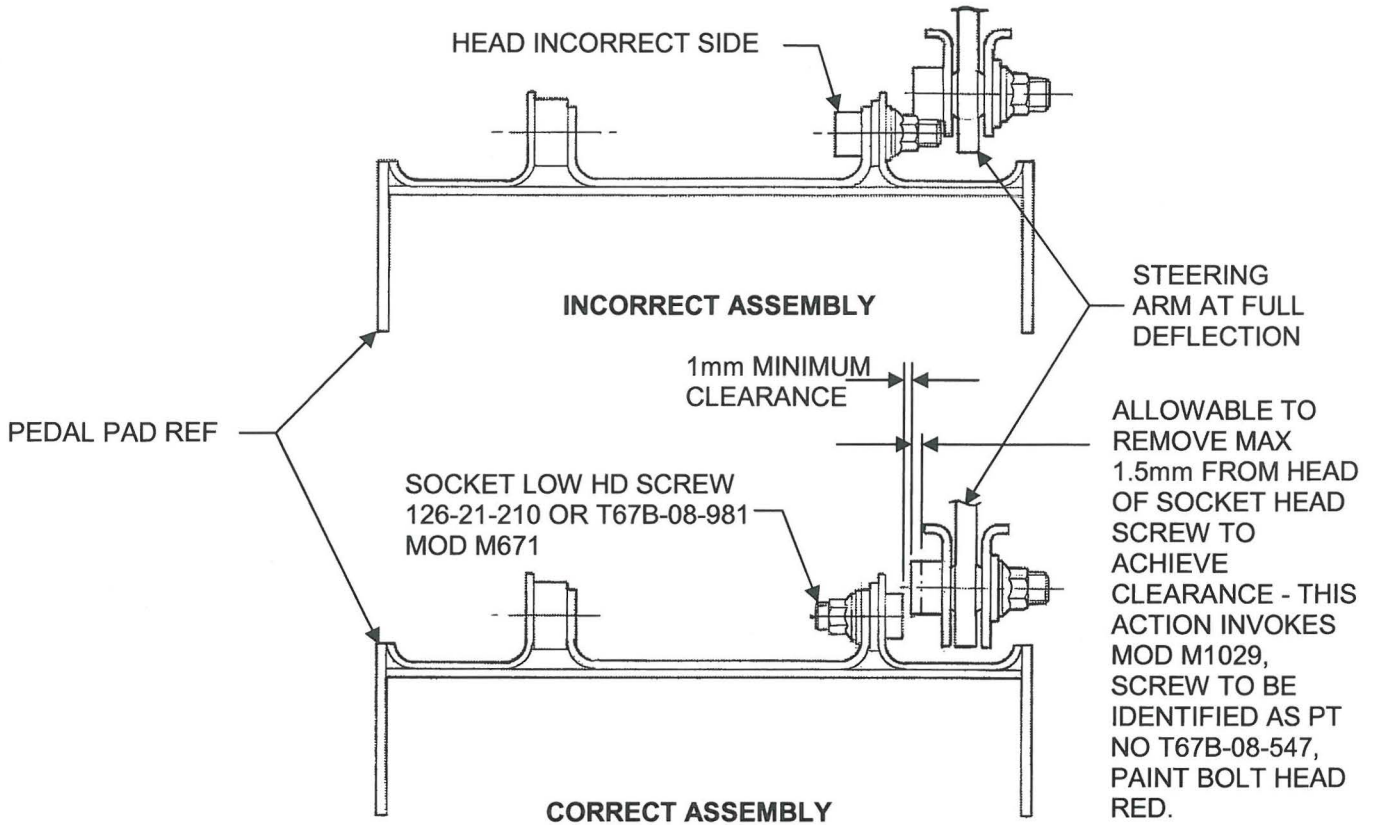
FIGURE 4

21. Ensure Pedal no 2 Pedal pad pivot bolt head height is less than 5mm and orientated as shown in Figure 4. A minimum of 1mm clearance is required, if not fit part no 126-21-210 or T67B-08-981, this invokes Mod M671 "Introduction of Low Head Rudder Pedal Pad Pivot Bolts – Pedal No. 2". If clearance is not still achieved check distance of steering arm from bar end, Figure 3 specifies. If the distance is incorrect, then return rudder bar to SACL for re-worked/new item. Alternatively if clearance of 1mm is still not achievable remove up to a maximum of 1.5mm from the steering arm screw this invokes Modification action M1029, Figure 4 refers, and paint modified screw head red.

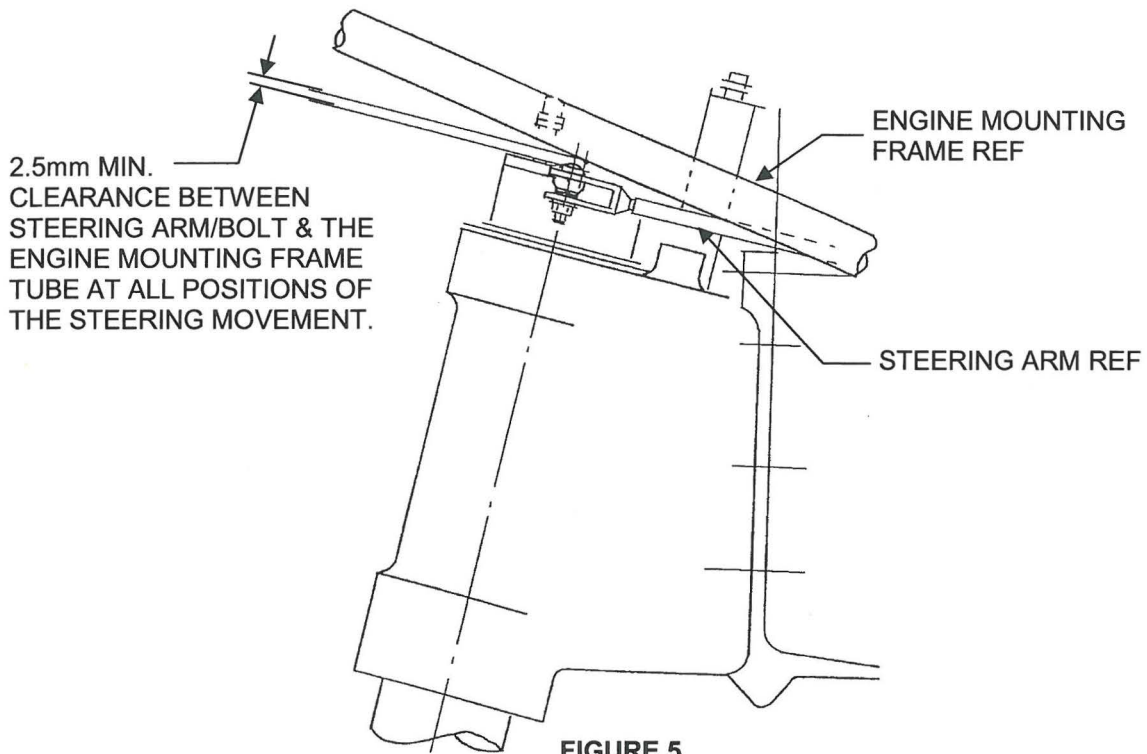
FIGURE 5

28. Ensure on aircraft fitted with the Fairey Hydraulic undercarriage, (Post Mod M468 or Mod M791), that there is a minimum clearance of 2.5mm with steering linkage to engine mounting frame, see Figure 5. Ensure there is no damage to engine mounting frame if clearance is less than 2.5mm. If engine mounting frame is damaged then aircraft must not be flown until damage is rectified, consult SACL. Also if clearance is less than 2.5mm embody Mod M575 "Introduction of Offset Steering Arm Pin – Ref Fairey Hydraulics Nose U/C", if Mod M575 is fitted and clearance is less than 2.5mm inform SACL.

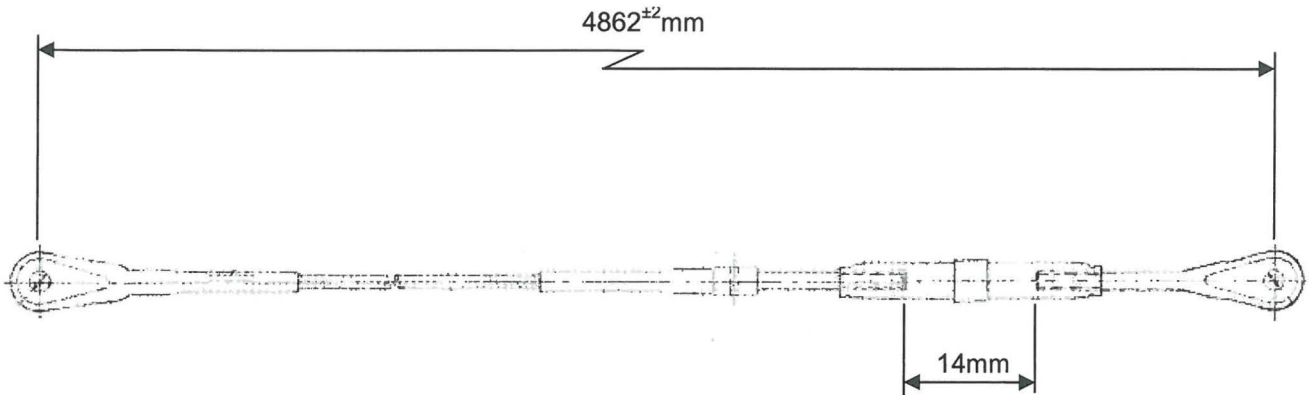
FIGURE 6

19. Ensure fuel pipe to rudder pedal slider clearance is met; refer relevant aircrafts Maintenance Manual Paragraph, 5.6.5.1, where relevant the minimum acceptable clearance is now to be 5mm. If clearance cannot be achieved then; i) remove Rudder Cable and check length, length should be 4862  $\pm 2$  mm, Figure 6 refers; ii) additionally check condition of rudder pedal assembly, refer paragraph 2, iii) if, i) and ii) do not achieve clearance remove fuel pipe, IAW relevant aircrafts Maintenance Manual, and re-orientate fuel pipe. If satisfactory clearance cannot be achieved inform SACL.

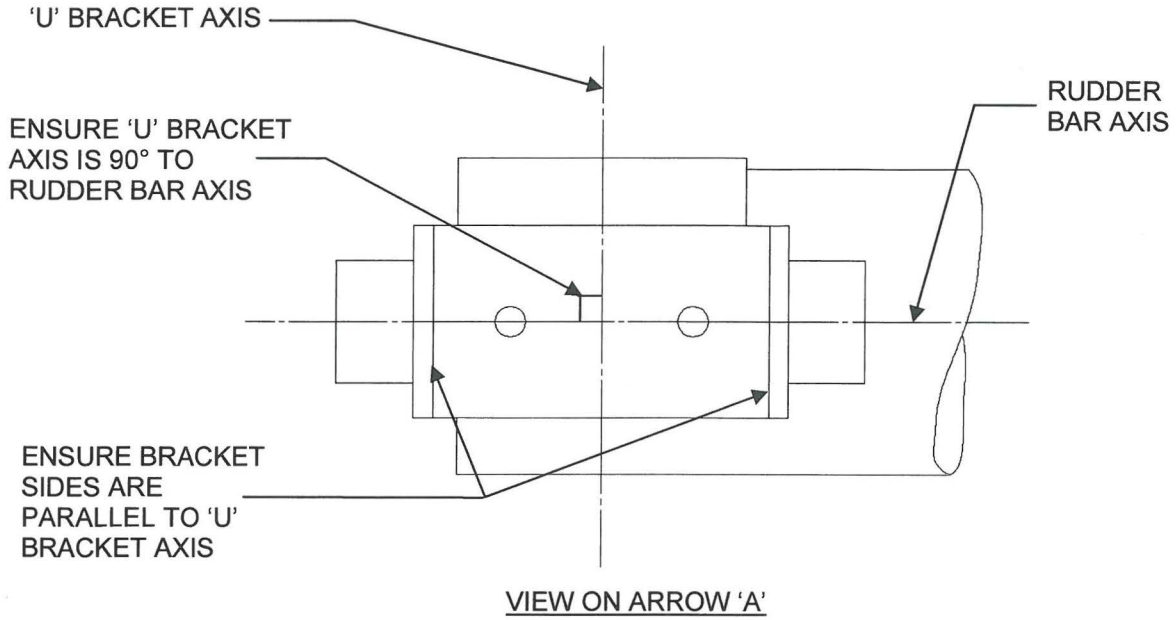
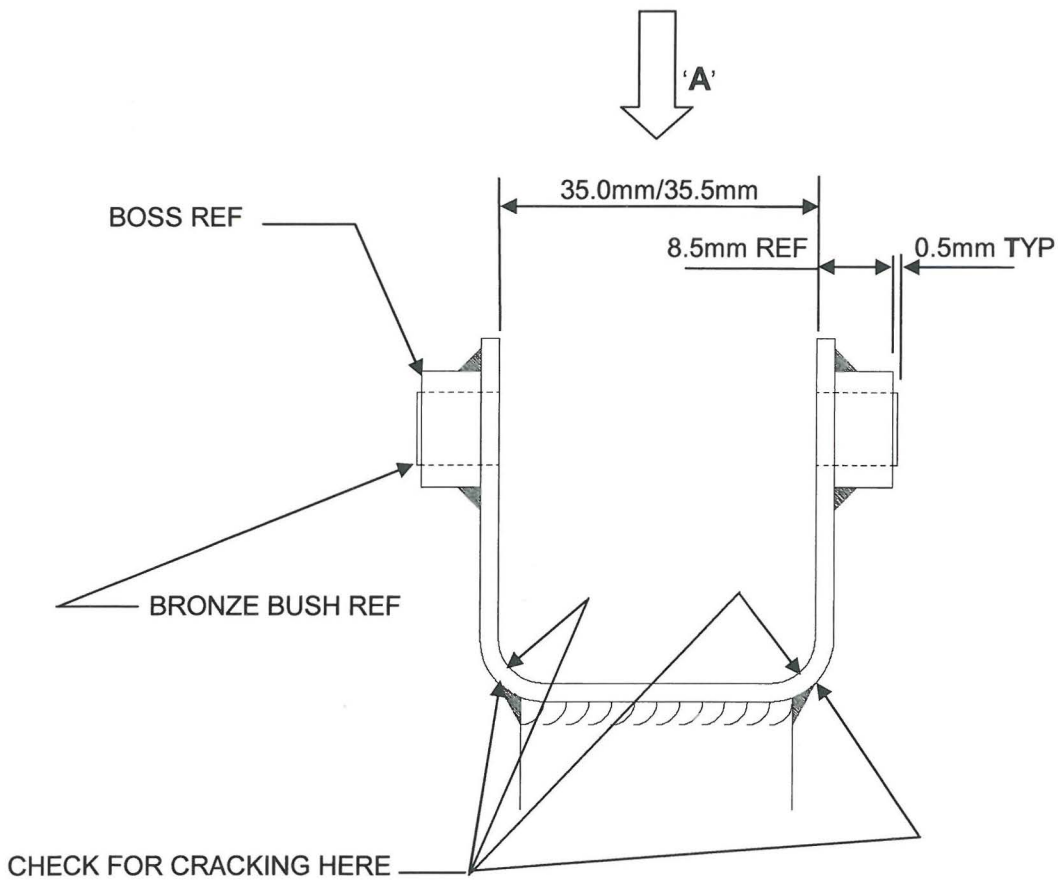
FIGURE 7

14. Check that the 'U' brackets are parallel and square to the rudder bar axis; Figure 7 View on 'A' refers. Also ensure the rudder pedal carriages have full and free movement. If binding is suspected then check the 'U' bracket internal dimension. This should measure 35.0mm to 35.5mm, also check that the pivot bush protrudes from its boss by 0.5mm. If the bracket internal dimension is greater or less, or if out of alignment then the bracket should be checked for cracking, refer Figure 7. If cracking is found then return rudder bar to SACL for rework. Finally check length of carriage pivot bolts, reference Figure 3, if binding is noted then replace bolts with bolt part number T67B-08-537 this introduces a bolt 15 mm long, measured from under head, and invokes Mod M808 "Introduction of Shortened Pivot Bolt to Rudder Pedal Slider Assembly Mounting". Also refer to SB130 Inspection of Rudder Pedals for Adjustment Restriction".

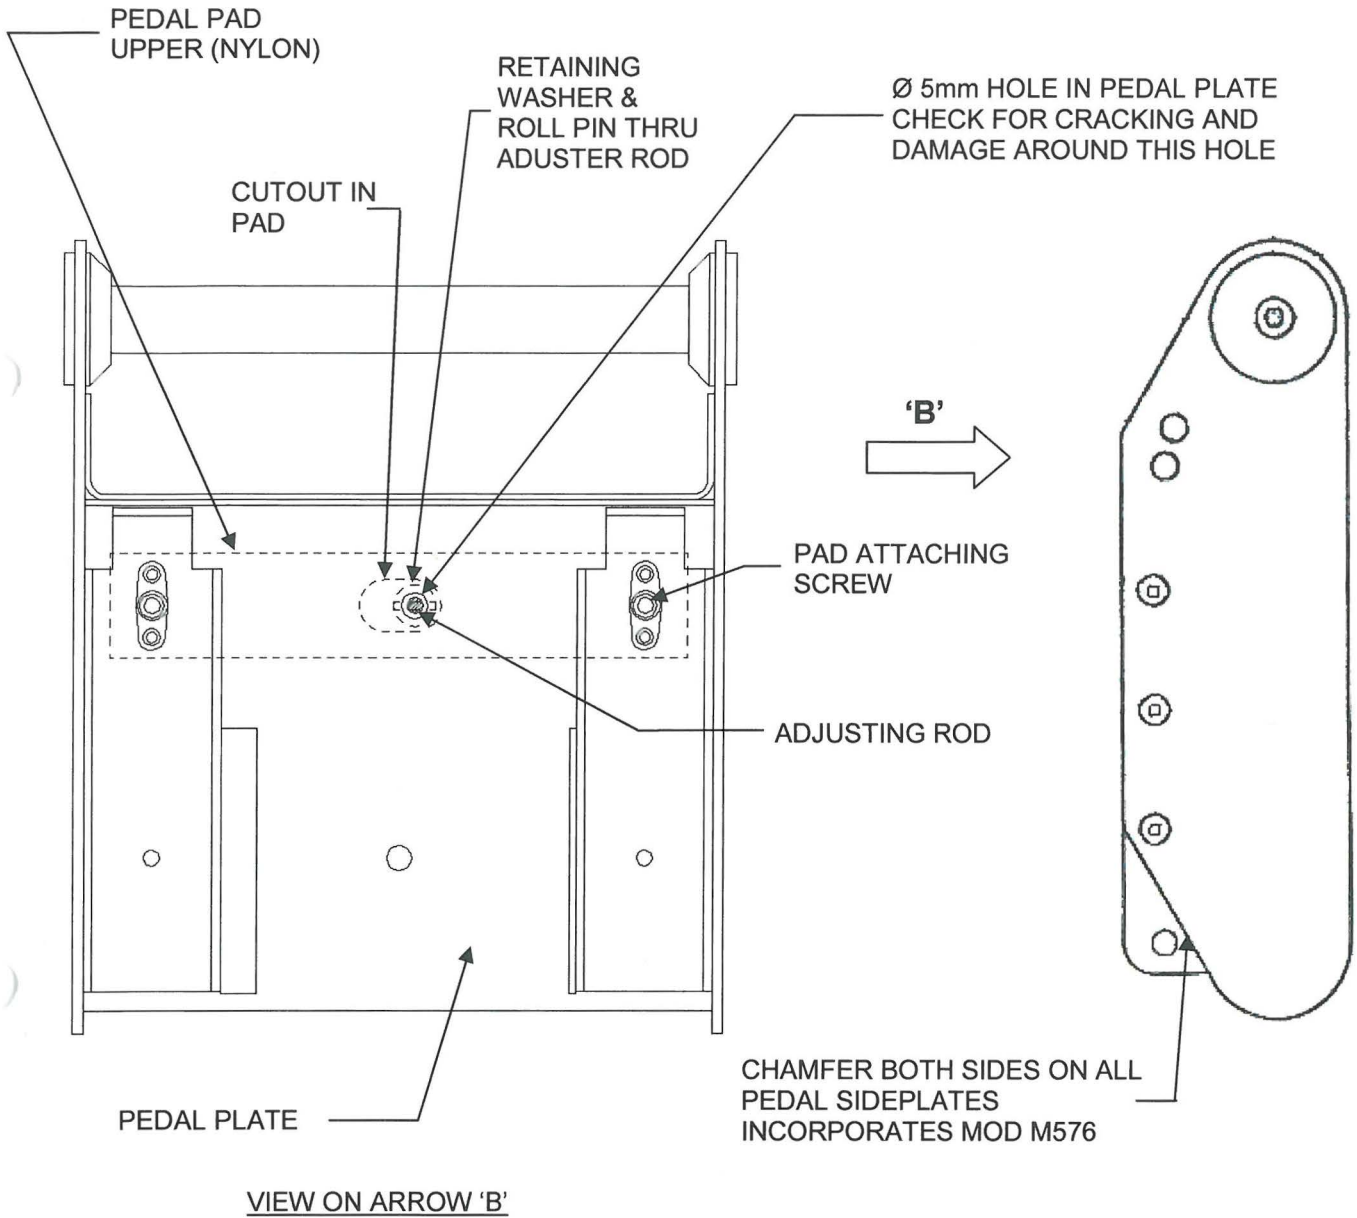
**FIGURE 8**

\*Mod M450 "Introduction of Improved rudder pedal sliders, adjusting mechanism and pedal incorrect assembly feature".
24. Ensure Mandatory Mod M576 has been invoked; CAA AD 013-05-94 refers. Pedal side plate should be as Figure 8.

25. Check structural integrity of pedal pad assembly especially around adjuster pushrod hole pedal plate, Figure 8 View on Arrow 'B' refers, if plate is cracked or damaged the pedal pad is to be repaired. Ensure riveting is secure, if rivets are loose then they have to be rectified. Contact SACL for new pedal pad assembly, materials and any applicable repair scheme.

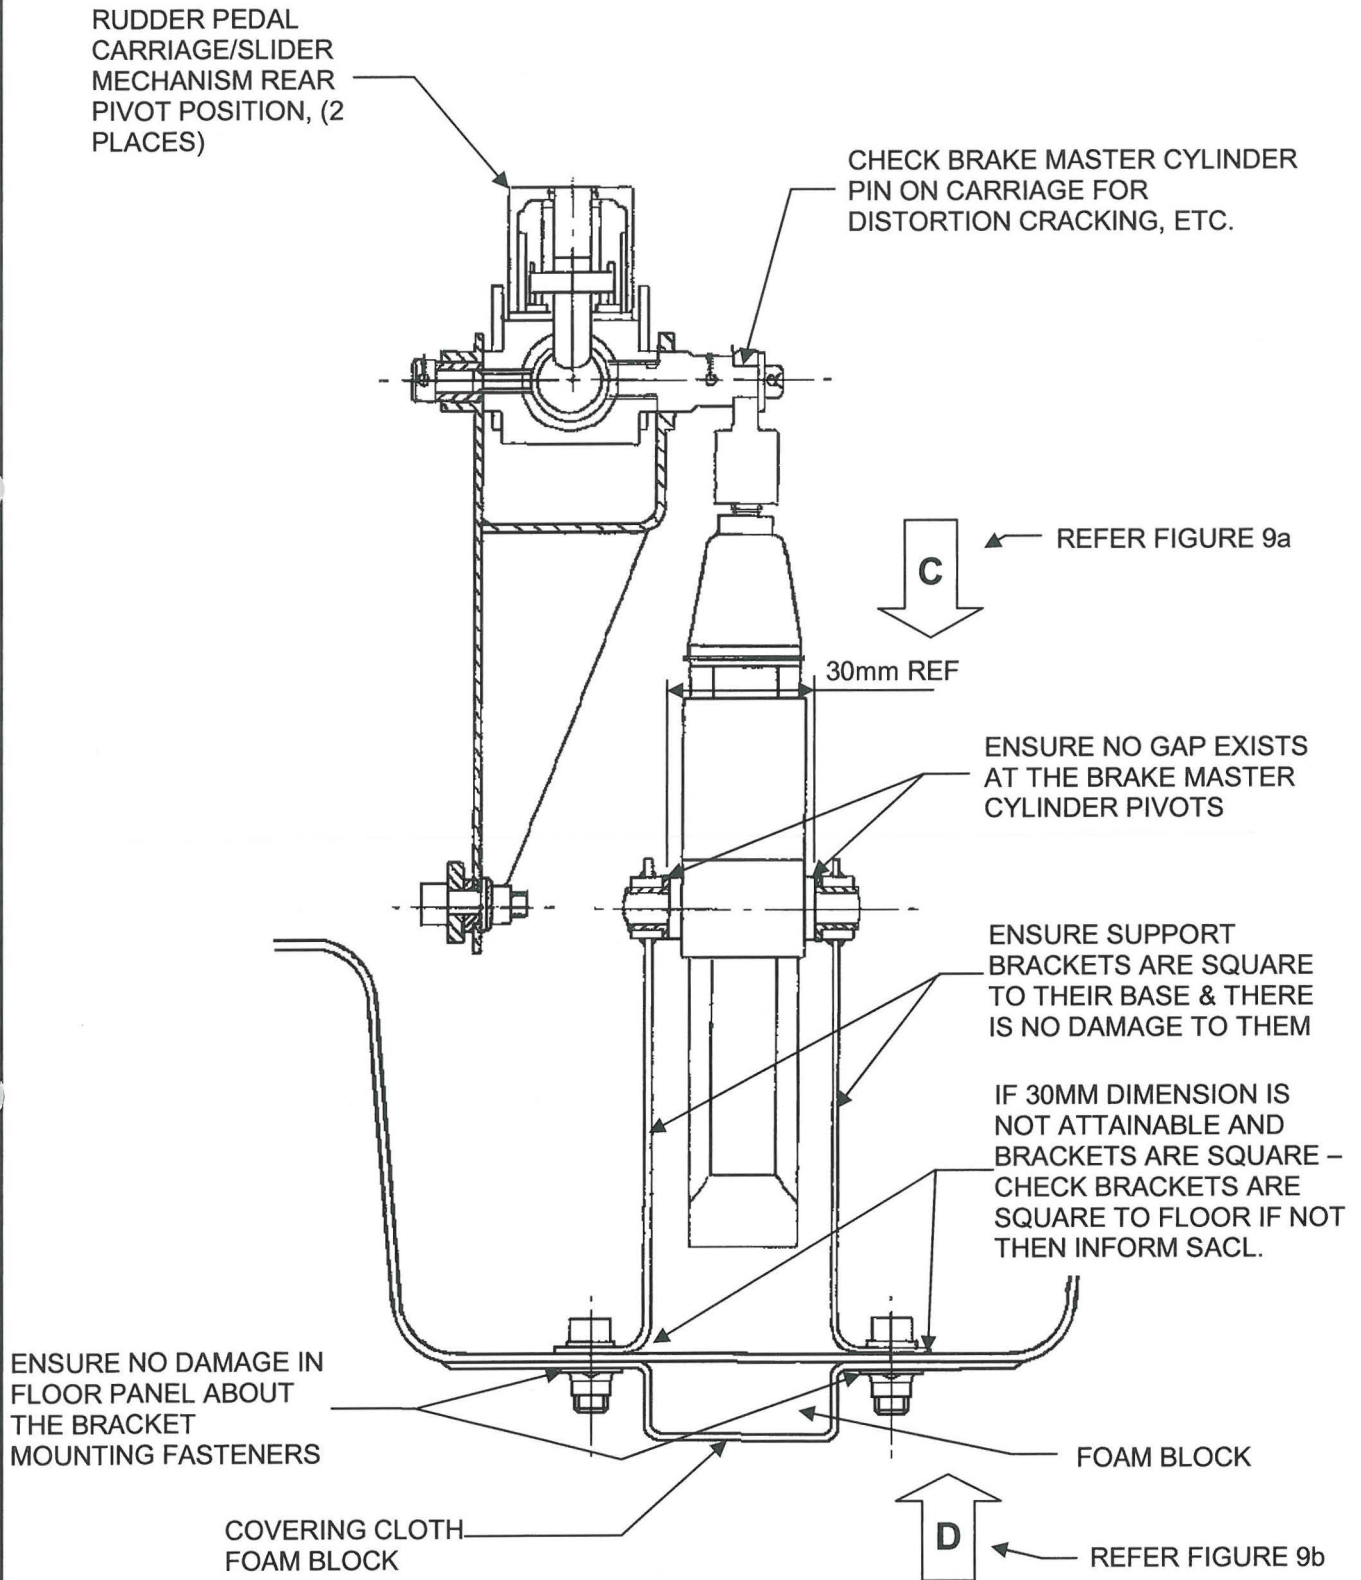
**FIGURE 9**  
**BRAKE MASTER CYLINDER SUPPORT BRACKETS**

9. Ensure that there is no gap at the brake master cylinder pivot points and that the support brackets are securely mounted to the floor panel, i.e. not loose, they should not deflect if base fastenings are sound. If bracket is seen to be suspect, i.e. out of square, twisted or bent, remove brackets and replace with new brackets if damaged. Check that there is no damage to the bracket anchorages in the removable floor panel, damage will show as whitening in the laminate surrounding the anchor nuts and foam reinforcement block, if in doubt remove panel and check anchor nuts for security. Figure 9 refers. The floor panel if found to be damaged is to be repaired or new panel fitted, refer to SACL Customer Support Department. If damage found then proceed as indicated by paragraphs 10 and 11. When rectified ensure all clearances and checks are accomplished as related to in this Service Bulletin.

11. If damage is found ref. Paragraph 9, then brake master cylinder to rudder pedal carriage attachment pin is to be checked for deformation/cracking, Figure 9 refers.

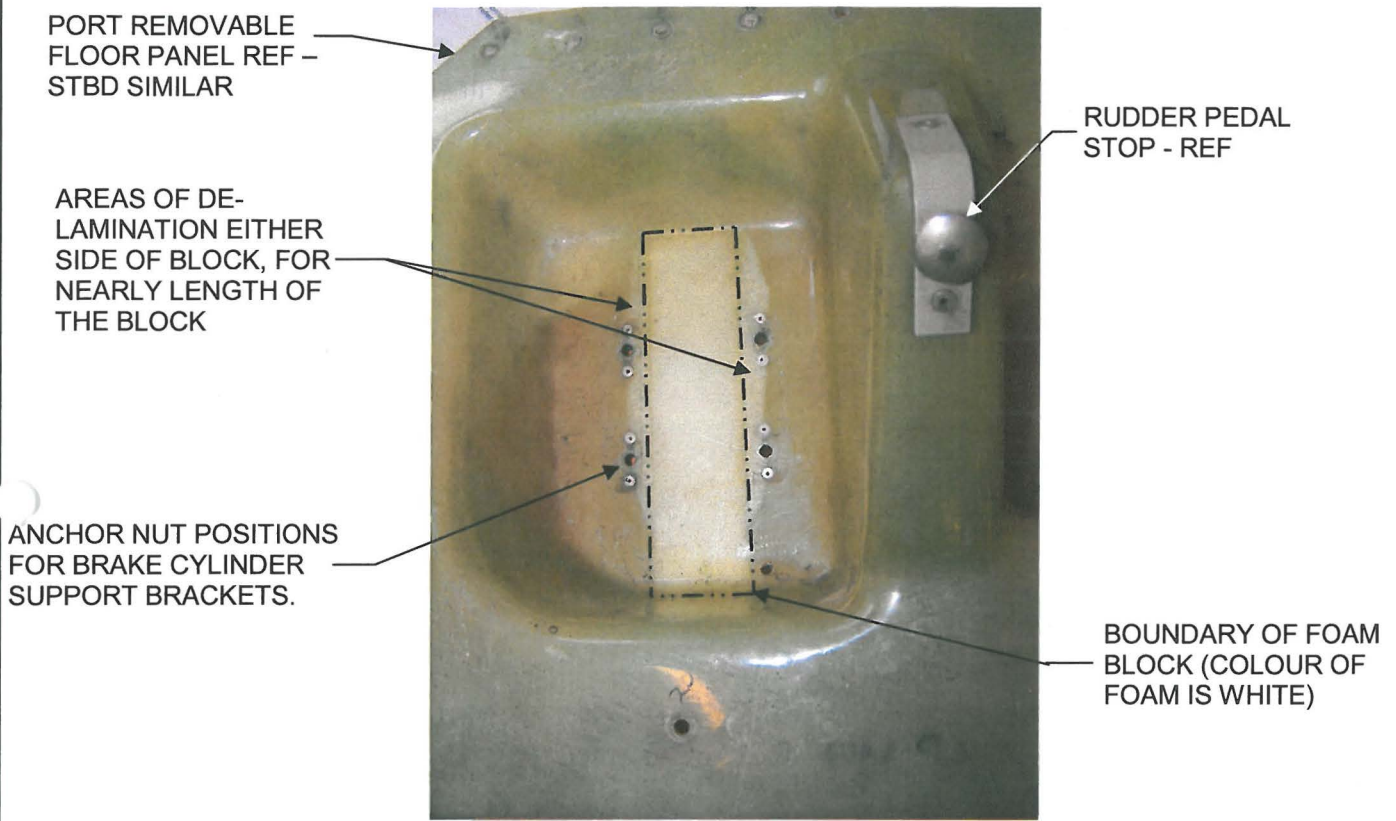
FIGURE 9a

Further to issue 2 an incident has been reported of the brake master cylinder becoming detached from its support brackets causing de-lamination to the port GRP floor panel. This failure occurred during aircraft taxiing. The failure was the direct result of the aircraft towing angle being exceeded.

PHOTOGRAPH ON ARROW C  
 VIEW INTO TOPSIDE OF REMOVABLE PANEL SHOWING EXTENT OF DE-LAMINATION

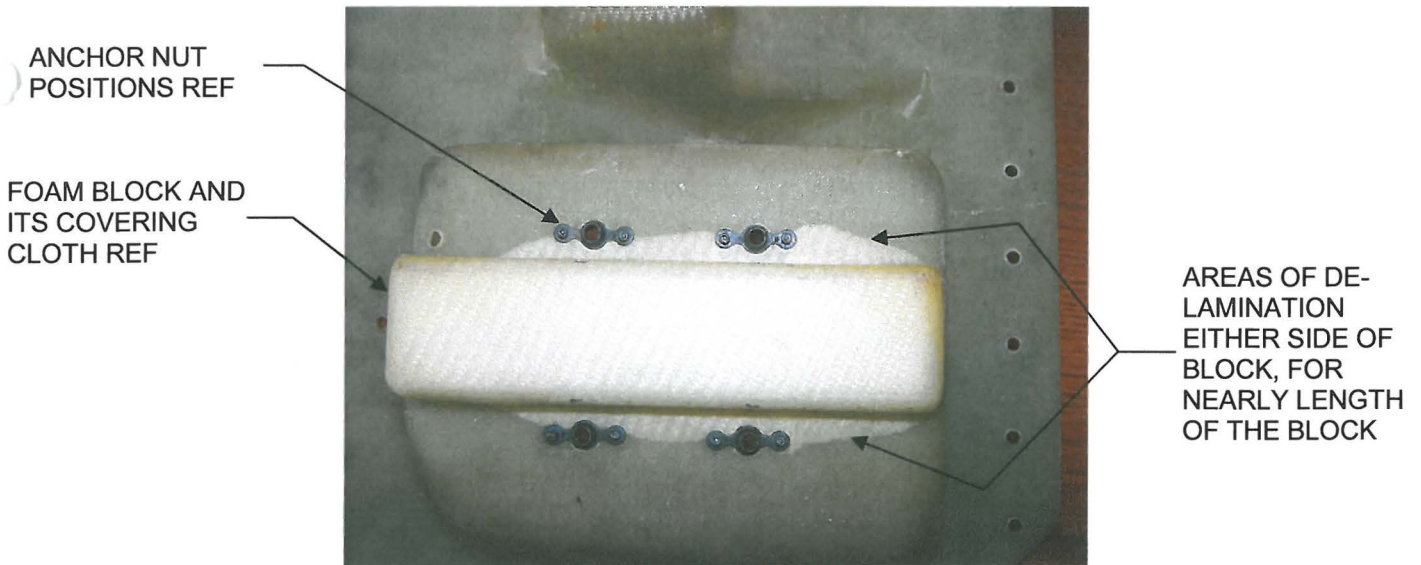
FIGURE 9b

PHOTOGRAPH ON ARROW D  
 VIEW ON UNDERSIDE OF REMOVABLE PANEL SHOWING EXTENT OF DE-LAMINATION

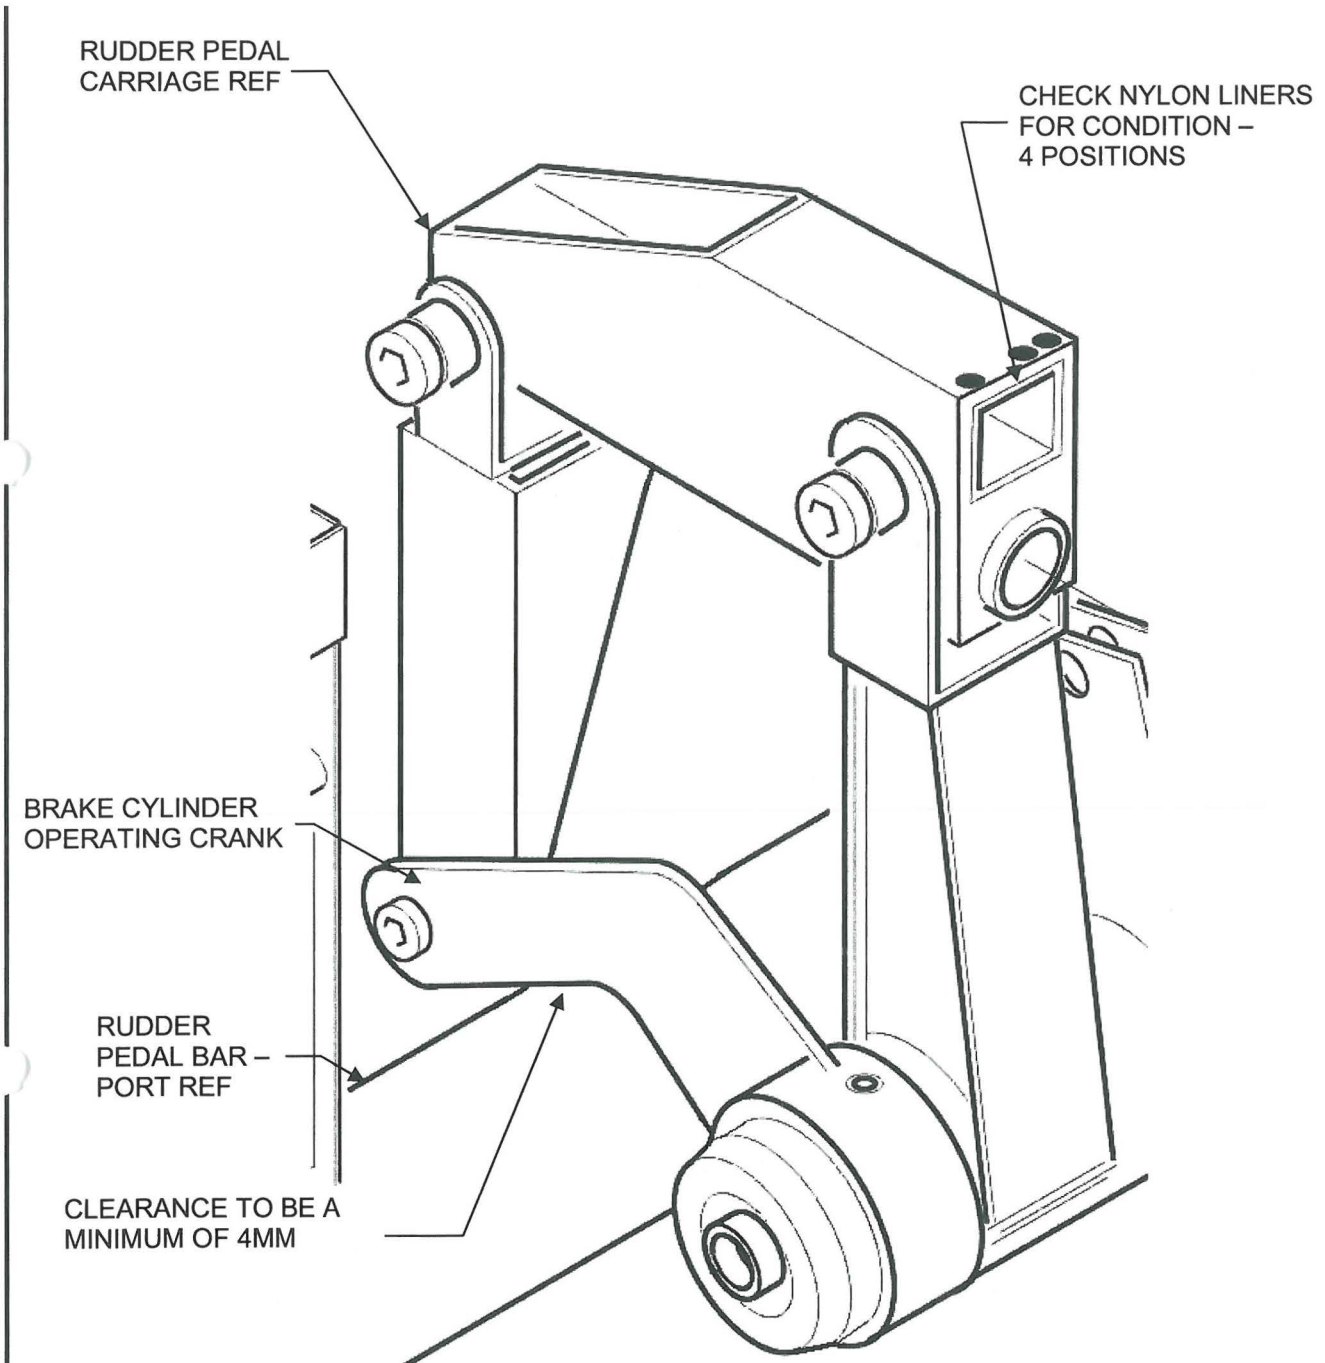
FIGURE 10

23. Ensure that all the nylon liners in the rudder pedal carriages are fitted, (4 pieces per carriage in Pre-Mod M450\* aircraft, 1 piece liner in Post Mod M450) and are in a good condition and not worn, Figure 10 refers, replace liners if unsatisfactory. Return carriages to SACL for replacement of liner.

26. Ensure that the brake operating crank, as shown at Figure 10, has a minimum clearance of 4mm relative to the rudder pedal bar following all checks and rectifications. Allow for various brake conditions, refer paragraph 29.2. Should bar show signs of chaffing check depth of groove. If depth is 0.0mm to 0.5mm, remove rudder bar, blend out groove, repaint and refit. If the groove is to a depth greater than 0.5mm, remove rudder bar and return to SACL for repair or replacement.
