Service Bulletin

S.B. No: 171

Title: INSPECTION OF MAIN UNDERCARRIAGE TOP MOUNTING COLLARS

Applicability: T67M-MkII (Post Mod M835), T67M200 (Post Mod M914), T67M260 and T67M260-T3A

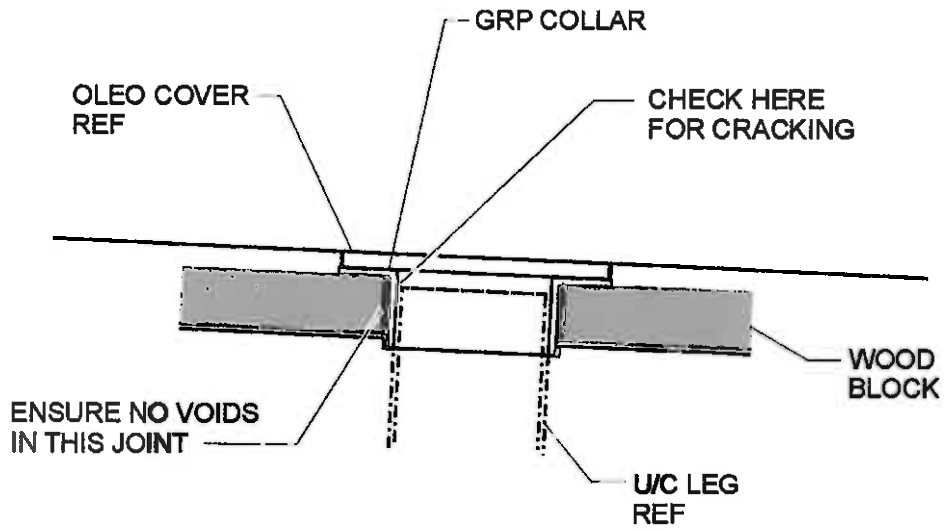
**FIGURE 1 TYPICAL SECTION THROUGH UNDERCARRIAGE TOP MOUNTING COLLAR
BOTTOM COLLAR SIMILAR**

Two cases have been reported of excessive movement of the starboard undercarriage in its mounting. In both cases, the aircraft were mounted on jacks and undergoing a 150-hour check.

Upon further investigation, it was noted that the GRP collar for the undercarriage mounting, had sheared through and had migrated down the leg.

1. At 150-hour check and with aircraft on jacks, remove oleo covers and i) Check for cracking around top of GRP collar; ii) Check for excess movement in the leg mounting.
2. Should a crack and or excessive movement be evident then remove the leg/s and replace collars by repairing in accordance with Slingsby Aviation Limited repair scheme DOI T67G-742. Annotate logbook that the requirements of this Service Bulletin SB171 have been carried out.
3. Should there be no crack or no excessive movement, then annotate logbook 150-hour inspection carried out. Repeat the 150-hour inspection until the next Annual inspection when the requirement at paragraph 4 is to be applied.

4. At the next Annual, remove the undercarriage legs and check the integrity of both the top and bottom GRP collars, as follows:
- i) Clean the collar's bore with acetone and inspect collar for signs of cracking, if cracks are present in the top collar, repair in accordance with DOI T67G-742. If cracks are present in bottom GRP collar inform Slingsby Aviation Ltd.
 - ii) Should no cracks be present, inspect both collar to block joints for voids, using visual and tap test methods.
 - iii) If a void is detected, then carefully drill a 1/16" diameter hole in the void/s and inject with Araldite 420. Ensure excess adhesive is removed. Allow adhesive to cure before reassembling leg back into mounting.
 - iv) Should collar be free of defects, reassemble leg into mounting.
 - v) After completing either 4 i), iii) or iv) annotate logbook "SB 171 complied with."
