SERVICE BULLETIN TIME

SB No. 031

SPECIAL INSPECTION - SAFETY HARNESS (NEGATIVE 'G' STRAP)

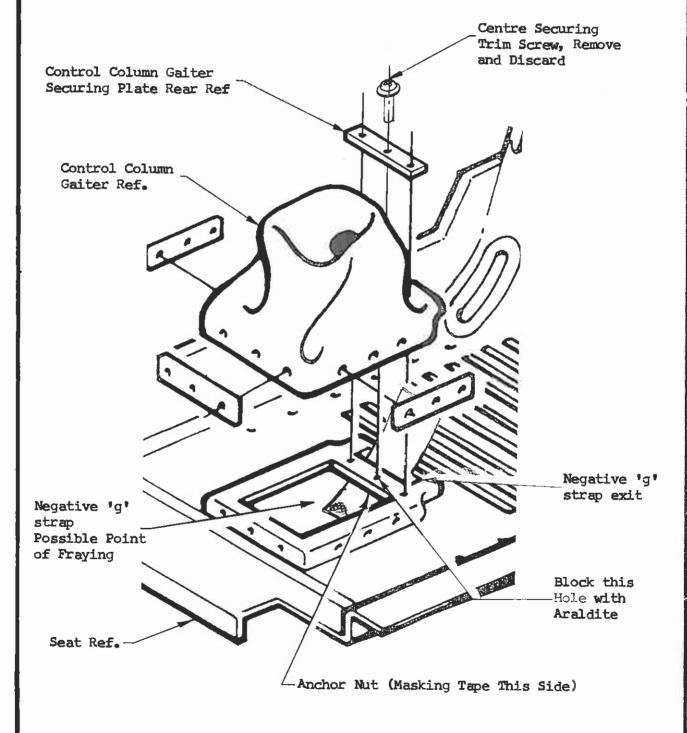
FIG. 1
PORT SEAT DRAWN STARBOARD SIMILAR

A case has occurred where the safety harness negative 'g' strap chafed against one of the screws securing the base of the control column

- 1. Loosen the control column gaiter from around both control columns. then remove gaiter retaining plates.
- 2. Inspect negative 'g' strap for fraying, especially in the area of the aft retaining plate's screw. Ref. Fig. 1, page 3.

- 3. i) If negative 'g' strap is satisfactory proceed to step 4.
 - ii) If negative 'g' strap is found to be damaged, remove seats as per standard practice, and renew negative 'g' strap. Then proceed to step 4.
- Cover the bottom of the centre hole, i.e. anchor nut lower face as indicated on Fig. 1 with masking tape or similar.
- 5. Fill hole with Araldite Rapid or equivalent adhesive.
- After curing, remove tape, smooth top surface and restore finish, i.e. paint black.
- i) If seat removed proceed as per 7 ii) otherwise refer to step 8.
 - ii) Replace seat and other items disturbed during implementation of this Service Bulletin. Re-assembly is opposite to dis-assembly. Ref. step 3 ii).
- 8. Re-assemble gaiter to seat. Re-assembly is opposite to dis-assembly. Ref. step 1.
- 9. Enter in logbook S.B. 31 Part A or B, as applicable, accomplished.
