SERVICE BULLETIN

SB No. 68 Issue No. 2

TITLE
CANOPY LATCH CORRECT OPERATION INSPECTION
CLASSIFICATION

T67C, T67M and T67M200 Aircraft, Post Mod M129 (Split Canopy), T67M-MkII, T67M260 and T67M260-T3A.

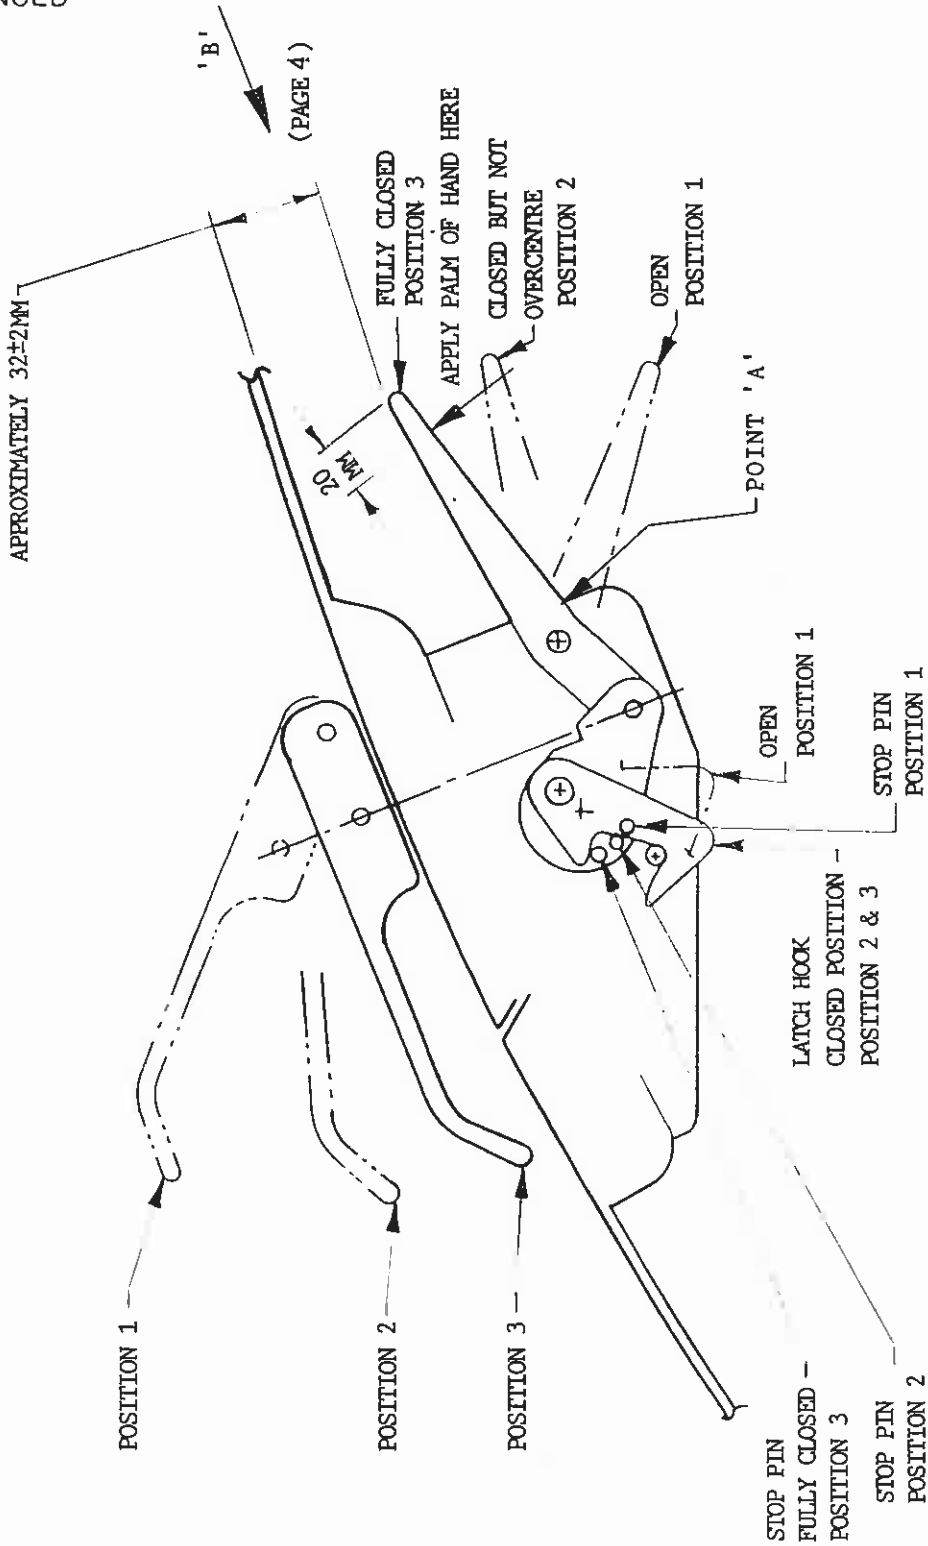
Fig 1

An incident has occurred where the canopy latch was apparently closed correctly but when engine revs were increased beyond 1500 RPM the canopy opened.

Fig. 1 page 2 shows 3 positions of the canopy mechanism:

Position 1 - Open/Unlatched

Position 2 - Latched but mechanism not over centre

Position 3 - Correctly closed, mechanism fully over centre.

- (i) Remove canopy mechanism and latch covers
- (ii) Close canopy fully. Ensure internal handle is in its correct position (Ref Fig.1).
- (iii) Check that stop pin is just touching latch hook. If not adjust in accordance with Maintenance Manual, Section 3, paragraphs 3.2.
- (iv) Check closure. By positioning palm of hand at point indicated, ref. Fig. 1, push up latch handle, which should close with reasonable resistance but without using excessive force.
- (v) Replace mechanism and latch covers, in accordance with Maintenance Manual, Section 3, paragraphs 3.2.
- (vi) Maintenance Manuals to be amended to reflect points contained in (ii), (iii) and (iv).

- (viii) Providing the mechanism is correctly adjusted it should be obvious to the pilot that the latch mechanism has gone over centre.
