# SERVICE BULLETIN

SB No. 158 Issue No. 1

**TITLE** INSPECTION OF RUDDER FOR CECONITE FABRIC DEBONDING

T67B, T67C Series, T67M, T67M-MkII, T67M200, T67M260 and T67M260-T3A

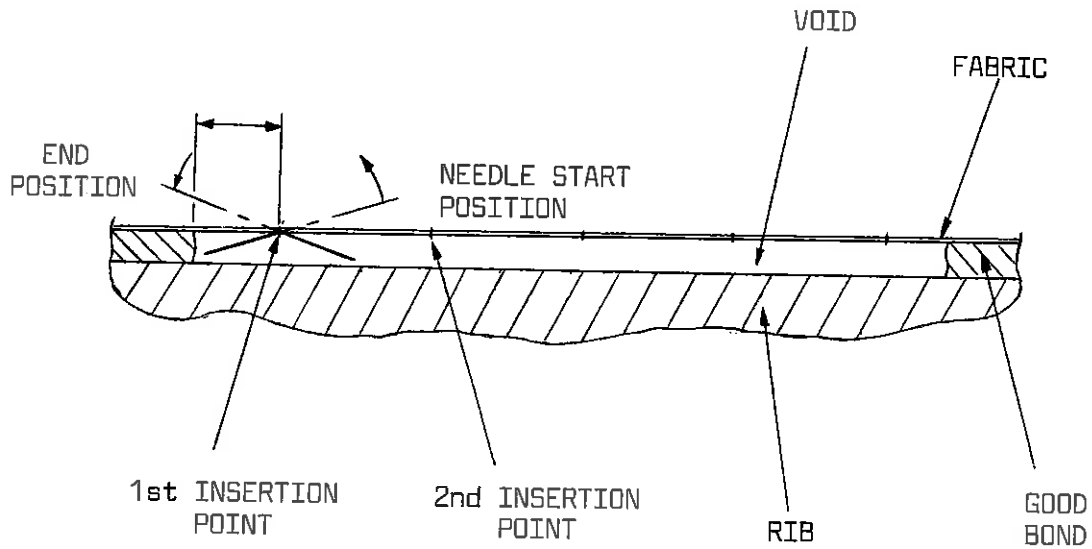
FIG - 1 APPLICATION OF RESIN INTO DEBONDED CONTROL SURFACE FABRIC

Cases have been reported of the bond between the rudder rib flanges and the covering Ceconite fabric becoming loose. This Service Bulletin requires an inspection and, if applicable, correction by injection of resin adhesive.

1. Inspect rudder surface for debonded regions. Debonding should be visible as an area where the rib structure is not apparent through the fabric and can be easily confirmed by light hand pressure, applied over the area of the rib flange.
2. If debonding found, remove rudder. Determine number and size of regions showing debonding.
3. Mix appropriate amount of Araldite (XD4473) to recommended weights and load mix into syringe. Refer T67 GRP Repair Manual.
4. Measure needle length.
5. Insert needle between fabric and rib positions along the joint equal to two needle lengths apart, extruding Araldite XD4473 in both directions in a continuous bead of resin, rotating needle as shown in Fig. 1.
6. Maintain a light pressure along joint to consolidate and allow 24 hours to cure.
7. Annotate Logbook "SB 158" complied with".
