**SERVICE BULLETIN**

SB No. 95 Issue No. 1

TITLE INSPECTION OF THROTTLE CABLE MOUNTING BRACKET

T67M and T67M-MkII.

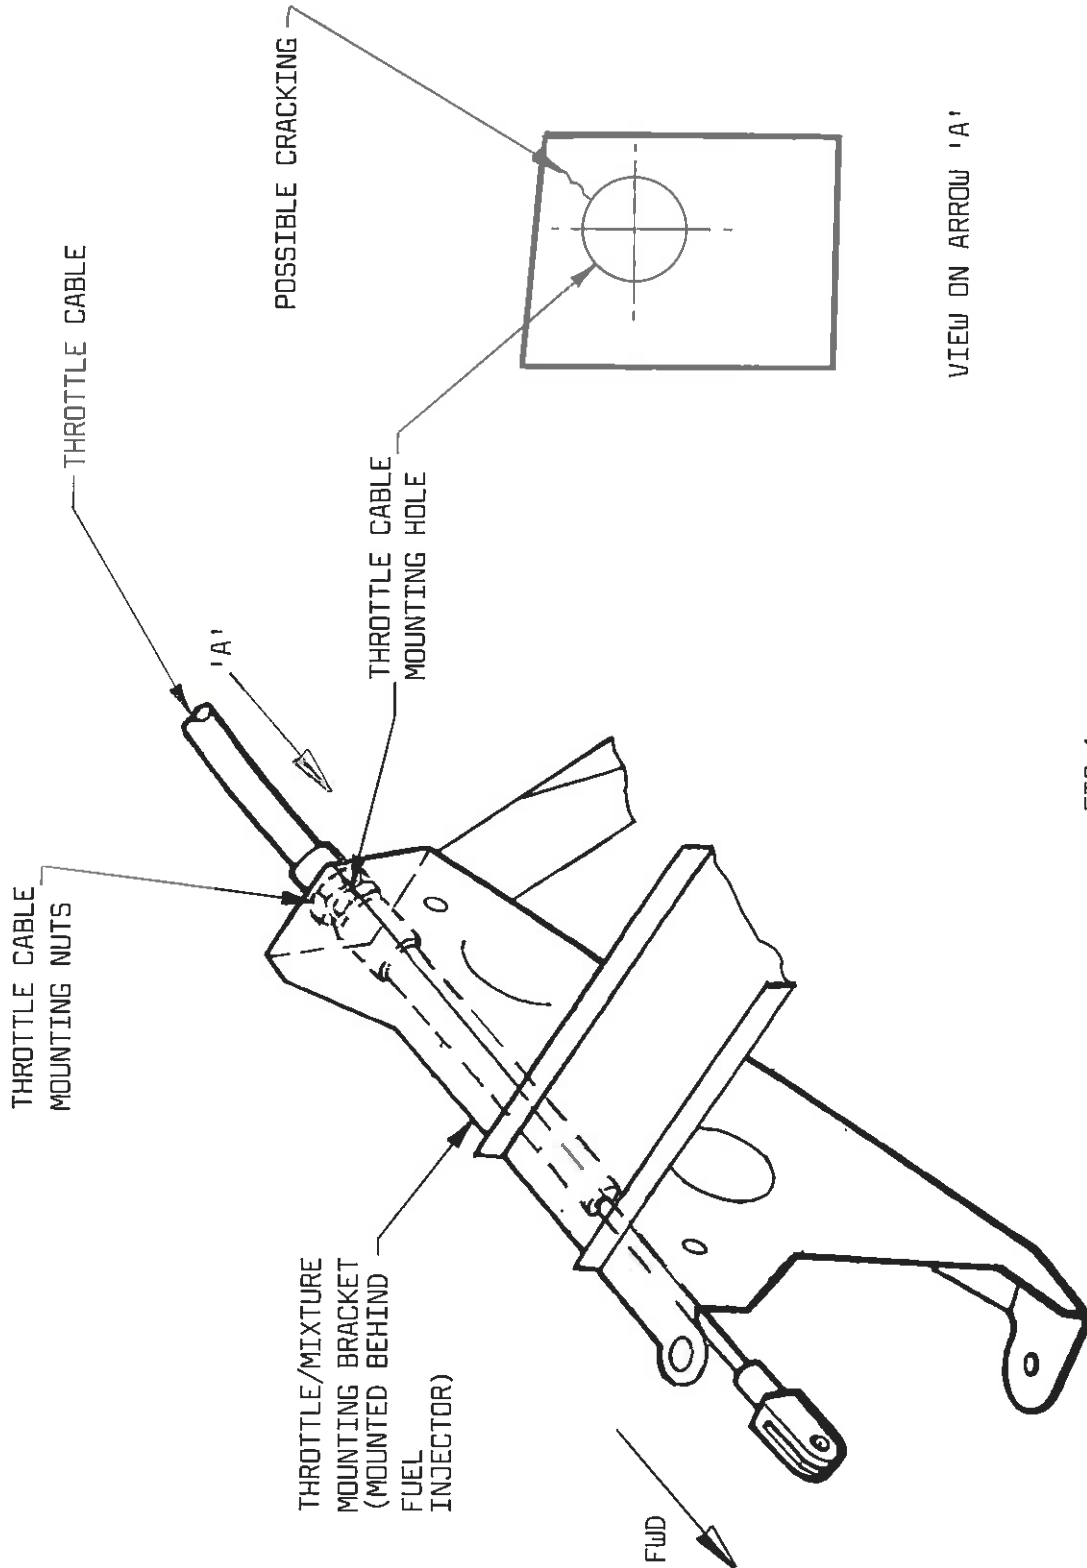
FIG 1  
THROTTLE CABLE FLUID MOUNTING

A case has been reported of cracking at the throttle/cable attachment position on the throttle/mixture cable mounting bracket, positioned behind the fuel injector.

1. Disconnect throttle cable mounting nuts. Ref Fig. 1.
2. Inspect for cracks around mounting hole. Ref View on Arrow 'A'.
3. If no cracks are found reassemble.
4. Annotate in logbook SB 95 complied with.
5. If cracks are found, replace throttle/mixture mounting bracket T67M-50-233. Report findings to SAL.
6. Annotate in logbook SB 95 complied with.

For replacement bracket T67M-50-233 contact SAL Product Support Department.
