Service Bulletin

S.B. No: 143

FAIREY HYDRAULICS MAIN UNDERCARRIAGE BACKLASH CHECK

Post Mod M468 equipped aircraft T67B, T67C Series, T67M, T67M-MkII and T67M200

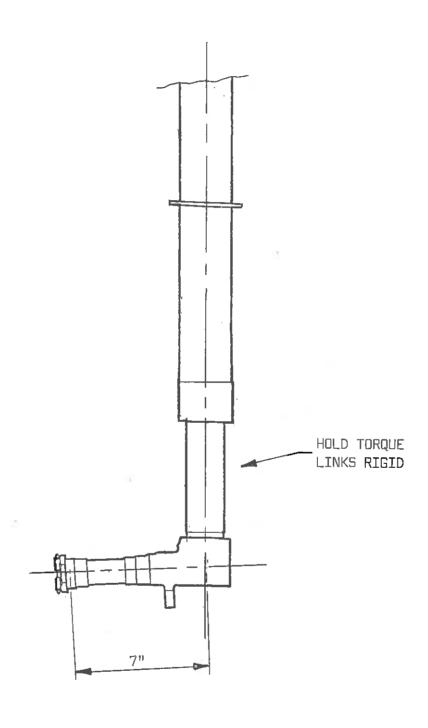
Fig 1 PLACEMENT OF DIAL INDICATOR

Cases have been reported of Fairey Hydraulics main undercarriage displaying movement between the stub and the leg.

- 1. Support aircraft safely on jacks and remove main wheel and tyre assembly. Ensure torque links are held rigidly during loading.
- 2. Measure 7 ins along the stub axle from the centreline of the plunger tube. See Figure 1.
- 3. Set up dial indicator for up and down checks at the 7 ins position.
- 4. Establish a means to record the neutral position and zero the indicator.
- Apply 2 lbs of force upwards. Measure and record the deflection.
- 6. With stub axle back to the neutral position and indicator set to zero, apply 2 lbs of force downwards. Measure and record the deflection.
- Total deflection up and down must not exceed 0.020 ins.
- 8. Set up the equipment to record fore and aft deflections at the same 7 ins mark. Zero the indicator.
- 9. Apply 2 lbs of force forward. Measure and record the deflection.

- 10. With stub axle back to the neutral position and indicator set to zero, apply 2 lbs of force rearwards. Measure and record the deflection.
- 11. Total deflection forwards and rearwards must not exceed 0.040 inches.
- 12. If either of the requirements for maximum allowable deflection are not met, moving strut and stub assembly should be returned to manufacturer for inspection.
- 13. Annotate Log Book "SB 143 complied with"
- 14. The Maintenance Manual is in the process of being amended.
