Service Bulletin

S.B. No: 165

Title: INSPECTION FOR WATER IN LEADING EDGE OF RUDDER PLUS ADDITION OF DRAIN HOLE

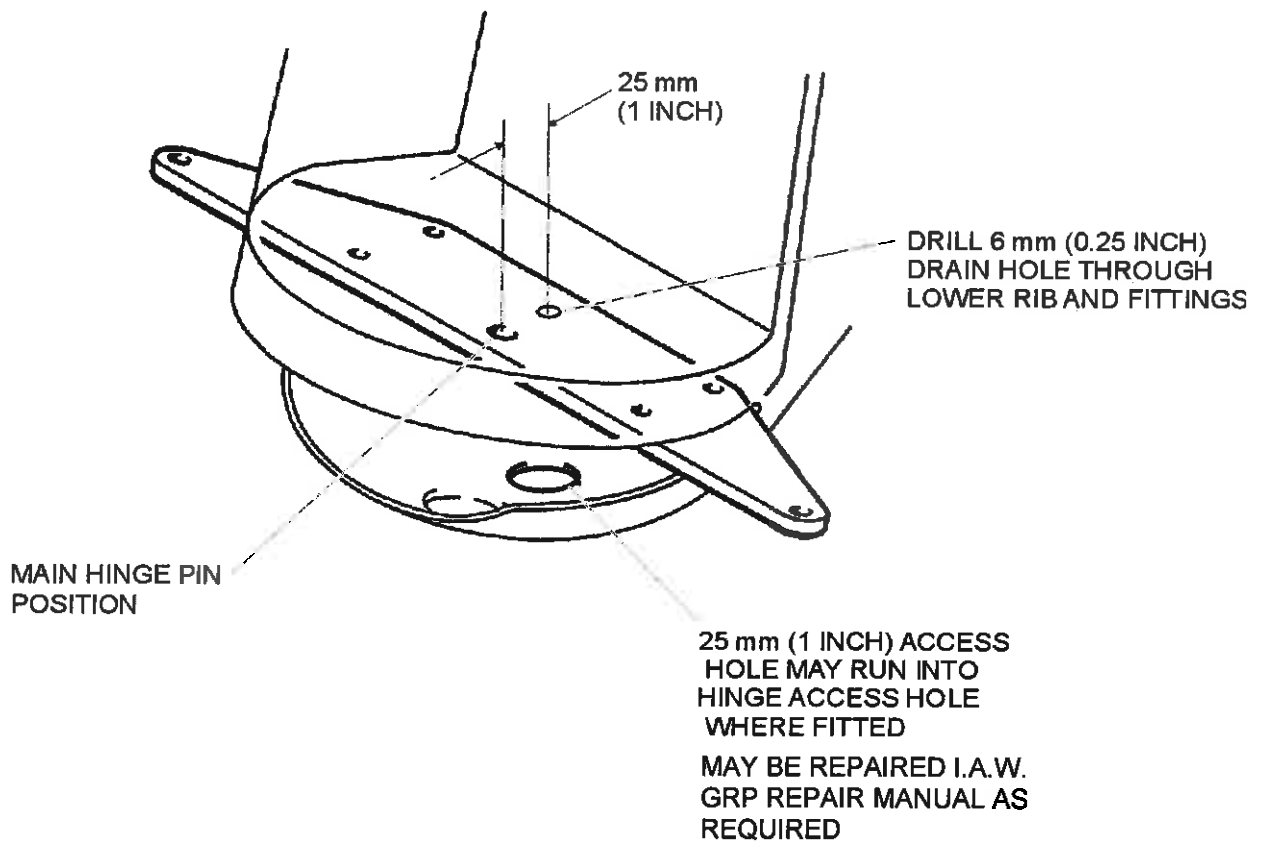
Figure 1 Rudder Lower Hinge

Cases have been reported of water accumulation in the lower 'D' box of the leading edge of the rudder and of "relief" of air pressure when applying drain hole to Issue 1 of this Service Bulletin.

1. Remove rudder from aircraft in accordance with Maintenance Manual.
2. Mark position of 6mm (.25 inch) drain hole on the rudder horn. Carefully form a 25mm (1 inch) diameter access hole in the rudder lower fairing on centreline. Ref Figure 1. This hole to be as directly under proposed drain hole as possible.
3. Carefully drill 6mm (.25 inch) diameter hole in the leading edge of the lower rib as shown in Figure 1.

Note 1: Drill through rudder horn fitting.

Note 2: Drill will also penetrate tapping plate 1.2mm (.048 inch) thick sandwiched in rib lay-up.

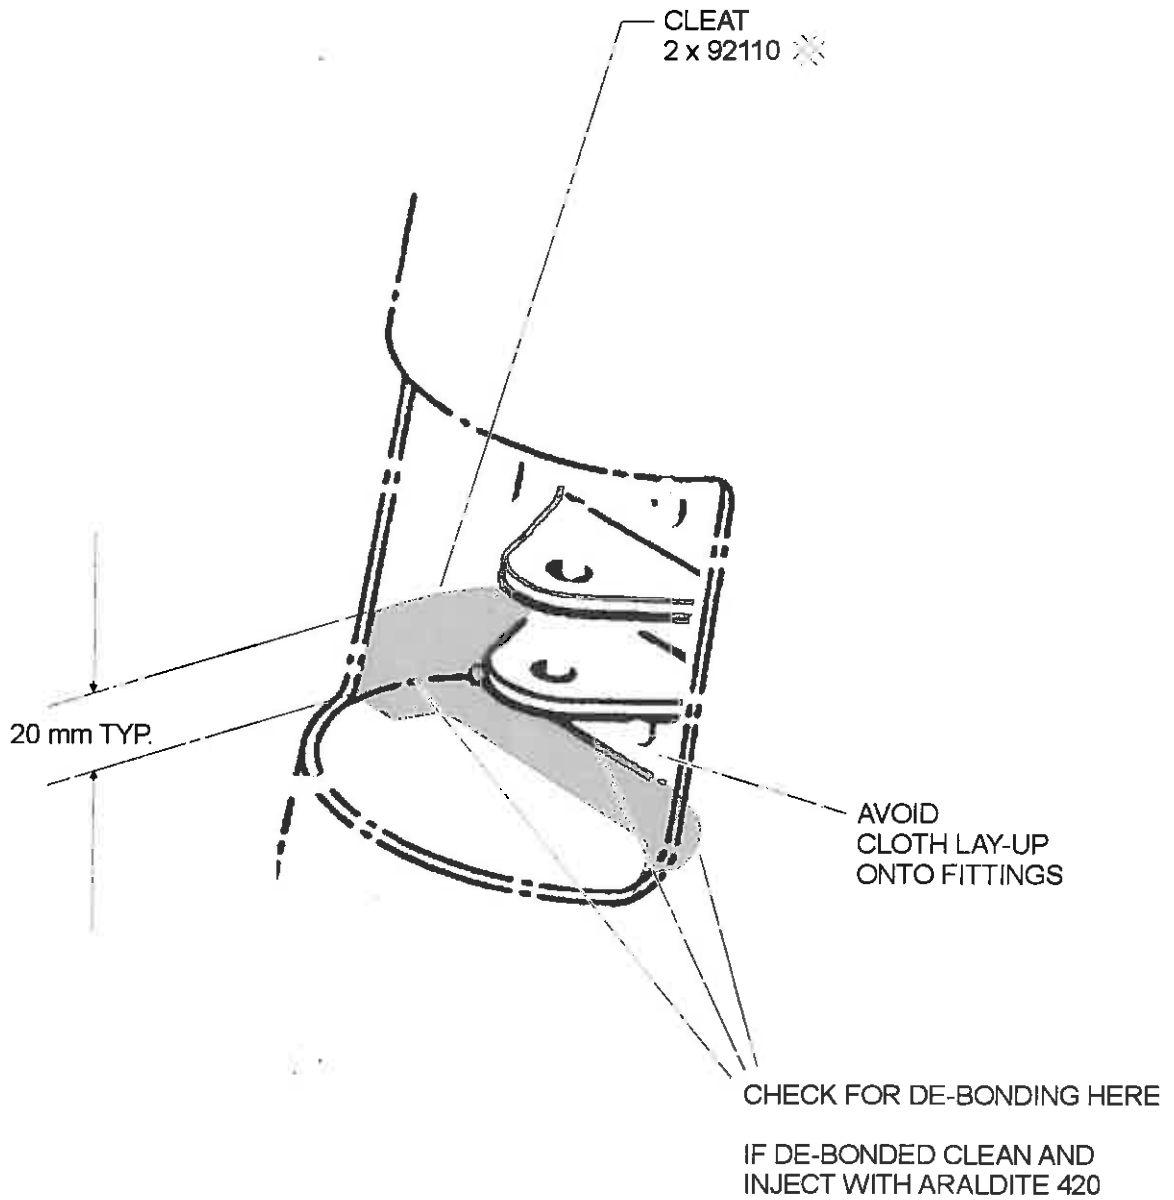
Figure 2 Rudder Top Hinge

The water ingress was through the top hinge lower rib spar joint debond, Subsequent inspection of later rudders by SAL, revealed de-pressurisation holes had been blocked during manufacture.

4. Drain out any water that may be present and allow to dry.
5. Inspect the upper rudder hinge lower closing rib bond, both to the rudder skin and spar, for signs of bond failure, ref Figure 2. If a debond is found, use a suitable feeler gauge to establish extent of failure.

6. Check rudder 'D' box structure for any de-bonds iaw T67 GRP Repair Manual. Perform 'tap' test over areas indicated, refer Figure 3.
7. Ref paragraph 5.
 - i. If bond has failed, clean joint and inject with Araldite 420. Allow to cure. Continue as per paragraph 9.
 - ii. If joint is sound, continue as per paragraph 9
8. Ref paragraph 6.
 - i. If a de-bond is found, or any doubt exists, contact SAL.
 - ii. If joint is sound, continue as per paragraph 9.
9. Refer to Figure 2 and prepare area for laminating. Laminate 2 layers 92110 ✱ cloth over area shown, allow to cure. Laminate in accordance with T67 GRP Repair Manual.
