Service Bulletin

S.B. No: 183

Title: Inspection of Tailplane Aluminium Fittings for Exfoliation Corrosion

Applicability: All T67A aircraft.

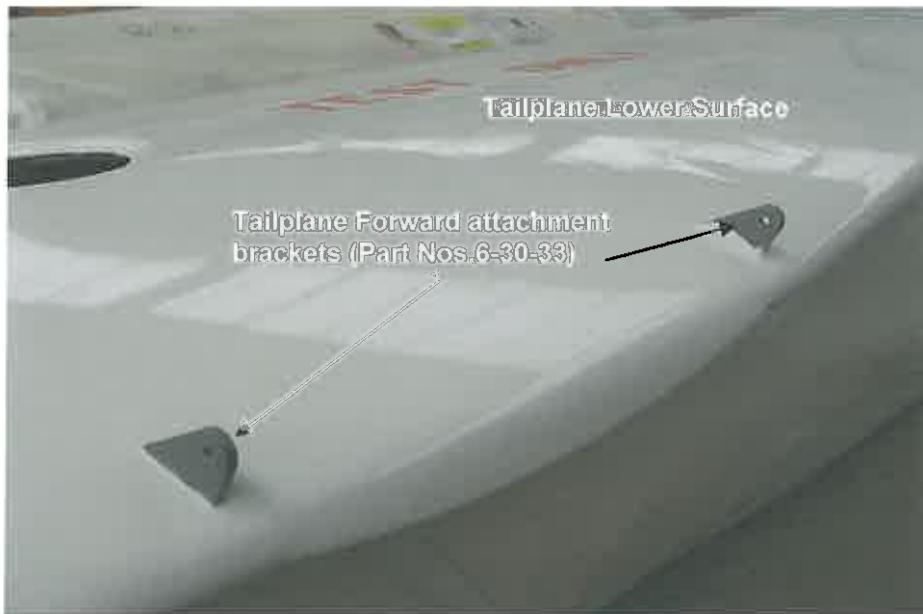
FIGURE 1A

A case has been reported of severe exfoliation corrosion of the two tailplane forward attachment fittings – Ref Figure 1A. The initial inspection of the part of the fittings visible from outside of the tailplane structure, revealed slight corrosion of one fitting only. However, when two holes were cut in the tailplane skins, in order to inspect the part of the fittings embedded in the tailplane structure, both fittings were found to be severely corroded.

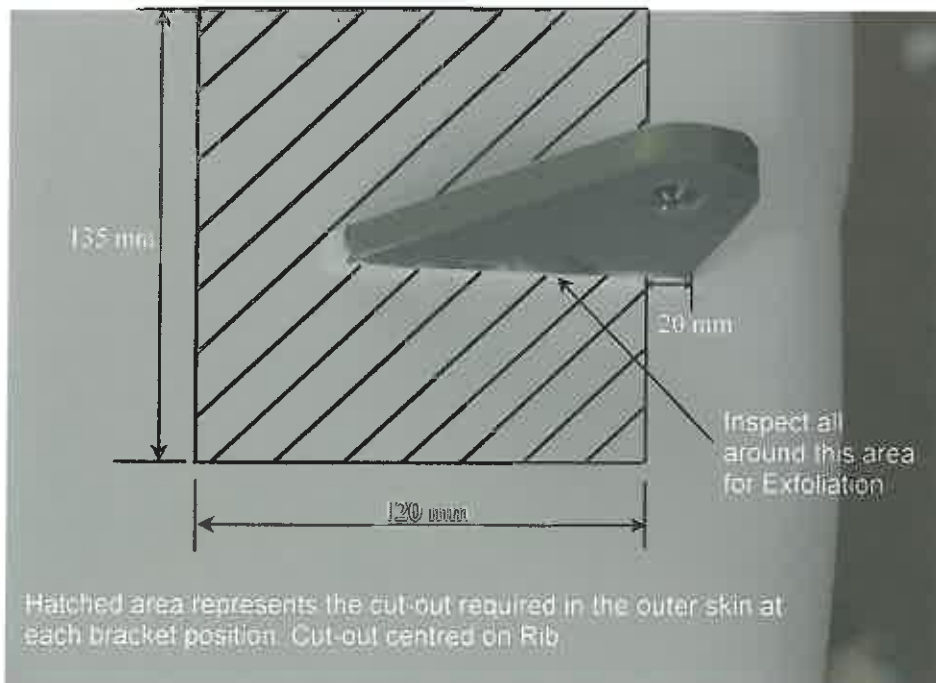
FIGURE 1B

3. Inspect the edges of the 2 aluminium alloy fittings for signs of exfoliation corrosion – see Figure 1B. This is evident by a swelling of the fitting and may have been severe enough to crush the mating wooden blocks.

1. Remove the tailplane from the aircraft in accordance with the T67A Maintenance Manual.
2. Cut two apertures in the tailplane lower skin in accordance with the dimensions and positions detailed in Figure 1B and DOI T67A-196.

4. If any sign of corrosion is found, replace both fittings in accordance with DOI T67A – 196.
5. If there is no sign of corrosion, inspect the surrounding wood structure for integrity and if found acceptable, repair the apertures in accordance with DOI T67A – 196.
