**SERVICE BULLETIN**

SB No. 100 Issue No. 2

TITLE WATER INGRESS INTO COCKPIT FROM ECS FRAME 2 BAY**CLASSIFICATION**

T67M260-T3A Post Mod M501A, Pre Mod 680B aircraft.

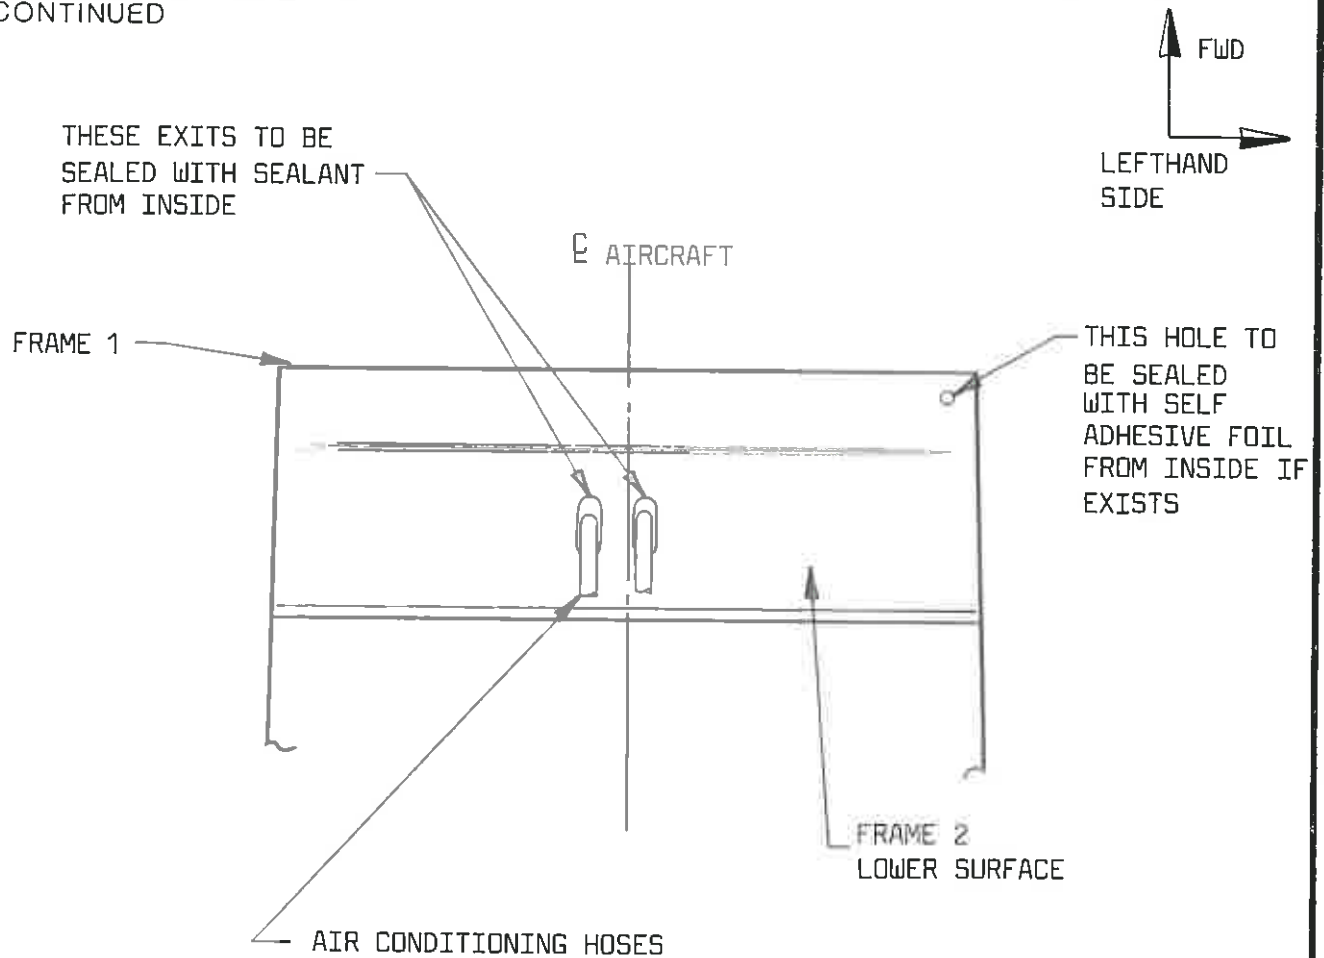
FIG 1
VIEW LOOKING UP ONTO UNDERSIDE OF FRAME 2

Cases have occurred of water ingress into cockpit from Frame 2 bay which houses the ECS evaporator. Upon further investigation it was found that the bay had not been sealed.

1. From the underside of Frame 2, check suspect areas for sealant. Refer Fig. 1.
2. If holes are visible gain access into Frame 2, remove any water, clean and degrease around areas to be sealed.
 - 2.1 Apply sealant RTV 781 (or 732 or 786) around air conditioning rubber hoses. This action is part of Mod M501A.
 - 2.2 If hole exists at forward left hand side of bay floor, then from a sheet of aluminium self adhesive foil, cut a blank approx. 1/2" oversize than the hole and bond into position.

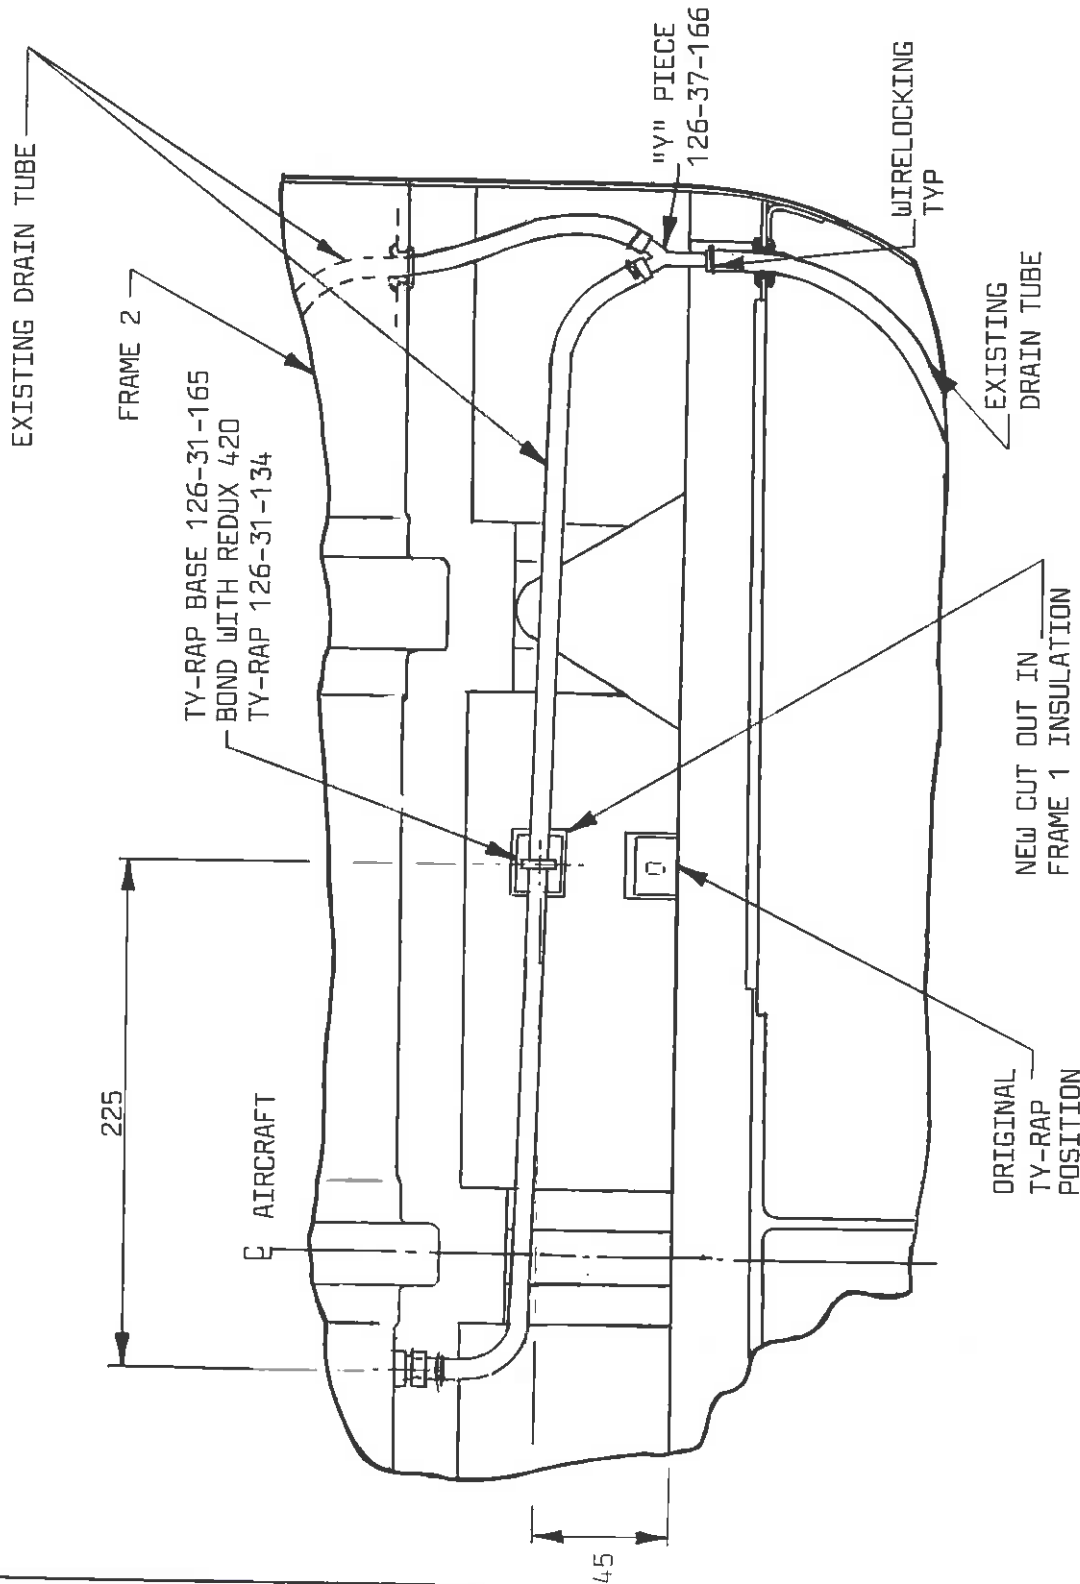
FIG 2
VIEW LOOKING FORWARD ONTO AFT FACE OF FR 1 - R H SIDE

In addition, to assist in draining any accumulated water in the ECS bay, the drain line is altered to accommodate a 'Y' junction piece in lieu of 'T' piece.

3. Refer Fig. 2. Gain access to right hand side of Frame 1 aft face, clip ty-wrap holding drain tube, mark new ty-rap base position and remove required insulation, bond new ty-rap base, 126-31-165, into position using Redux 420. Allow to cure.

Remove 'T' piece and replace with 'Y' piece, 126-37-166, wirelock to secure. Ty-rap drain tube to new ty-rap base with ty-rap 126-31-134. Ensure drain tube has minimal water traps. This action incorporates Mod M680B.
