Service Bulletin

S.B. No: 120

Title: INSPECTION OF RUDDER BAR SUPPORT BRACKETS

Applicability: T67B, T67C series, T67M (excluding works no. 1999), T67M-MkII, T67M200, T67M260 and T67M260-T3A.

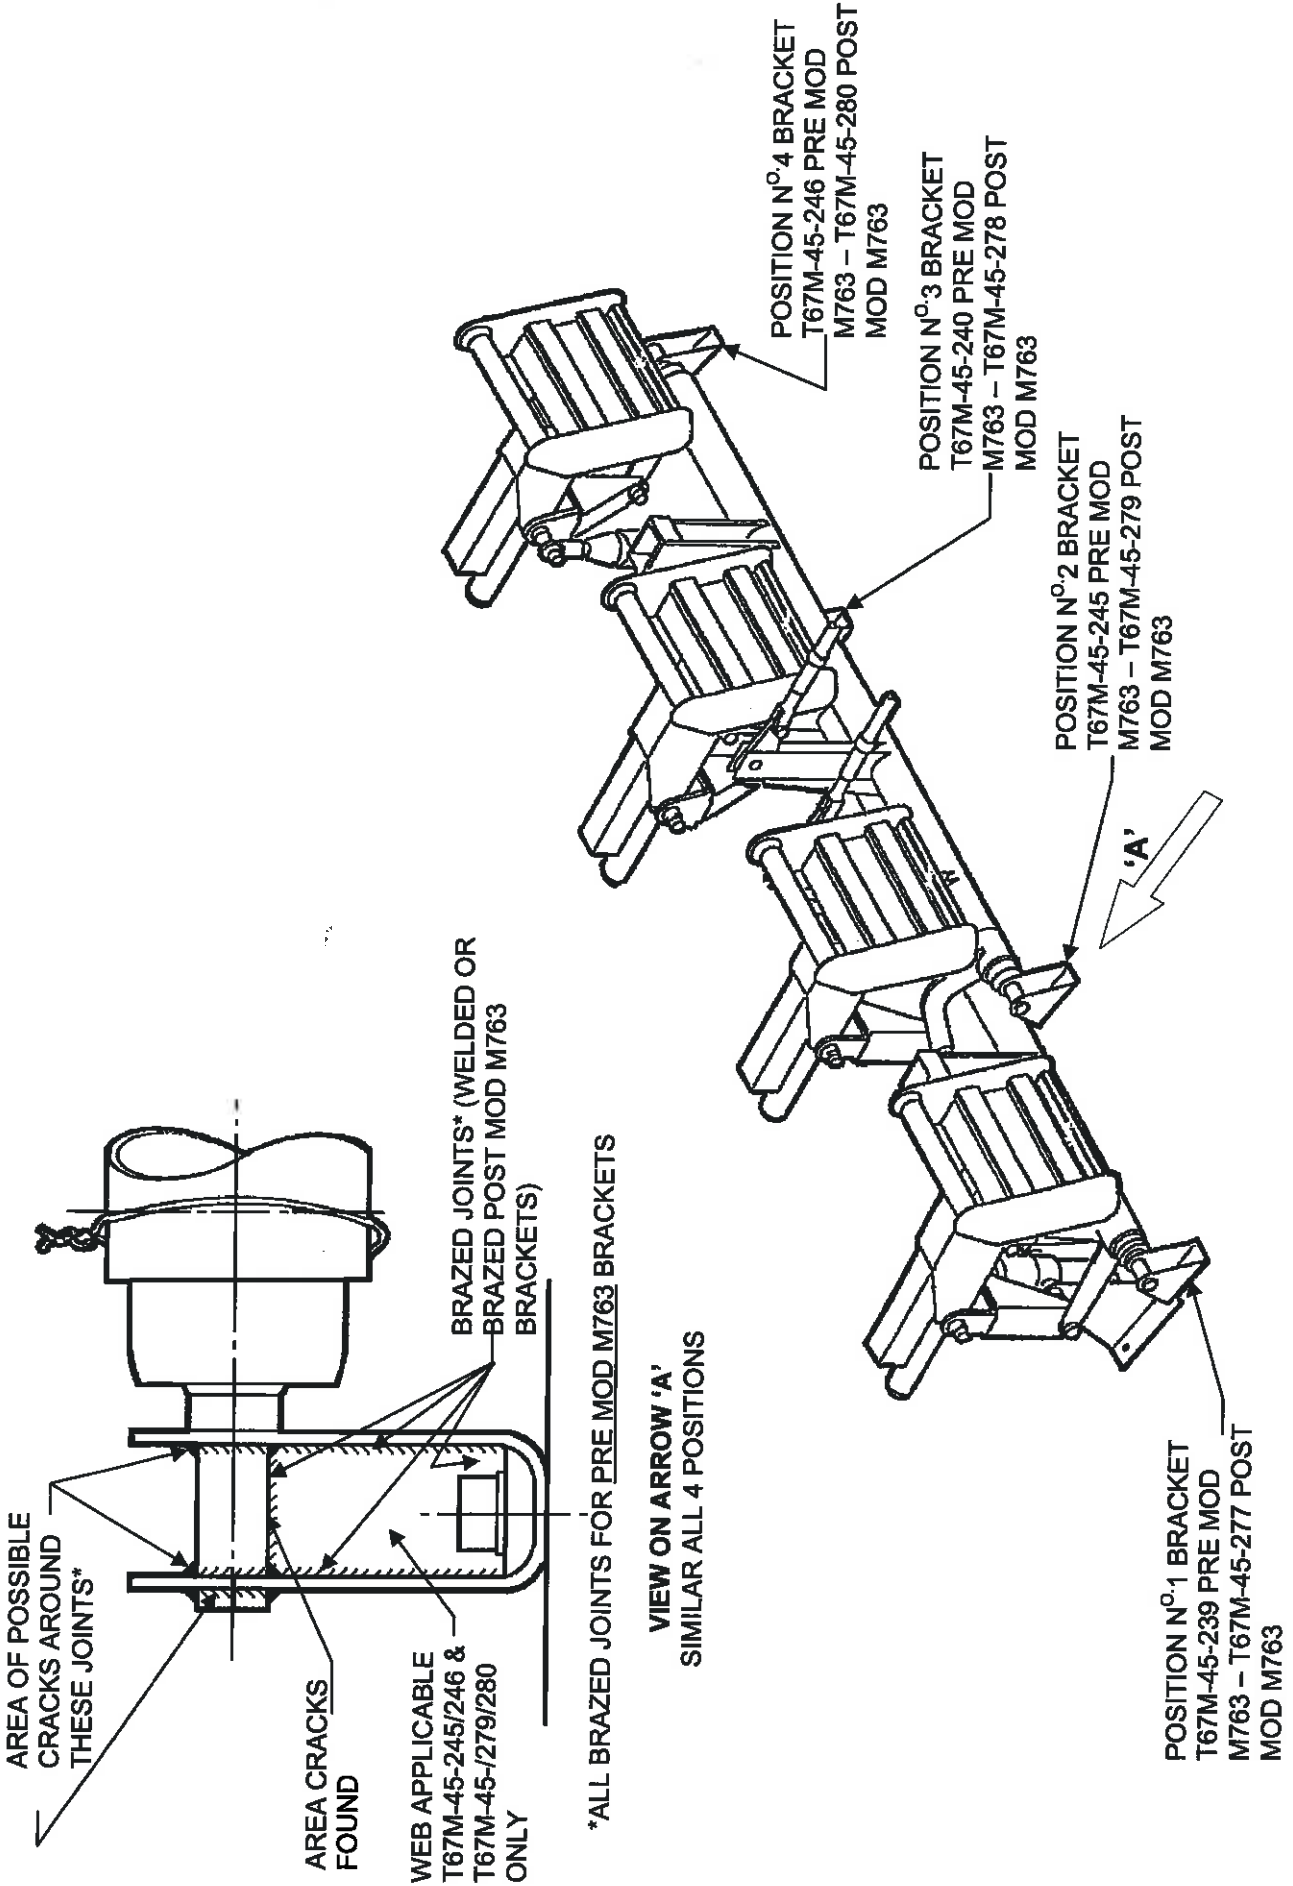
FIGURE 1
RUDDER PEDAL MECHANISM

Cases have been reported of cracking in the following brazed joints on the rudder pedal bar support bracket T67M-45-245: inboard pin joint and web to pin joint.

Subsequent to the Modification action it has come to light that due to a sub-contractor manufacturing error Brackets identified as T67M-45-277/278/279 & 280 have been assembled as completely brazed. Therefore as a consequence an inspection is required on the brackets to establish their method of assembly and if necessary re-identify or as in the case of the T67M260 series and T67M200 works numbers 2264 & 2265, replaced with correctly welded/part welded items.

1. Gain access to rudder bar support brackets, refer to Figure 1.
2. Establish whether the brackets are brazed or welded. Recommend removing portion of paint from pin fillets and web fillets. Weld will show as a natural steel colour, brazing as a "brass" colour.

6. Further to actions 2, 3 and 4 inspect both welded and brazed joints for cracking. If cracks found then replace bracket with new item. Refer View on Arrow 'A' Figure 1.

Note: reference T67B, T67C series, T67M (excluding works no. 1999), T67M-MkII, T67M200, (excluding works numbers 2264 & 2265), if brazed bracket is cracked then all four brazed brackets are to be replaced with Post Mod M763 brackets, i.e. T67M-45-277/278/279 & 280, refer Figure 1.
7. Restore paint finish.
8. Annotate logbook inspection carried out and, as applicable, Post Mod M763 brackets fitted.
9. Inspection steps 6 & 8 at each Annual in conjunction with SB 187 & SB 188 (latest issue) as applicable.
