# Service Bulletin

S.B. No: 84

**Title:** INSPECTION OF RIB 2 LOWER FLANGE BOND TO WING SKIN

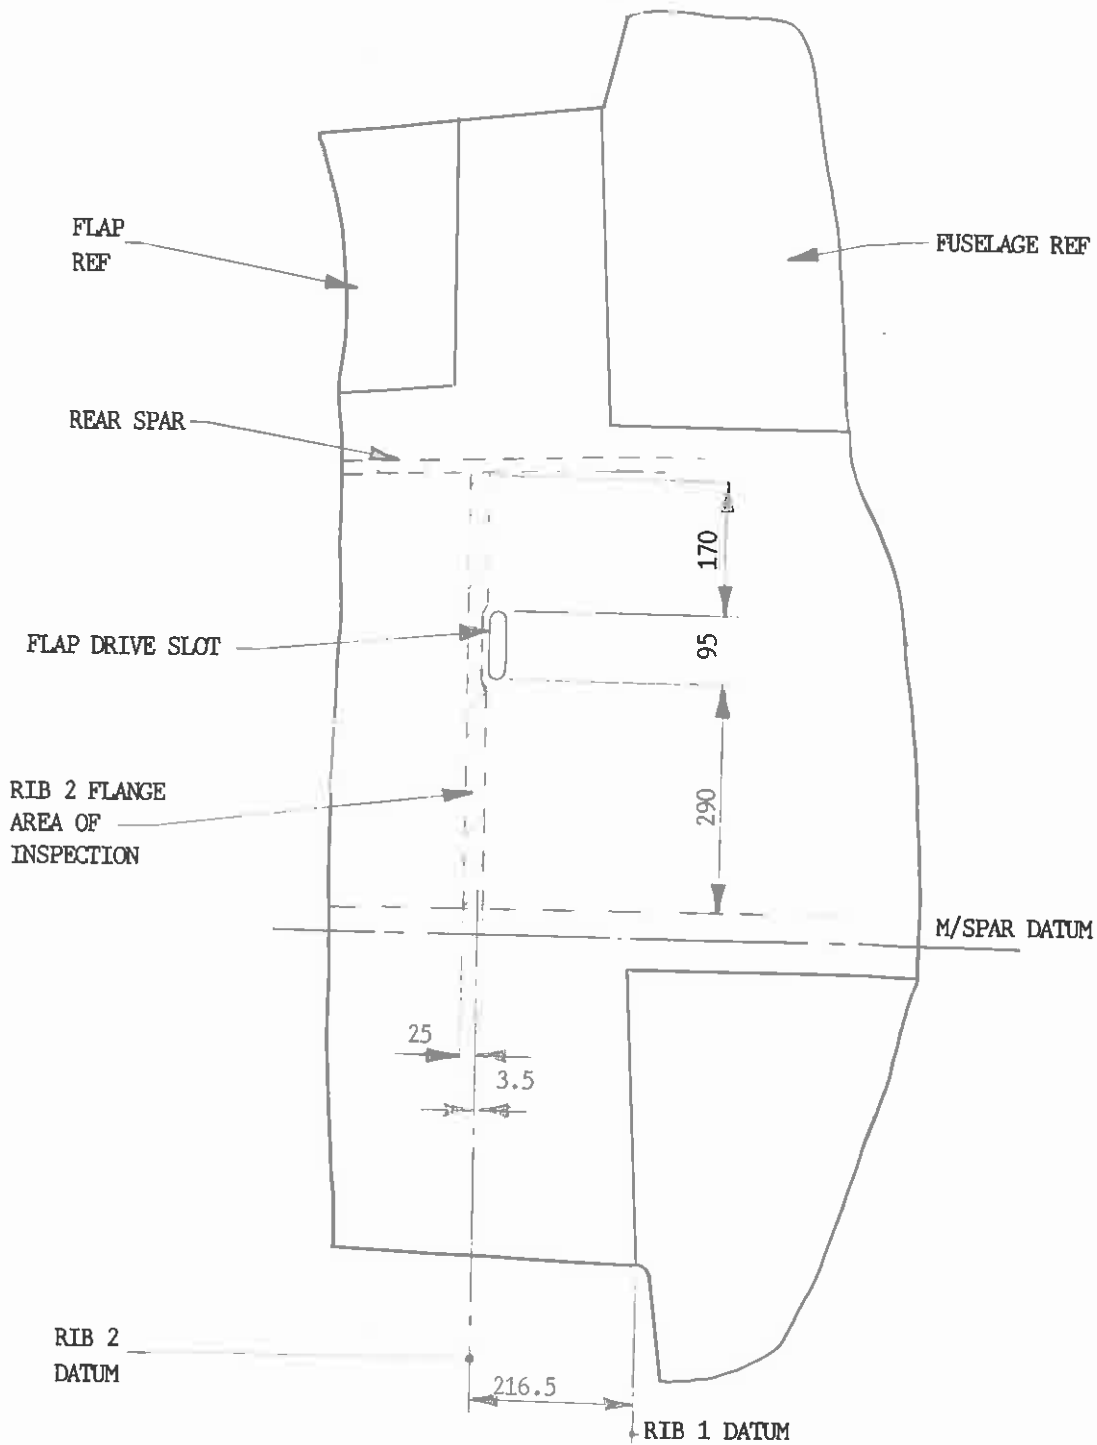
FIG 1  
 LOWER SURFACE PORT WING  
 STBD SIMILAR

It is possible that the bond between Rib 2 lower flange and inner wing skin is not satisfactory.

This Issue 2 has been raised to reflect the findings of Issue 1, issued July 27<sup>th</sup> 1995, requiring compliance by August 31<sup>st</sup> 1995. Following fleet inspection, one aircraft was found to be debonded and was repaired iaw T67G-03-049 (Mod M678) and seven aircraft were found to have minor debonding and were subject to negotiation between SAL and USAF.

1. Referring to Figure 1, determine integrity of bond over area indicated, by applying tap test and listen for tonal changes which indicate voids. (This should only be carried out by persons with composite bonding experience). Record area of de-bond.
2. If area of the void is determined to be greater than previously recorded, Mod M678 is to be invoked ref para 4.
3. If bond is found to be satisfactory, ie no greater than previously recorded, annotate in Logbook "SB 84 complied with this Annual Inspection". Repeat paras 1, 2 and 3 at next Annual Inspection.
4. If the bonded area has grown, inform SAL Product Support Department quoting Works/Construction/Serial Number of affected aircraft. Rectify in accordance with Repair Drawing T67G-03-049 (Mod M678) before further flight.
5. On completion of repair, annotate logbook "Mod M678 incorporated".

For Repair Drawing T67G-03-049 "Repair to Rib 2 Flange to Lower Skin Bond" contact SAL Product Support Department.
