Service Bulletin

S.B. No: 179

Title: INSPECTION OF TAILPLANE ATTACHMENT BRACKETS

Applicability: T67A, T67B, T67C, T67M, T67M-MkII, T67M200, T67M260 and T67M260-T3A:
All construction numbers except 2266 and subsequent.

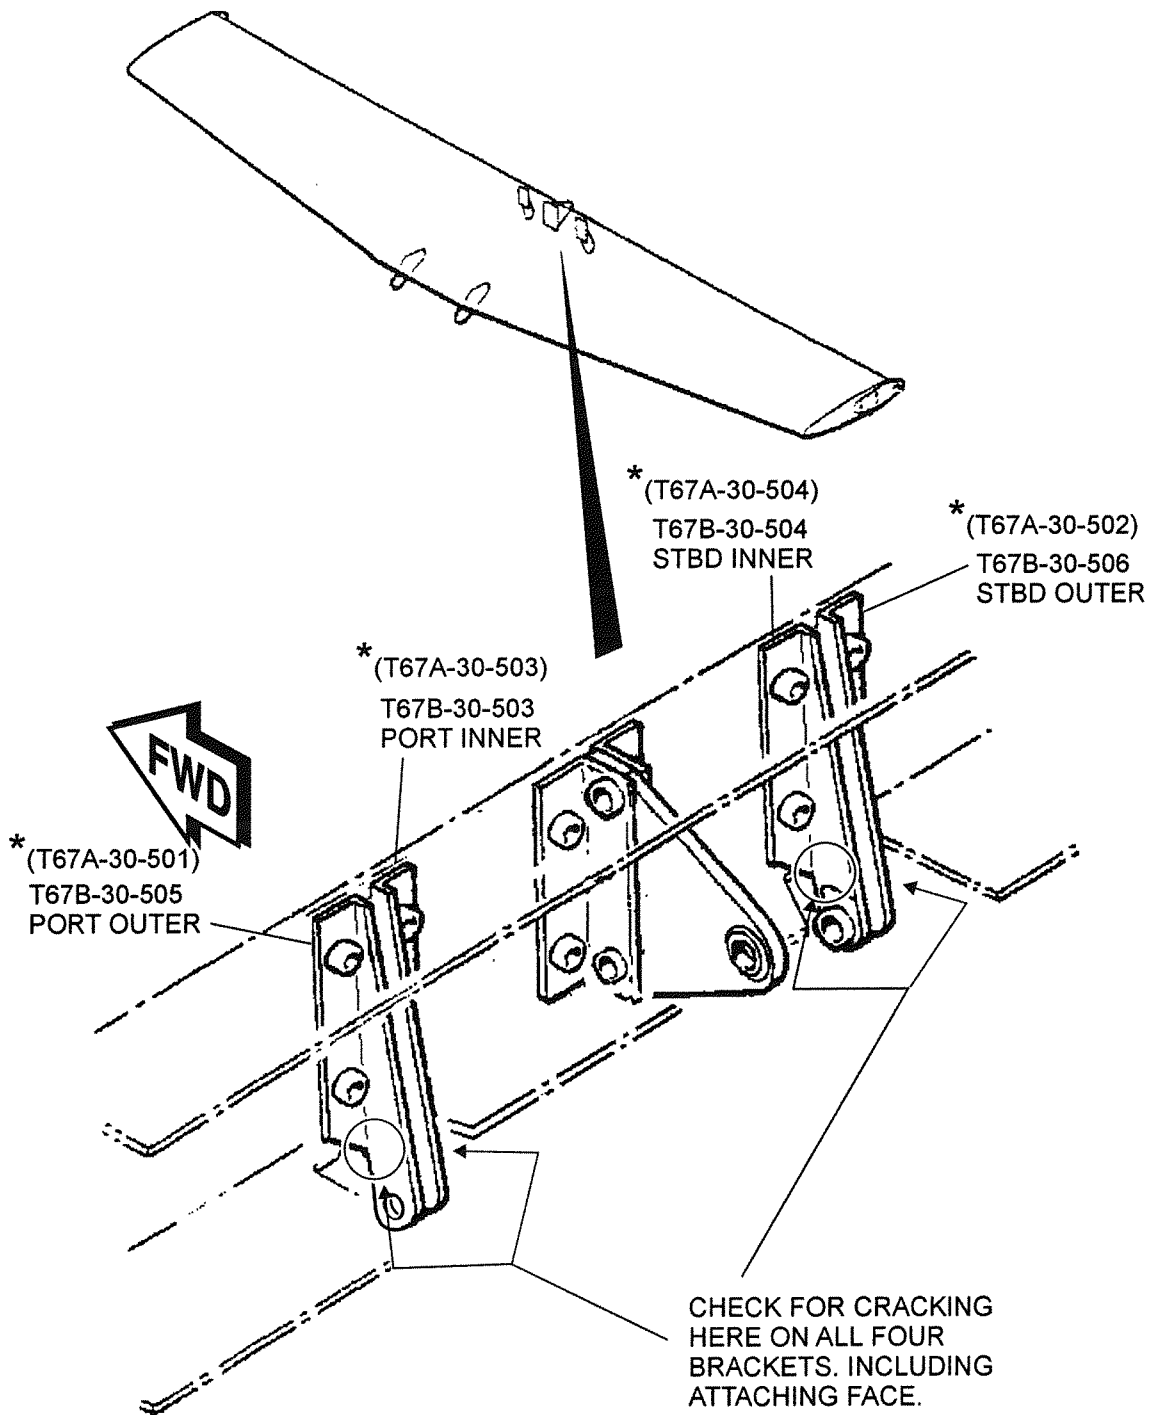
FIGURE 1

Cases have been reported of cracked tailplane brackets. This Service Bulletin details inspection of the aft tailplane brackets in order to discover similar cracks.

3. Remove paint from bracket.
4. Perform dye penetrant (or similar) NDT crack detection on brackets and examine, paying particular attention to the region illustrated in Figure 1.
5. Should any crack be discovered, then all four tailplane mounted brackets from the subject aircraft shall be returned to SAL and replaced with new items.

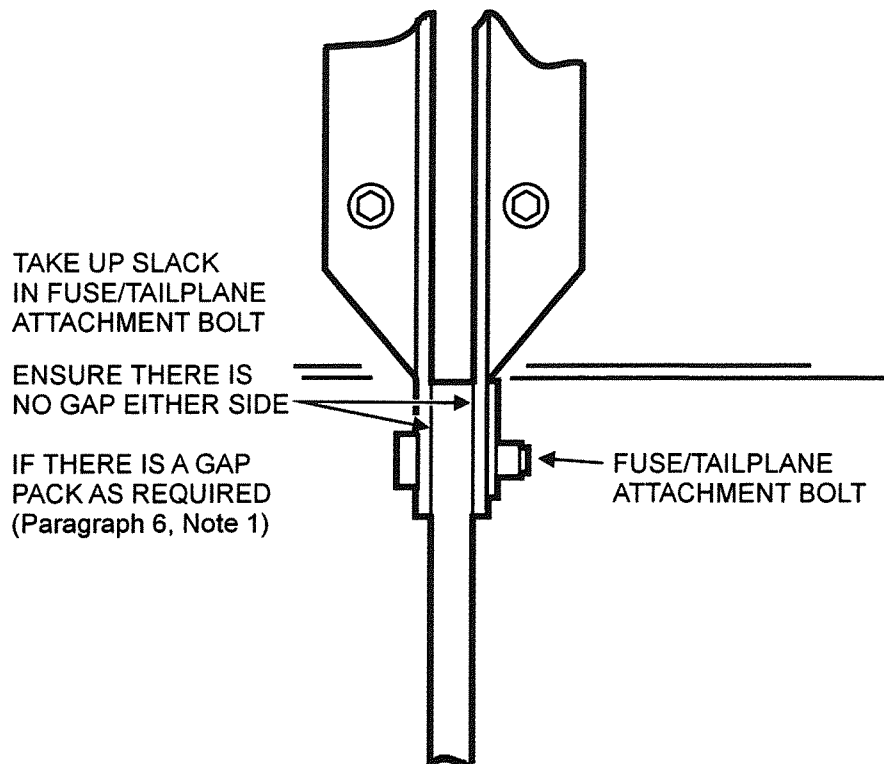
FIGURE 2

6. Tailplane attachment brackets are to be re-fitted to tailplane, bolts to be "finger tight". The tailplane is to be offered up to the aircraft and main tailplane to fuselage bolts fitted and torqued to 60 lbf in . Then tighten tailplane attachment bracket bolts.

NOTE 1 Prior to torquing main bolts, ensure there is either no gap or a gap of up to a maximum of .010" (.25mm) between fittings. If a gap greater than .010" (.25mm) does exist after taking up slack then it is permissible to fit washers as follows:

Washer/s of thicknesses 0.016" (.4mm) (SAL Stores Code 126-23-750) or 0.018" (.46mm) (SAL Stores Code 126-23-754) or 0.032" (.81mm) (SAL Stores Code 126-23-747). Thinning of 0.032" is acceptable providing faces of washer remain parallel. Re-protect modified face.

NOTE 2 Ensure that the brackets are not forced apart when fitted.
