SERVICE BULLETIN

120

TITLE
INSPECTION OF RUDDER BAR SUPPORT BRACKETS
CLASSIFICATION

T67B, T67C Series, T67M (Works No.1999 Not applicable), T67M-MkII, T67M200, T67M260 and T67M260-T3A.

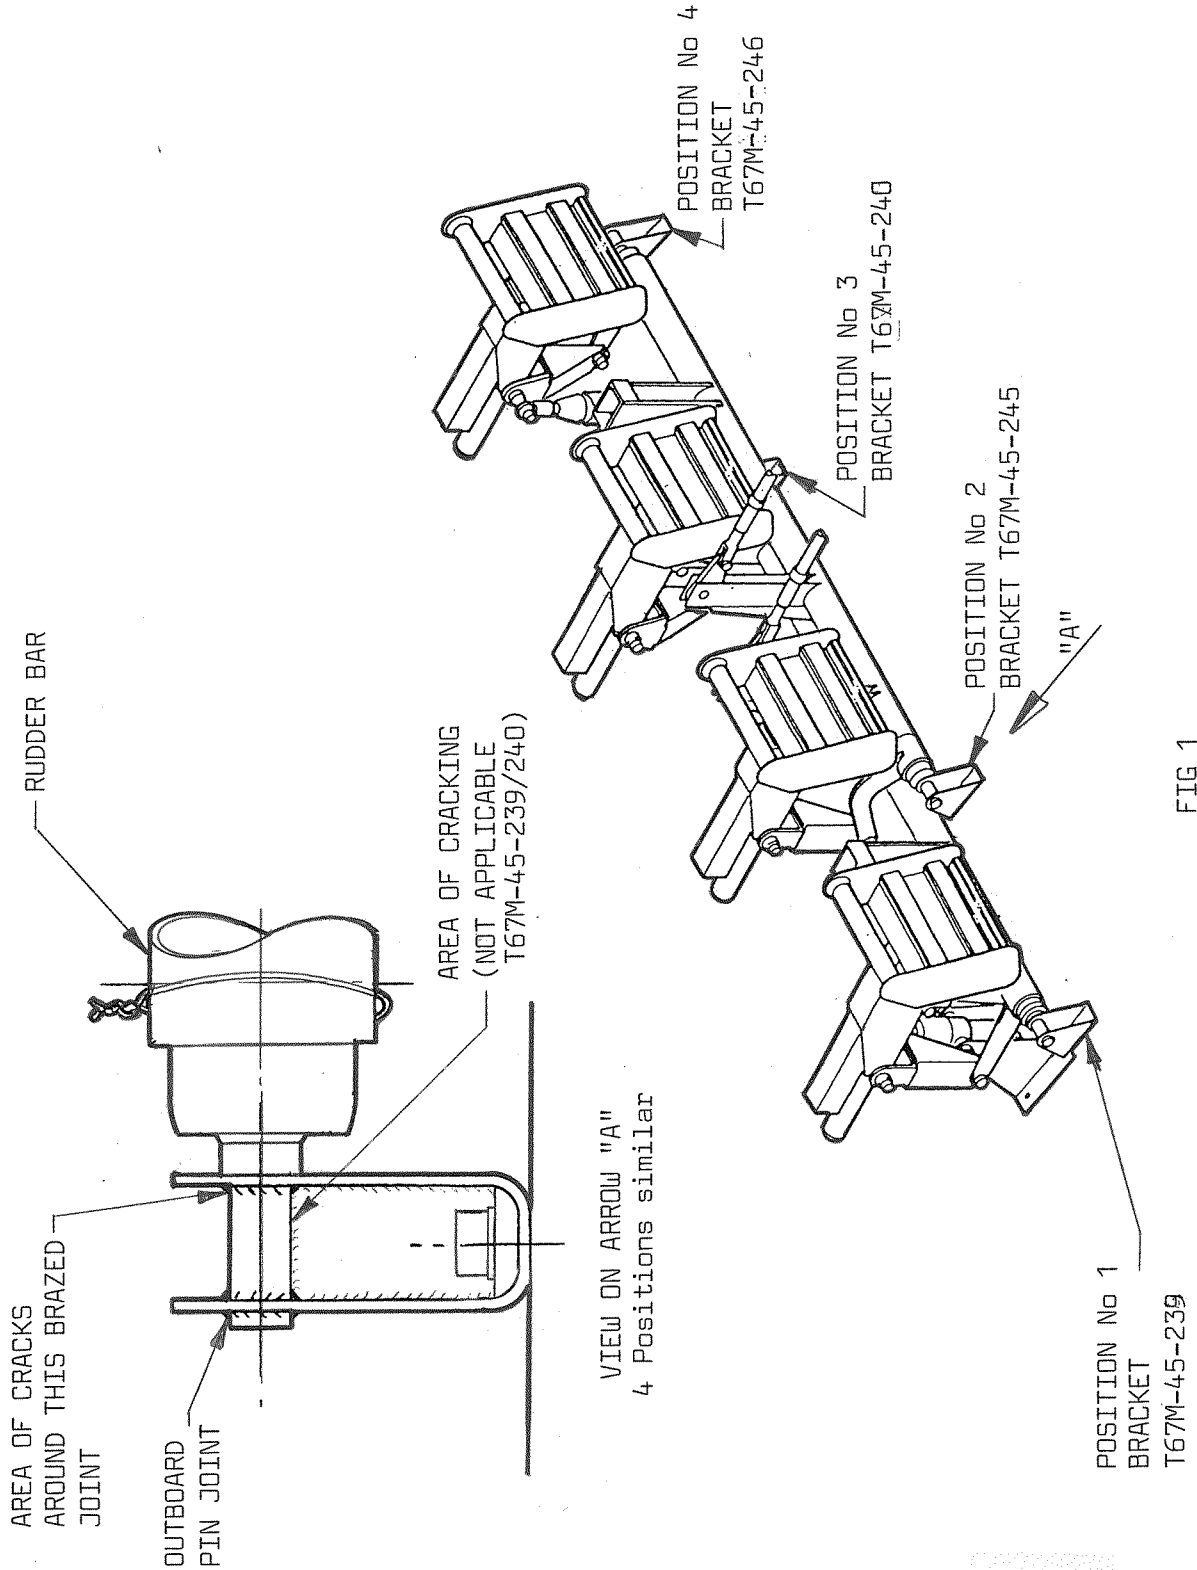
FIG 1
RUDDER PEDAL MECHANISM

Cases have been reported of cracking in the following brazed joints on the rudder pedal bar support bracket T67M-45-245: inboard pin joint and web to pin joint.

2. Check brazed joints for cracking Ref Fig. 1 View on Arrow A.
 - 2.1 If no cracks are found, annotate logbook SB120 Iss 3 satisfied. Repeat inspection at 150 hour intervals.
 - 2.2 If cracking is found.
 - 2.2.1 Provided web crack is no more than 50% of the joint length, and the outboard joint to the pin is intact, flying is permitted, but bracket is to be replaced within 150 hours.

It is acceptable to have pin inboard joint with a 100% failure and still fly for up to 150 hours.
 - 2.2.2 Should web crack exceed 50% of its joint length and 100% of pin inbd joint cracked, then no further flight is permitted until bracket is repaired or new item fitted.
3. Following inspection rectification 150 hr inspection still to apply.

For replacement brackets or repair information, contact SAL Product Support Department.
