SERVICE BULLETIN

SB No. 126 Issue No. 2

TITLE INSPECTION OF PORT RUDDER BAR FOR CHAFING

T67B, T67C Series, T67M, T67M-MkII, T67M200, T67M260 and T67M260-T3A

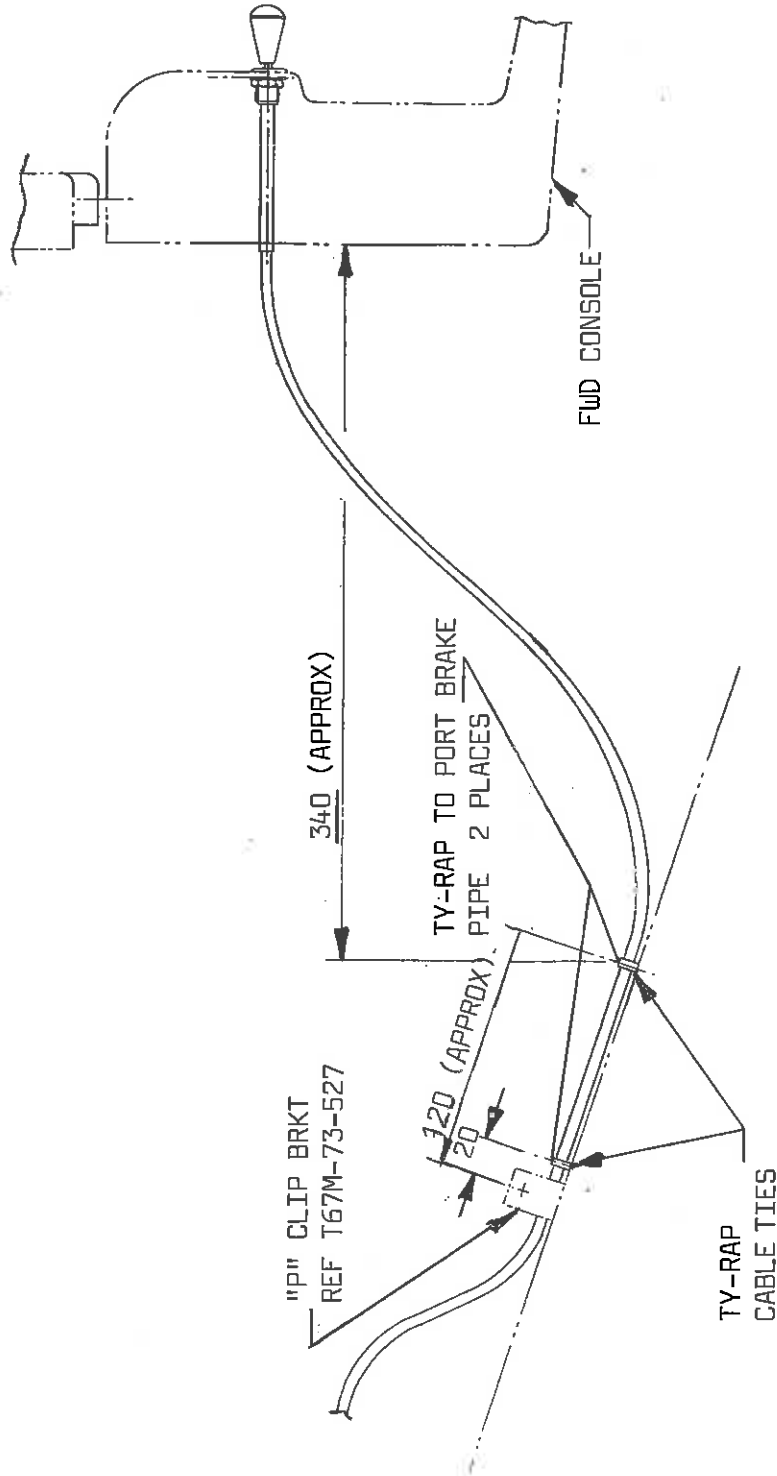
FIG 1
CORRECT CABLE ROUTING AND TYING

A case has been reported of the hot air control cable fouling and damaging the rudder crossbar due to poor routing.

1. Inspect, using a strong light and a mirror, the lower (port) rudder bar above hot air control cable for signs of chafing.
2. If no chafing has occurred, ensure cable routing conforms to Fig. 1.

3. Should the rudder bar T67M-45-257 be damaged, ie paint removed or grooved to a depth of less than 0.1mm, the rudder bar should be deemed serviceable, repaint damage. A new cable should be fitted according to Fig. 1. Hot air cable Pt No. T67B-74-217 Pre Mod M234, T67B-74-225 Post Mod M234 applicable T67B, T67C Series, T67M, T67M-MkII and T67M200; T67G-74-205 T67M260 and T67M260-T3A aircraft.

4. If rudder bar T67M-45-257 is grooved to a depth of between 0 and 0.5mm, remove rudder bar, blend out groove, repaint and refit. If rudder bar is grooved to a depth greater than 0.5mm, strip down rudder bar assembly and return rudder bar to manufacturer for repair, fit replacement rudder bar. Hot air control cable should be replaced and fitted according to Fig. 1.
