No. SBM-202

Modification MA2458 - Additional Securing of Nose Landing Gear Axle Bolt

LETTER OF TRANSMITTAL COVERING INITIAL ISSUE OF SERVICE BULLETIN SBM-202

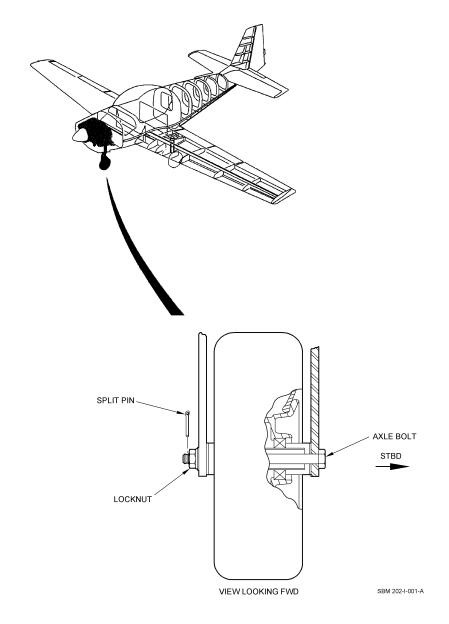
Castellated nut and split pin installation into SAB nose leg assembly (Sheet 1)
FIGURE 1

- A. EFFECTIVITY
 - (1) Pre Mod M468 aircraft (fitted with SAB undercarriage); T67B, T67C Series, T67M, T67M MkII, T67M200 and T67M200 Club Sport Pro.
- B. CONCURRENT REQUIREMENTS
 - (1) None.
- C. REASON
 - (1) Following completion of an aerobatic sortie and during a low speed taxiing manoeuvre a T67 Slingsby Firefly suffered a separation of the nose wheel from the nose undercarriage assembly.
- D. DESCRIPTION
 - (1) Modification MA2458 introduces additional securing of the nose landing gear axle bolt.
- E. COMPLIANCE
 - (1) Classification
 - Must be accomplished.
 - (2) Accomplishment Time scale
 - This Service Bulletin should be completed at the next opportunity or the next 50 hour or annual check.
- F. APPROVAL
 - (1) The technical content of this document is approved under the authority of DOA ref EASA 21J.181.

- (1) Remove the nosewheel locknut (Part No. HM14-100) from the axle bolt.
- (2) Referring to Fig 1, install a new nosewheel locknut (Part No. HM14-100) and tighten until the wheel drags, then back off one flat, ensuring there are enough threads showing for safety and to accomplish Step 4.

- (3) Check the installation of the nosewheel locknut (Part No. HM14-100) does not cause the SAB nose undercarriage forks to bend inwards, if it does then carry out Slingsby Aviation Service Bulletin 153 SAB Undercarriage Nosewheel Fork Inspection.
- (4) Drill a 3/32 in. hole, through the axle bolt not less than two threads from the axle bolt end.
- (5) Ensure all swarf is removed and the work area is clean.
- (6) Install the split pin (Part No. SP90-E11) through the axle bolt.
- D. REASSEMBLY
 - (1) Remove the trestle support from under bump stop at aft of airframe.
 - (2) Lower the aircraft off the jack.
- E. RE-IDENTIFICATION OF THE UNIT
 - (1) Not applicable.
- F. TEST
 - (1) Not applicable.
