SERVICE BULLETING

SB No. 014

BEARINGS IN CONTROL COLUMN AILERON TIE ROD

All T67A, B, M, M-MkII, and M200 aircraft.

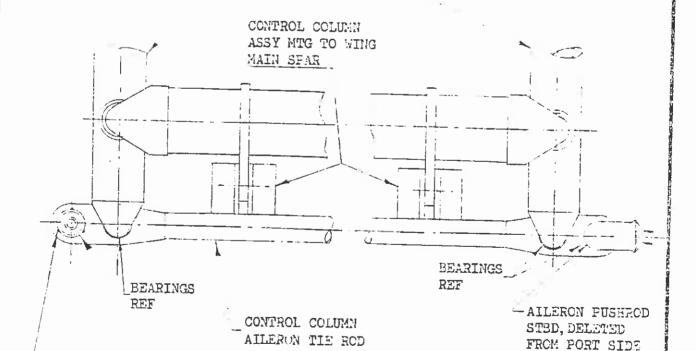
VIEW SHOWING RELEVANT BEARINGS

An isolated occurrence has been reported of the 4 bearings in the control column aileron tie rod coming loose in their housings.

- 1. Remove port and starboard control column gaiters.
- Inspect, using a torch and mirror as necessary, the 4 bearings in the control column aileron tie rod for correct locations in their housings. See sketch.
- 3. If any bearings are loose or out of position, proceed as follows:
 - 3.1 Remove seats for method see Maintenance Manual Section 3.4.1 which includes seat removal. Ref. GRP aircraft. For T67As remove seats, centre consoles and control covers.
 - 3.2 Remove control column tie rod.
 - 3.3 Reassemble the bearings to their housings using Loctite Studiock 270 adhesive, and "centre punch" in 3 places at 120° pitch on both sides.

CENTRE PUNCH EACH BEARING 3 TIMES AT 120° PITCH BOTH SIDES
