SERVICE BULLETIN IIIIII

SB No. 014

BEARINGS IN CONTROL COLUMN AILERON TIE ROD

All T67A, B, M, M-MkII, and M200 aircraft.

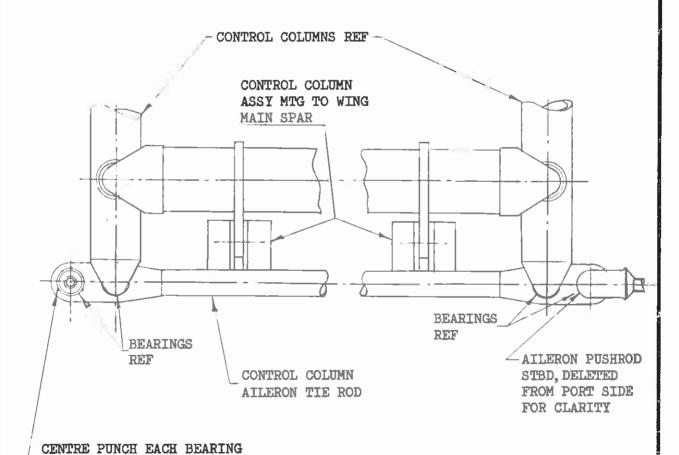
An isolated occurrence has been reported of the 4 bearings in the control column aileron tie rod coming loose in their housings.

- Remove port and starboard control column gaiters.
- Inspect, using a torch and mirror as necessary, the 4 bearings in the control column aileron tie rod for correct locations in their housings. See sketch.

3 TIMES AT 120° PITCH BOTH

- 3.2 Remove control column tie rod.
 - Reassemble the bearings to their housings using Loctite Studlock 270 adhesive, and "centre punch" in 3 places at 120° pitch on both sides.

- N.B. Check inner ball for full and free movement.
 - 3.4 Refit rod and seats by reverse action of 3.2 and 3.1 above.
- 4. Annotate aircraft log book Service Bulletin No. 014 satisfied.
