**SERVICE BULLETIN**

SB No. 036

INSPECTION OF NOSE UNDERCARRIAGE SLIDING LEG WELD

All T67 aircraft, except as detailed in Action 1.1 below.

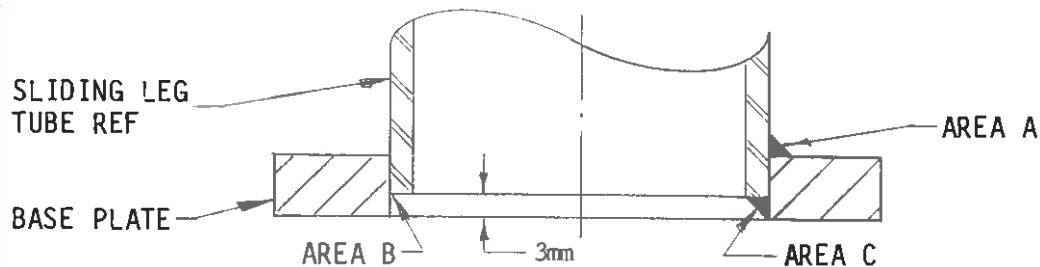
FIG. 2

3.1 With reference to Fig. 2, area A:

(a) grind away the weld metal in the area affected by the crack(s), and carry out further dye penetrant checks and further removal of metal as necessary until all traces of the crack are removed.

(b) Carry out a weld repair using argon arc (t.i.g.) to produce a fillet equivalent in area to at least the original weld.

The parent metal is the French Specification 15CDV6.

The weld filler rod recommended is Bostran 41, (BS 2901, Part 1, A32) supplies of which are available from Slingsby Aviation.

3.2 With ref. to Fig. 2, area B, grind or machine away metal to produce a 90° angle between the bottom of the tube and the inner diameter of the base in the rectangular plate to a depth of 3mm.

Carry out a standard weld as shown in Area C, using argon arc welding and Bostran 41, see 3.1.(b) above.

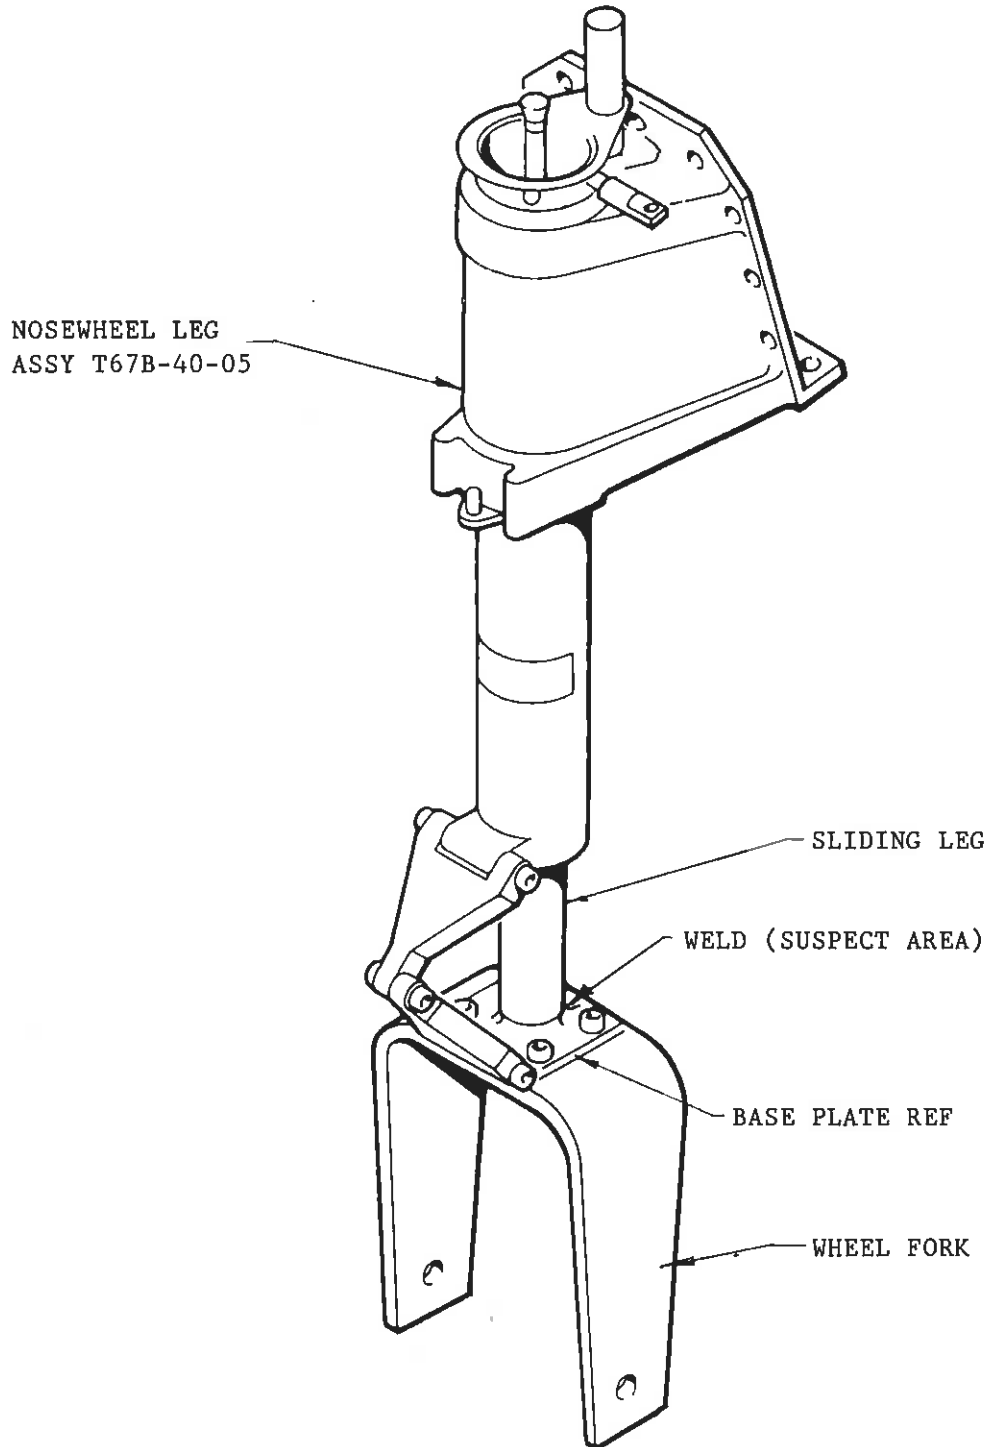
FIG 1

Several cases of cracking of the weldment at the lower end of the nose undercarriage sliding leg have been reported recently, and in 2 cases the welded joint has failed - see Fig. 1 for location.

- 1.1 With reference to Fig. 1 examine the plate welded to the lower end of the inner, sliding, leg. If this plate is circular with 6 bolts securing the nose-wheel fork, then this S.B. does not apply.

In all other cases the weld joining the tubular leg to the rectangular (4-hole) plate is the suspect area.

- 1.2 Remove all paint from the area of the weld.
1.3 Carry out a dye penetrant check of the weld area.

- 1.4 (a) If no cracks are found, re-protect with clear lacquer or equivalent and the aircraft may then continue to the next scheduled 50-hour check.

(b) If any crack is found, the aircraft must not be flown until the component is either replaced, or repaired as in para. 3.
