**SERVICE BULLETIN**

SB No. 033 Issue No. 3

SPECIAL INSPECTION OF RUDDER BAR PEDAL SUPPORT LUGS ON
T67 GRP SERIES AIRCRAFT

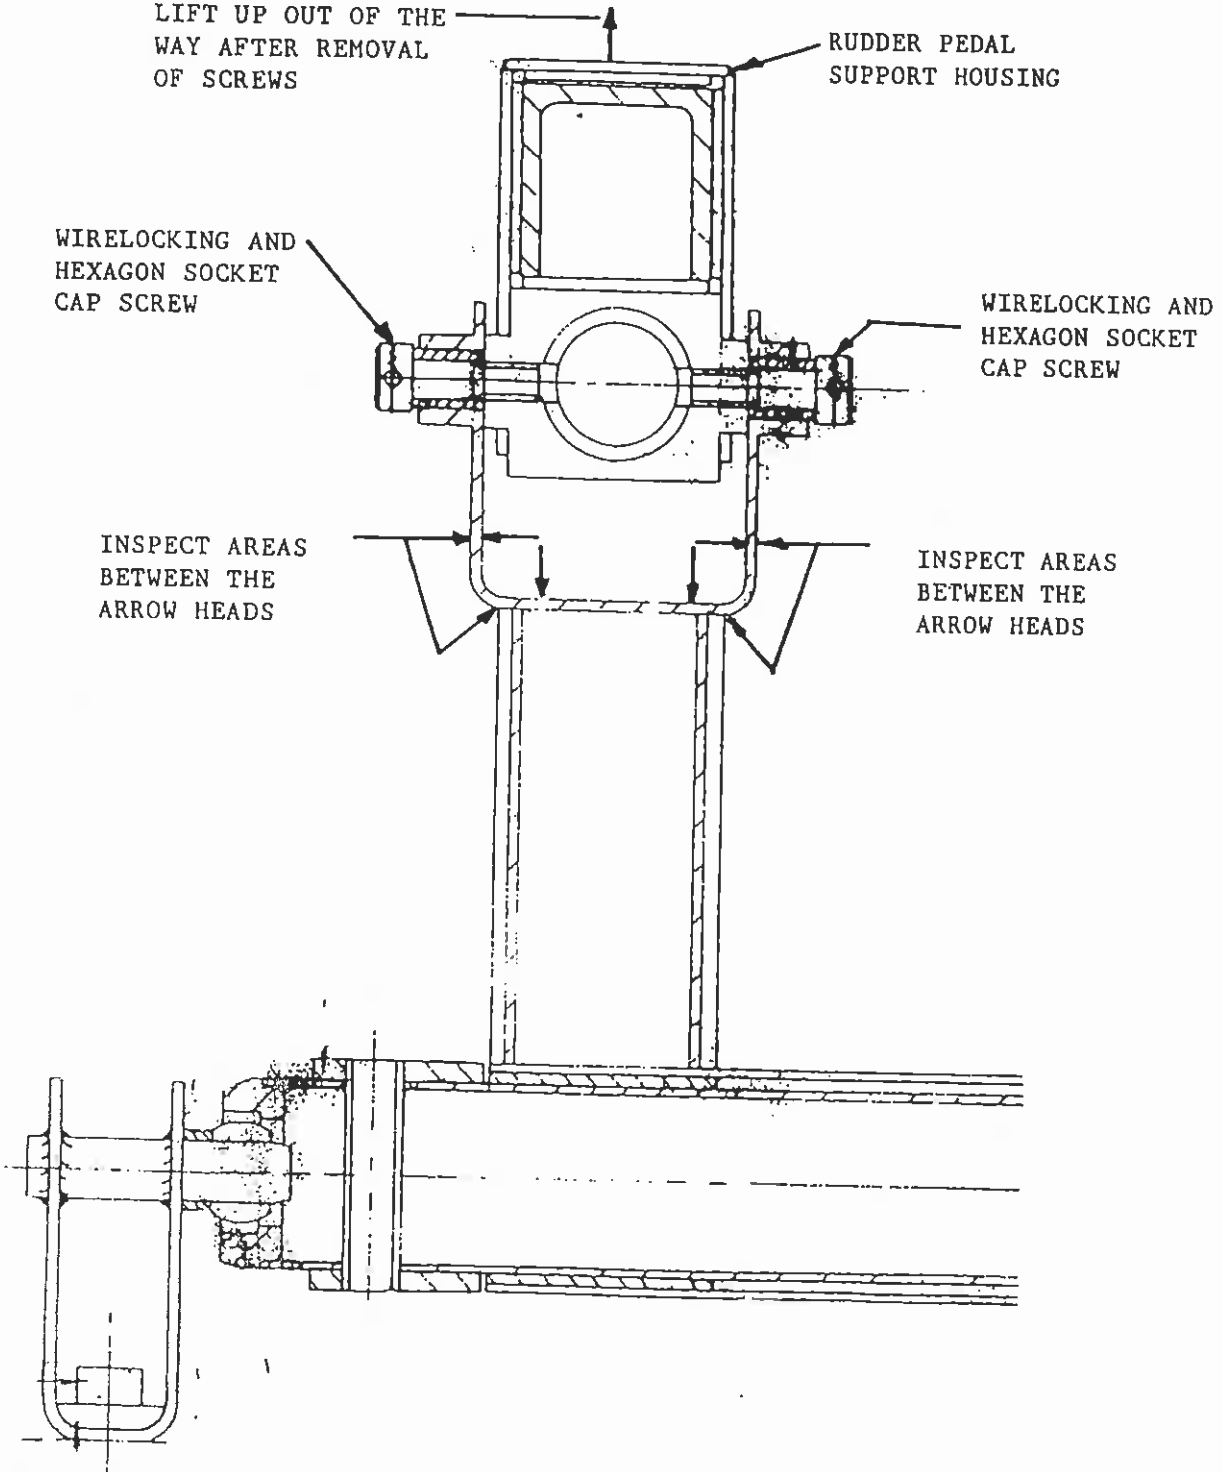
FIG 1: SECTION THROUGH PART OF RUDDER BAR ASSY. (TYP 4 POSNS)

Two instances of the rudder bar pedal support lugs having broken off
have occurred. The first case was considered to be caused by damage
sustained during the manufacturing process. The second case occurred
during taxiing manoeuvres. Following an investigation Mod 412 has been
produced; this Mod provides strengthened support lugs.

INSPECT AREAS BETWEEN THE ARROW HEADS

- (i) Remove the hexagon socket cap screw retaining each of the
rudder pedals. Remove the rudder pedals.
- (ii) Remove the locking wire from the 2 (off) hexagon socket cap
screws retaining the aft end of each rudder pedal support
housing. See Fig. 1. Remove the screws.
- (iii) Lift the aft end of the rudder pedal support housings upwards
out of the way - retain in this position.
- (iv) Remove the protective treatment from the area of the lug lower
radii shown in Fig. 1.
- (v) Inspect the areas shown using a dye penetrant method to check
for cracks.

- (vi) If cracks are not found then restore to standard finish i.e. etch prime and spray 1 coat cellulose hammerite hammer grey, or equivalent, and reassemble as standard practice.
- (vii) If any cracks are found then the relevant rudder bar/s must be replaced by new items before next flight. (Note that all new items supplied by Slingsby after this issue of the Service Bulletin will be post Mod 412 standard.)
