Service Bulletin

S.B. No: 179

Title: INSPECTION OF TAILPLANE ATTACHMENT BRACKETS

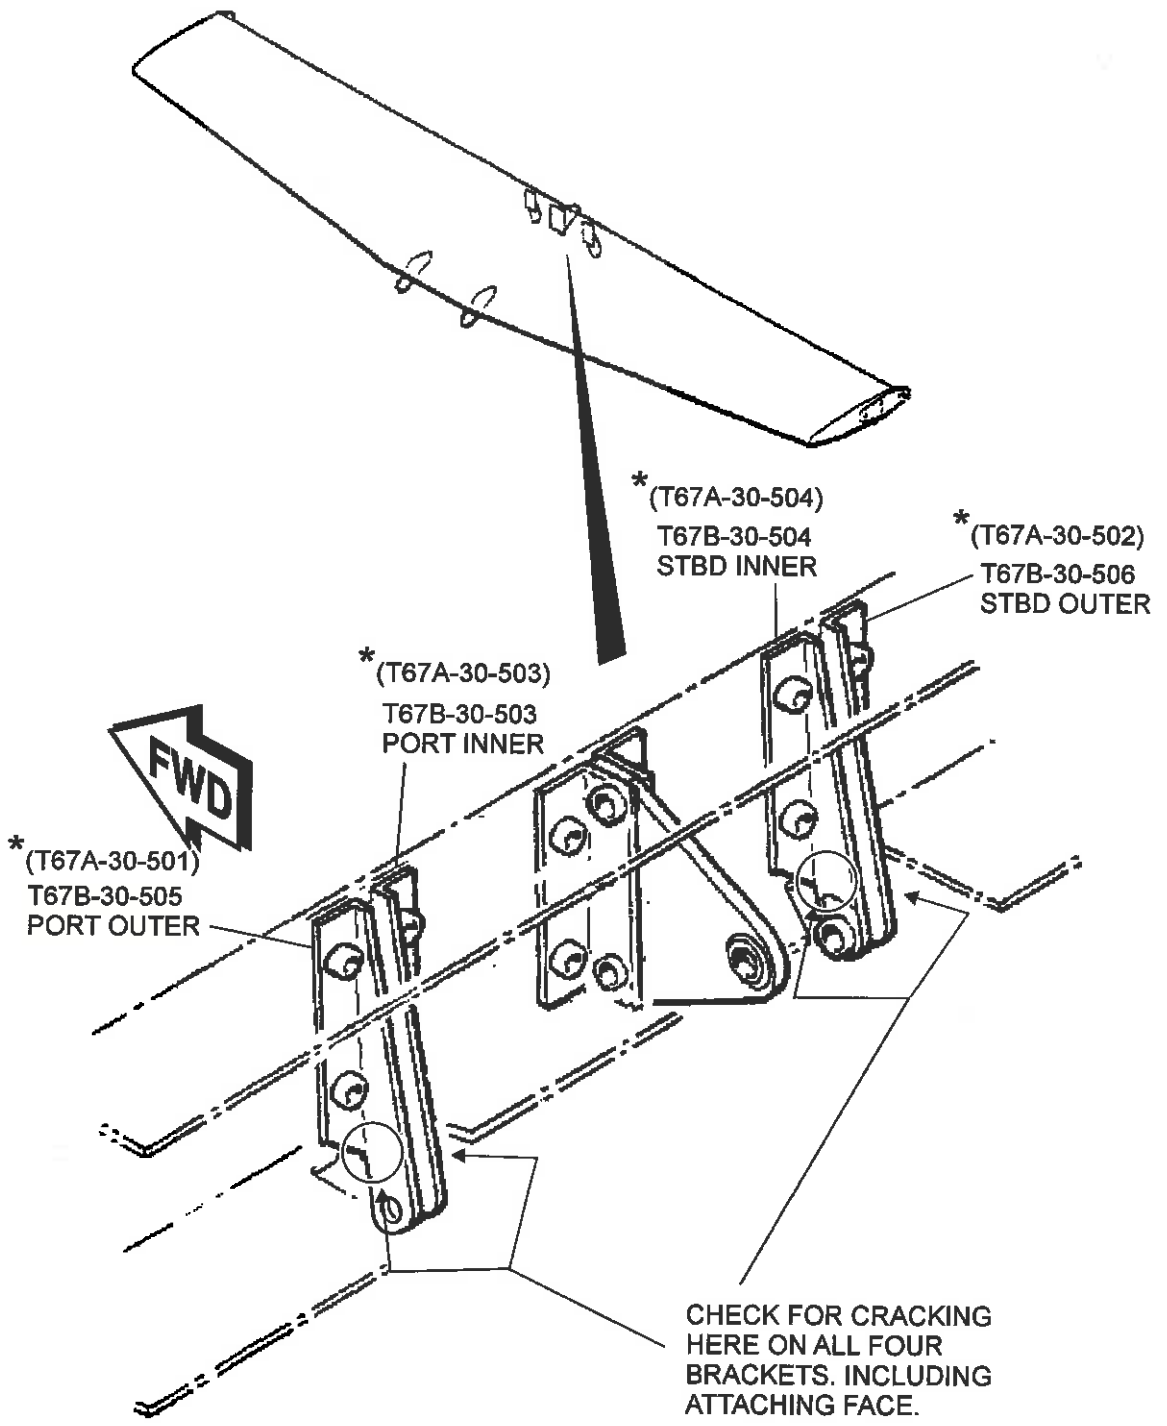
FIGURE 1

Cases have been reported of cracked in aluminium tailplane mounted attachment brackets – see Figure 1. This Service Bulletin details inspection of the aft tailplane brackets in order to discover similar cracks.

3. Remove paint from bracket.
4. Perform dye penetrant (or similar) NDT crack detection on brackets and examine, paying particular attention to the region illustrated in Figure 1.
5. Should any crack be discovered, all four tailplane-mounted brackets from the subject aircraft shall be returned to SACL for investigation and disposal and new Pre Mod M988A or B, or Post Mod M988A or B brackets are to be fitted.

In any case, inspection in accordance with this Service Bulletin shall be every Annual thereafter until the brackets are replaced by Mod M988A or B Titanium Brackets. Also refer to Action paragraph 8.

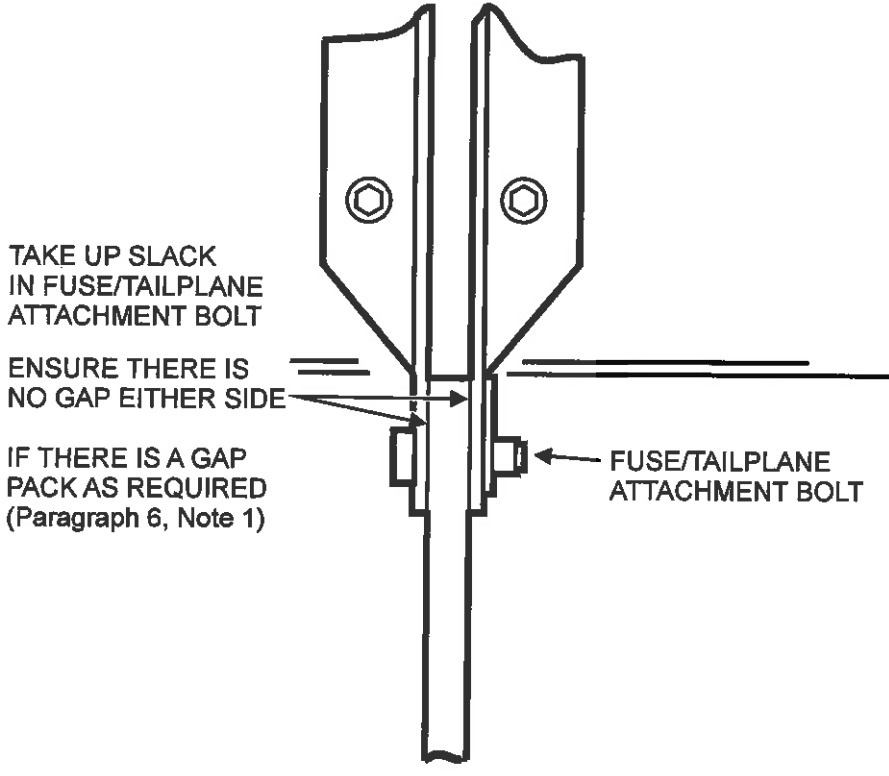
FIGURE 2

PORT ATTACHMENT SHOWN
STARBOARD SIMILAR
