SERVICE BULLETIN

SB No. 133 Issue No. 2

TITLE INSPECTION OF FLAP LEVER PIVOT ATTACHING POINT FOR CRACKING

T67A, T67B, T67C Series, T67M, T67M-MkII, T67M200, T67M260 and T67M260-T3A.

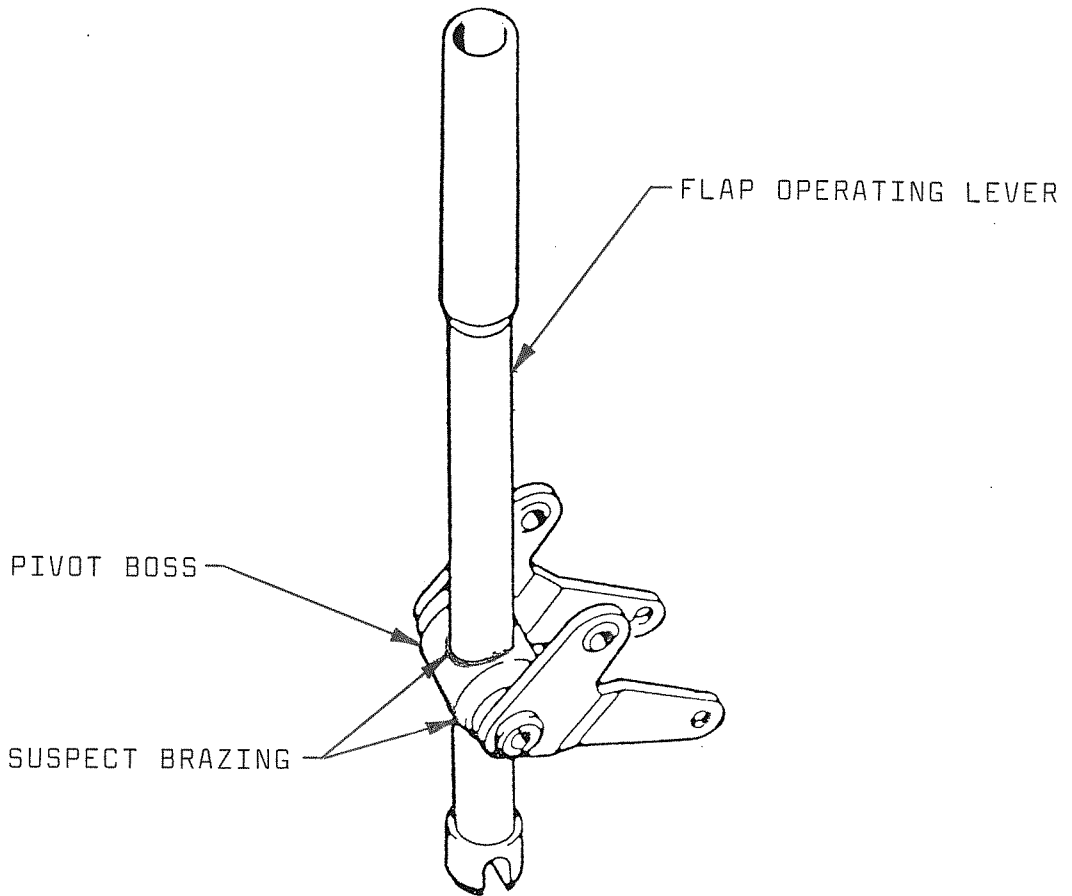
FIGURE 1 FLAP OPERATING HANDLE
(ITEMS DELETED FOR CLARITY)

Cases have been reported of cracking in the brazed joints above and below the lever pivot point.

1. Gain access to the flap lever pivot boss.
2. Establish whether flap lever is brazed or welded. If in doubt, remove paint from joint. Welded joint will be the natural metal colour. If welded joint identified, restore finish. Annotate Log Book, "SB 133 complied with". If brazed joint identified, continue as para 3 below.
3. Inspect, using strong light and mirror, all brazing between lever and pivot boss, above and below pivot.
 - i. If no cracking present, certify item as serviceable. Annotate aircraft log book, "Service Bulletin No.133 complied with". Re-inspect at next annual.
 - ii. If brazed joint is found to be cracked, remove flap lever assembly, strip down flap lever completely and replace lever with Part No.T67B-45-262.

4. Return any cracked levers to manufacturer for repair.
5. Report findings, cross referenced to aircraft serial number to Slingsby Aviation.
6. Annotate aircraft Logbook "SB 133 complied with".
