# Service Bulletin

S.B. No: 092

**Title:** INSPECTION AND RECTIFICATION OF FUEL VENT AND HYDRAULIC RESERVOIR TUBE, PLUS VENT PIPE INLET RE-ORIENTATION

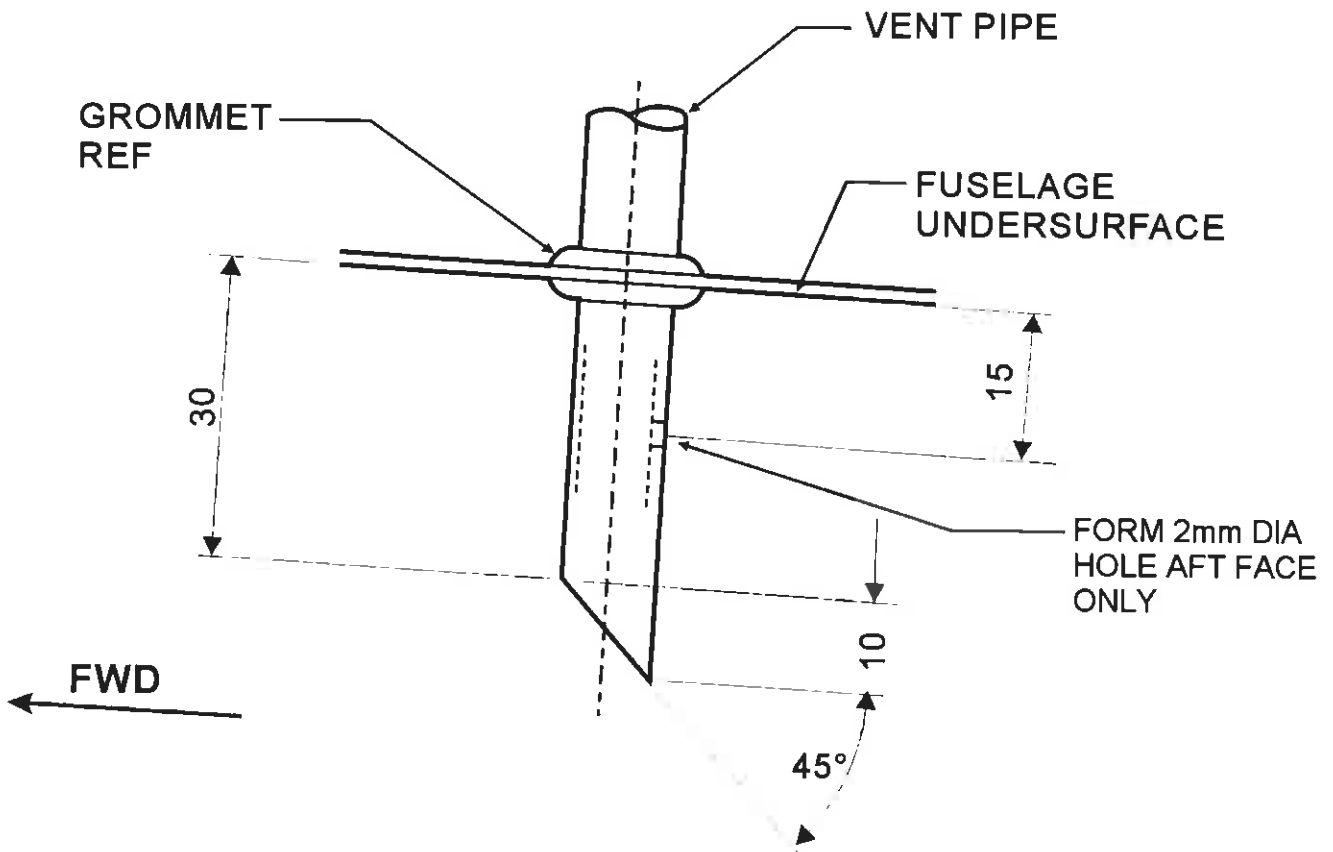
FIGURE 1

During the course of this inspection, ref. T67M260-T3A, ensure the vent pipe inlets are facing forward ref. Figure 1. The pipes are to be re-orientated through 180° to minimise the possibility of fuel in the vent line draining from the aircraft during flight. This action invokes a modification, Mod M701.

Further to Issue 1 of this Service Bulletin, a case has been reported on a T67C aircraft, of the incorrect orientation of the wing fuel vent pipe. This Service Bulletin is now updated to include the checking of the orientation (and length) of the fuel vent pipes on all wing tanked aircraft and to ensure on replacement of the pipe that it is correctly assembled to the aircraft.

Further to Issue 2 of this Service Bulletin, a case has been reported on a T67M260 aircraft, of possible icing on the vent, blocking the main vent and Ø2mm hole. On inspection Ø2mm hole was found to be less than 2mm. This Service Bulletin is updated to inspect and rectify 2mm hole.

1. **T67M260-T3A only.** Inspect the fuel tank vent pipes below the centre section.
  - i. If the vent pipes are found to be stiff and hard, replace.
  - ii. If the vent pipes do not appear to have a yellow cast to them, replace.
  - iii. If in doubt, replace.
2. Vent pipe inspection:
  - 2.1 **T67M260-T3A only.** During inspection or during course of replacement, re-fit vent tubes with opening facing forward. Form (see paragraph 2.3 below) Ø2mm diameter hole in aft face. Ref. Figure 1.

This action invokes Modification M701. Annotate in aircraft logbook "Mod M701 incorporated.
  - 2.2 T67C wing tank (Post Mod M156) only, T67M-MkII, T67M200 and T67M260. Inspect the fuel vent pipe for correct orientation and configuration, ref. Figure 1. If incorrect, re-assemble as shown. If necessary fit new item (SAL Stock Code 126-36-002, length 230mm), to the configuration shown in Figure 1, ensuring vent tubes opening faces forward and 2mm diameter hole is in aft face.

This action invokes Modification M701. Annotate in aircraft logbook "Mod M701 Incorporated if applicable
  - 2.3 **All aircraft.** Check the Ø2mm hole for correct size, if it is undersize, and then remove pipe and open hole up until it is of the correct diameter. This may be done by using oversize drill or oversize punch or forming with hot needle of the appropriate size.

Whichever method is employed it is recommended that the rework of the pipe is done off the aircraft; that if in doubt trial on scrap piece of vent pipe and ensure pipe is not damaged during rework.
  - 2.4 It is recommended that at every annual that the Ø2mm hole is checked for correct size and rectify as per paragraph 2.3 if applicable.
  - 2.5 Ensure during replacement of vent tube during the course of the aircrafts service that the vent pipes are fitted IAW this Service Bulletin, ref. Fig. 1.
  - 2.6 **All aircraft.** Ensure wing seals are correctly fitted, rectify or replace as required.
