SERVICE BULLETIN

SB No. 101 Issue No. 1

TITLE INSPECTION AND REPLACEMENT OF FLAP TORQUE TUBE BEARING AT RIB 2

T67B, T67C Series, T67M, T67M-MkII (Pre Mod M519) and T67M200.

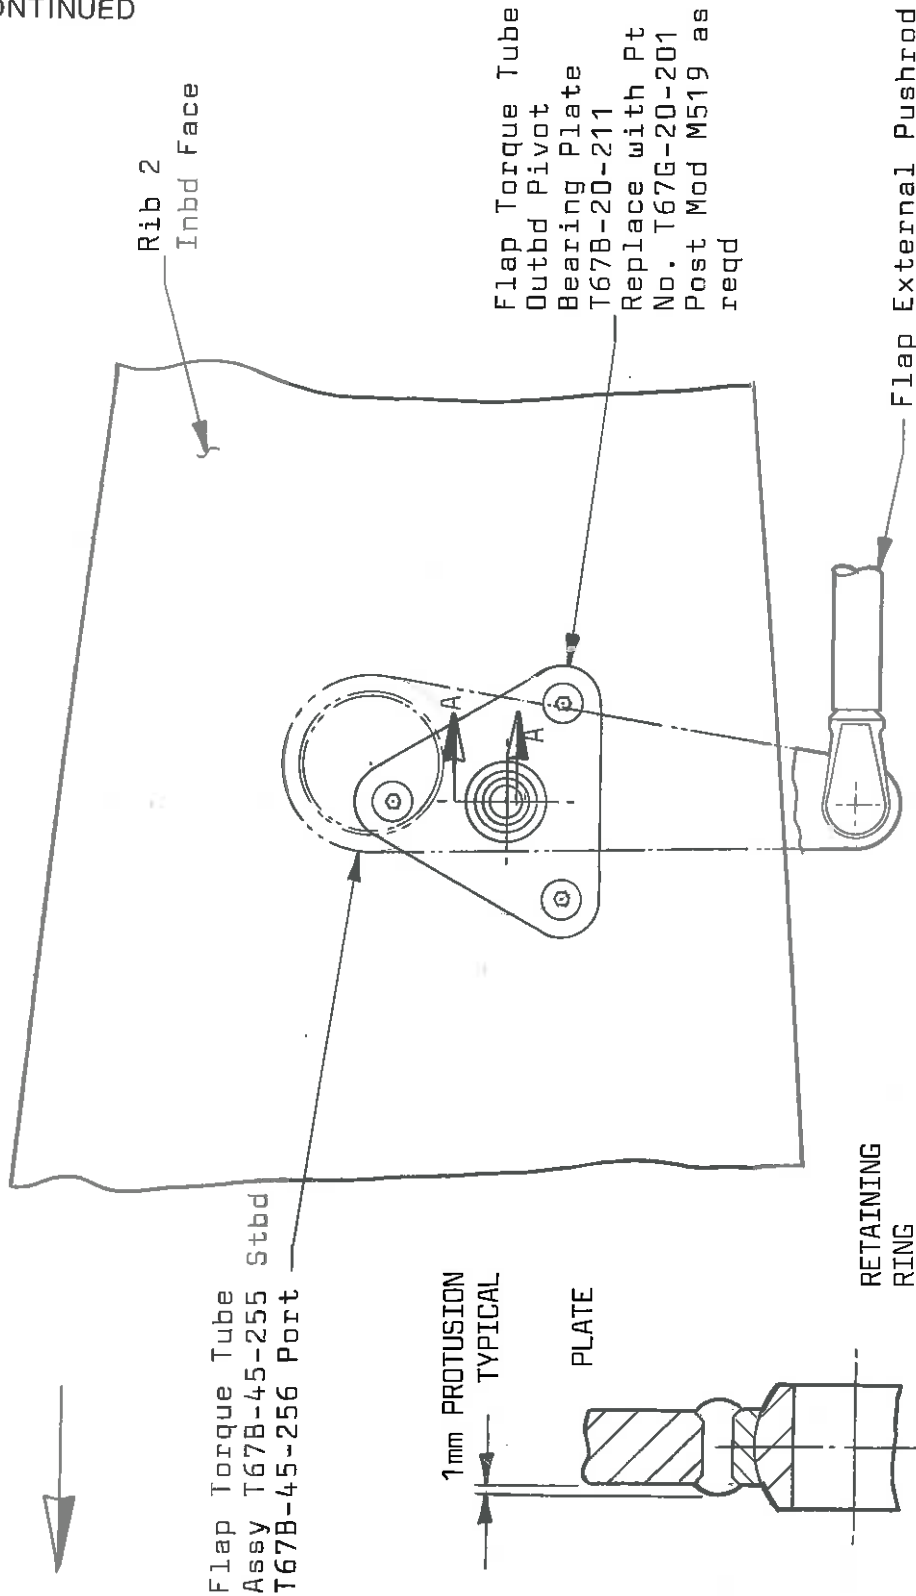
Fig 1
View looking Outbd onto Stbd Wing
Rib 2. Port similar

A case has been reported of the flap operating torque tube outboard pivot bearing on Rib 2 having become loose.

RETAINING RING
BEARING
SECTION A-A
SHOWING CORRECT BEARING RETENTION
SCALE 2:1

1mm PROTRUSION TYPICAL

1. Gain access to Rib 1 and remove flap torque tube.
2. Inspect bearing for retention in mounting plate. Should be .5mm max protrusion. Check by pushing on bearing. If in doubt remove bearing plate from rib and check retention, See Section 'AA', Page 2.
3. If retention unsatisfactory, remove both port and starboard bearing plates T67B-20-211 and replace with Part No. T67G-20-201.
4. On completion of Service Bulletin, annotate in logbook SB 101 complied with. Mod M519 invoked.

Flap Torque Tube Outbd Pivot Bearing Plate T67B-20-211 Replace with Pt No. T67G-20-201 Post Mod M519 as reqd
