# SERVICE BULLETIN

SB No. 153 Issue No. 1

**TITLE** SAB UNDERCARRIAGE NOSEWHEEL FORK INSPECTION

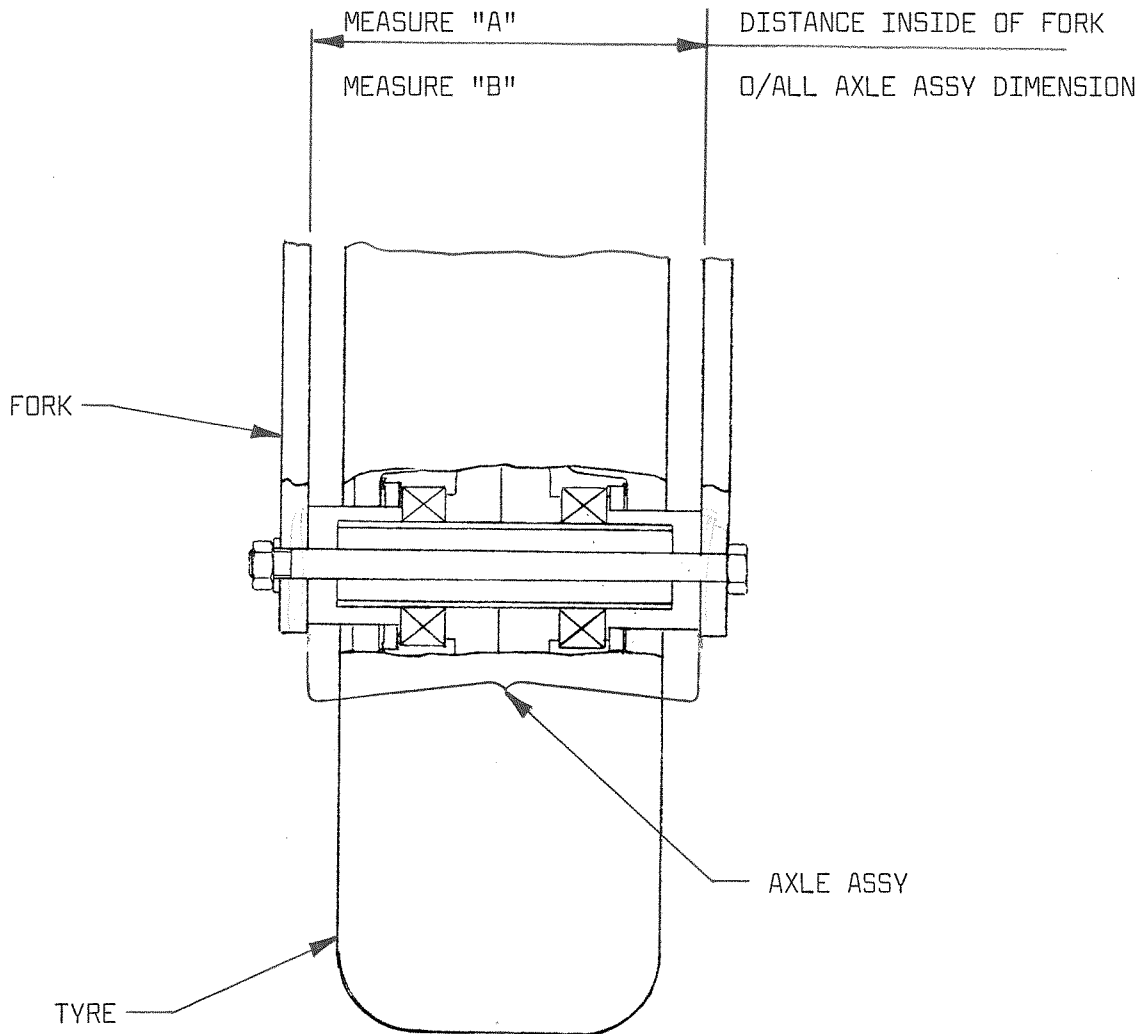
FIG 1

Cases have been reported of the space between the SAB nose undercarriage forks and the wheel axle being sufficiently wide to cause the forks to bend inwards when tight and ultimately cause the axle nut to loosen. This SB requires a one time inspection to determine the width of the gap and fitting of corrective spacers if applicable.

1. Check master switch, ignition switch and fuel are off. Disconnect external power and hangar aircraft, as applicable.
2. Jack or hoist aircraft to bring nosewheel clear of ground with oleo pneumatic strut fully extended
3. Place a suitable trestle support under bottom centre of fuselage 12 inches behind firewall.
4. Remove wheel stiffnut, withdraw axle bolt from axle fork and remove wheel assembly.
5. Leave wheel assembly together and clean outer surfaces of axle spacers and inner surfaces of nosewheel forks.
6. Determine by measurement at axle centreline, the following dimensions, ref Fig. 1.
  - a. Measurement A: The distance between the inner faces of the nosewheel forks. Fork ideally should be parallel.
  - b. Measurement B: The dimension between the axle spacer outer faces when wheel assembly is pushed together, as on aircraft.

7.
  - i. If the difference between the two dimensions is less than 1.5mm, then no further action need be taken.
  - ii. If the difference between the two dimensions is 1.5mm to 4.0mm, then Mod M832 is to be incorporated.
  - iii. If the gap is more than 4.0mm, then new fork is to be procured.
8. Annotate Logbook "SB 153" complied with".
